Innovative Rehabilitation Gives new Life to a 100-Year-Old Steel Truss Bridge

K.Lima, P.Eng, Associate, DIALOG
S.Kanji, P.Eng, Bridge Engineer, The City of Edmonton
J. DiBattista, P.Eng. Principal, DIALOG

Paper prepared for presentation at the
“Bridges – Successes: Let’s Build on Them” Session
of the 2011 Annual Conferences of the
Transportation Association of Canada
Edmonton, Alberta

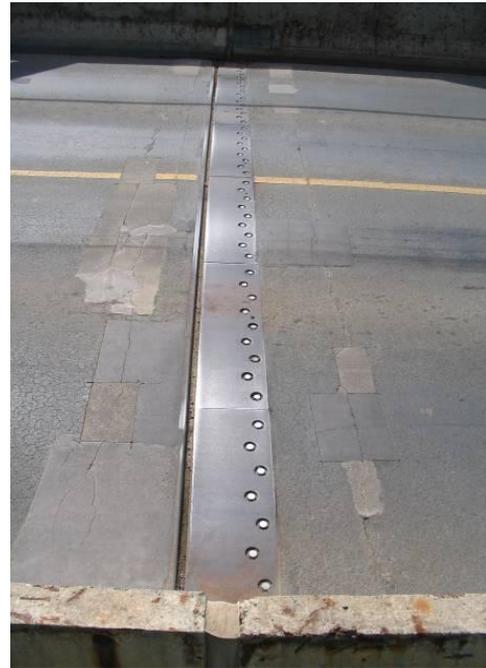
Figure 2: Deck deterioration over floor beams on each side of expansion joint.

Though its relatively light weight was beneficial for limiting overall dead loads, the 165 mm concrete deck was too flexible to resist cracking. In particular, where the concrete deck passed over the existing transverse floor beams, the deck section was reduced to only 65 mm thick, creating a stress concentration in the concrete and making it nearly impossible to control cracking. Figure 2 shows severe deterioration of the thin traffic deck membrane at floor beams on each side of an expansion joint.

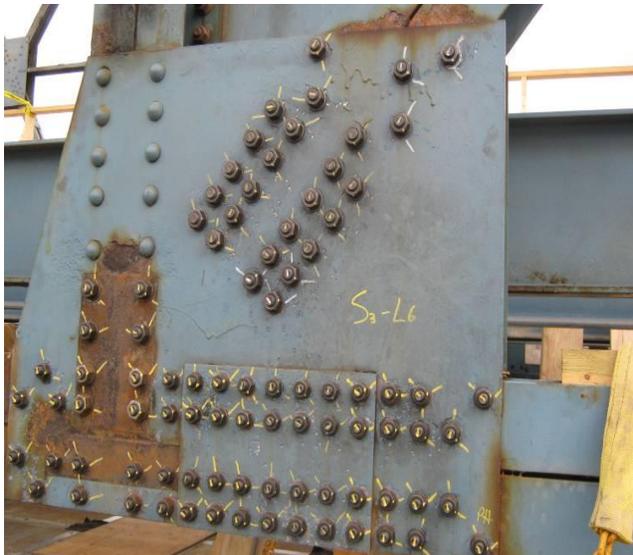
Figure 3: Rivets replaced by high-strength pretensioned bolts at all critical tension connections.

To counter the risk of future fatigue crack growth, the design team implemented a simple and economical fatigue strengthening strategy: replacement of all rivets at critical connections with high-strength pretensioned bolts. High-strength bolts have a higher fatigue stress range threshold (Category B, 110 MPa) than riveted connections (Category D, 48 MPa). The improvement in performance is primarily attributable to local compressive stresses generated by the bolt tensioning, which retard fatigue crack growth.

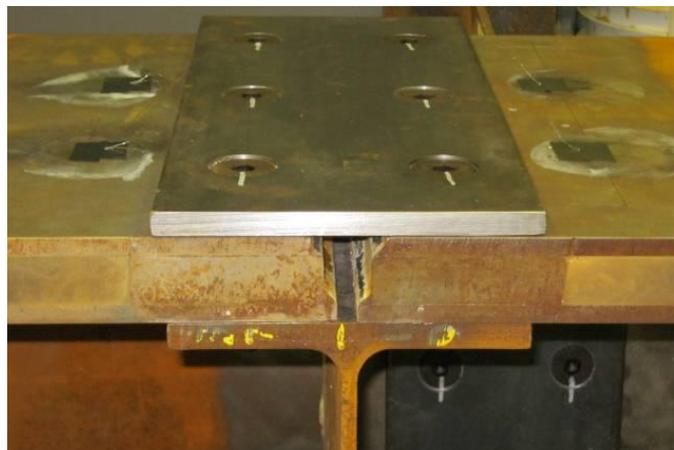
Figure 5: Laboratory prototype of bolted connection of composite steel plate and elastomer decking panels at longitudinal stringer.

To support the results of the analytical analysis, three proof-of-concept samples of the longitudinal bolted deck connection detail were built at 1:1 scale and tested under fatigue loading at the University of Alberta. The goal of the test program was to observe the fatigue behaviour of the deck panel and the longitudinal bolted connection, and to conservatively estimate the fatigue category of the connection. Those tests demonstrated that the new connection detail can withstand fatigue loads nearly double in magnitude to those expected in actual in-service conditions.

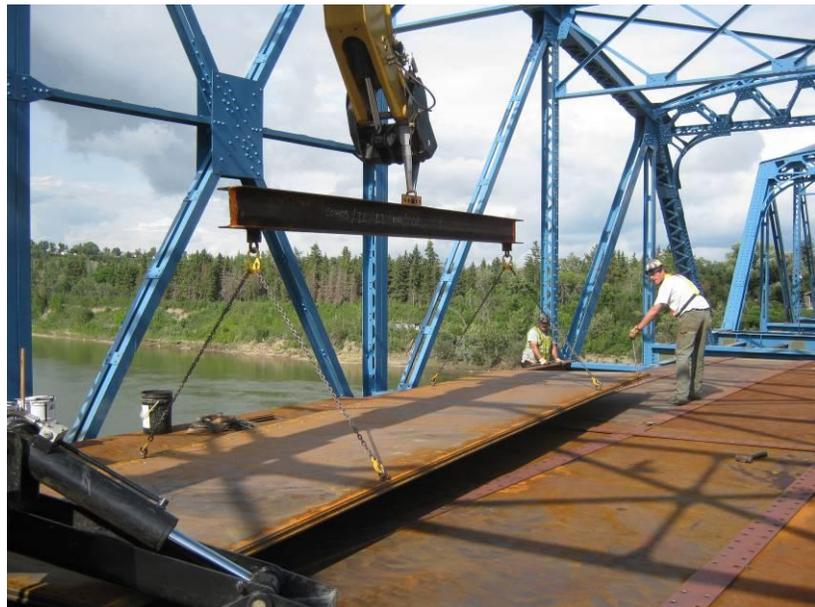
Figure 6: Installation of composite steel plate and elastomer decking panels.

After removal of the existing concrete deck, wood sub-deck and original steel stringers was complete, five new lines of longitudinal structural steel stringers were installed between existing floor beams, matching the 1.9 m deck panel width. All stringer flanges were pre-drilled with holes to accept the composite steel plate and elastomer deck panels, which were hoisted into place and bolted to the stringers using countersunk pre-tensioned ASTM A325 bolts (Figure 6).

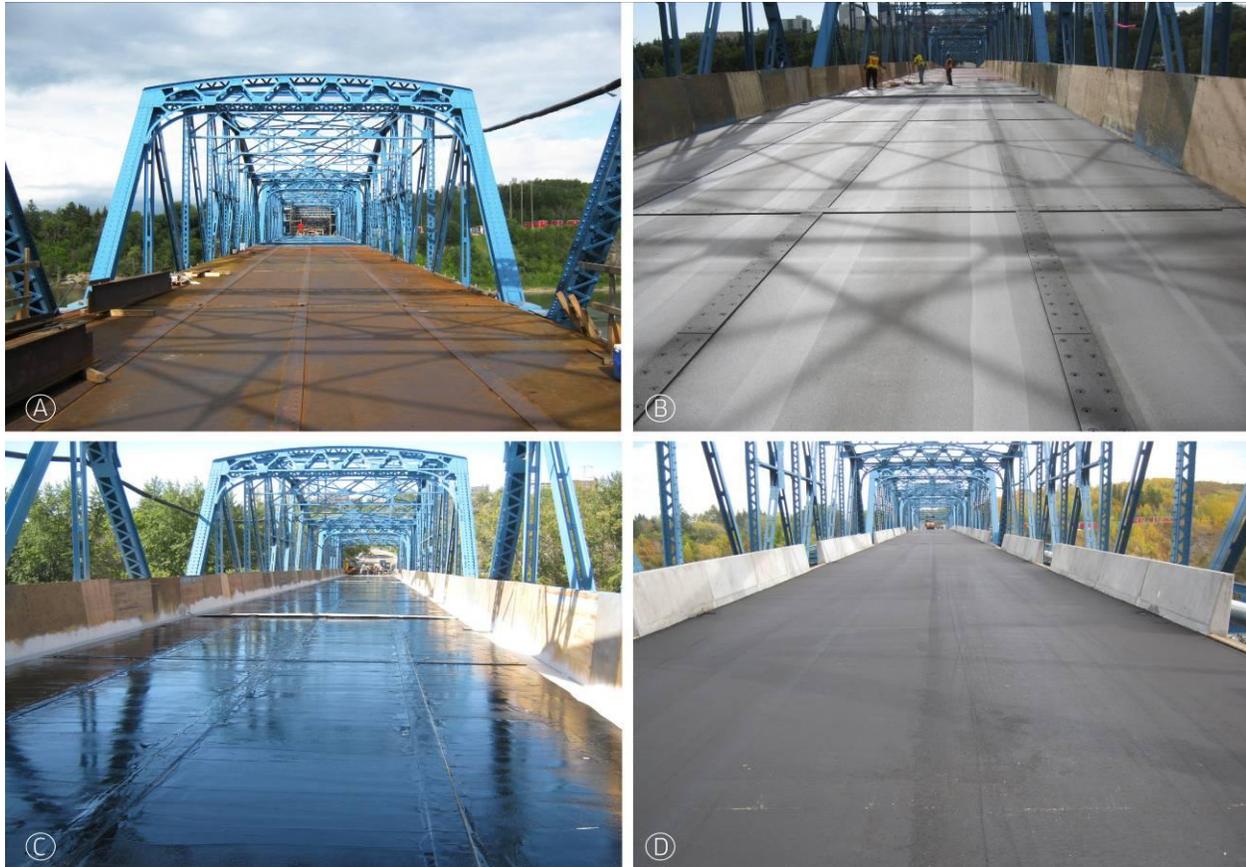
Figure 7: Deck construction sequence: A) panel bolting; B) grit blast surface; C) apply multi-coat waterproofing membrane; D) polymer-modified asphalt wearing surface.

In order to make deck detailing and construction simpler, the deck in each span is planar with no cross-fall. Deck steel is protected by a multi-coat waterproofing membrane and has an asphalt wearing surface. To achieve positive drainage, the asphalt has cross-fall and varies in thickness from 40 mm at the edges to 100 mm along the deck centreline. Polymer-modified asphalt (PMA) was specified to reduce the probability of cracking at the splice plates atop the deck panels. Figure 7 illustrates the construction sequence used to achieve the finished deck surface.
