Harwood Avenue and Bayly Street (Reg. Rd. 22)
A Concrete Pavement Urban Intersection Pilot Project
The Regional Municipality of Durham

Paper prepared for presentation at the
Innovations in Pavement Management, Engineering and Technologies Session
of the 2017 Conference of the Transportation Association of Canada
St. John's, NL

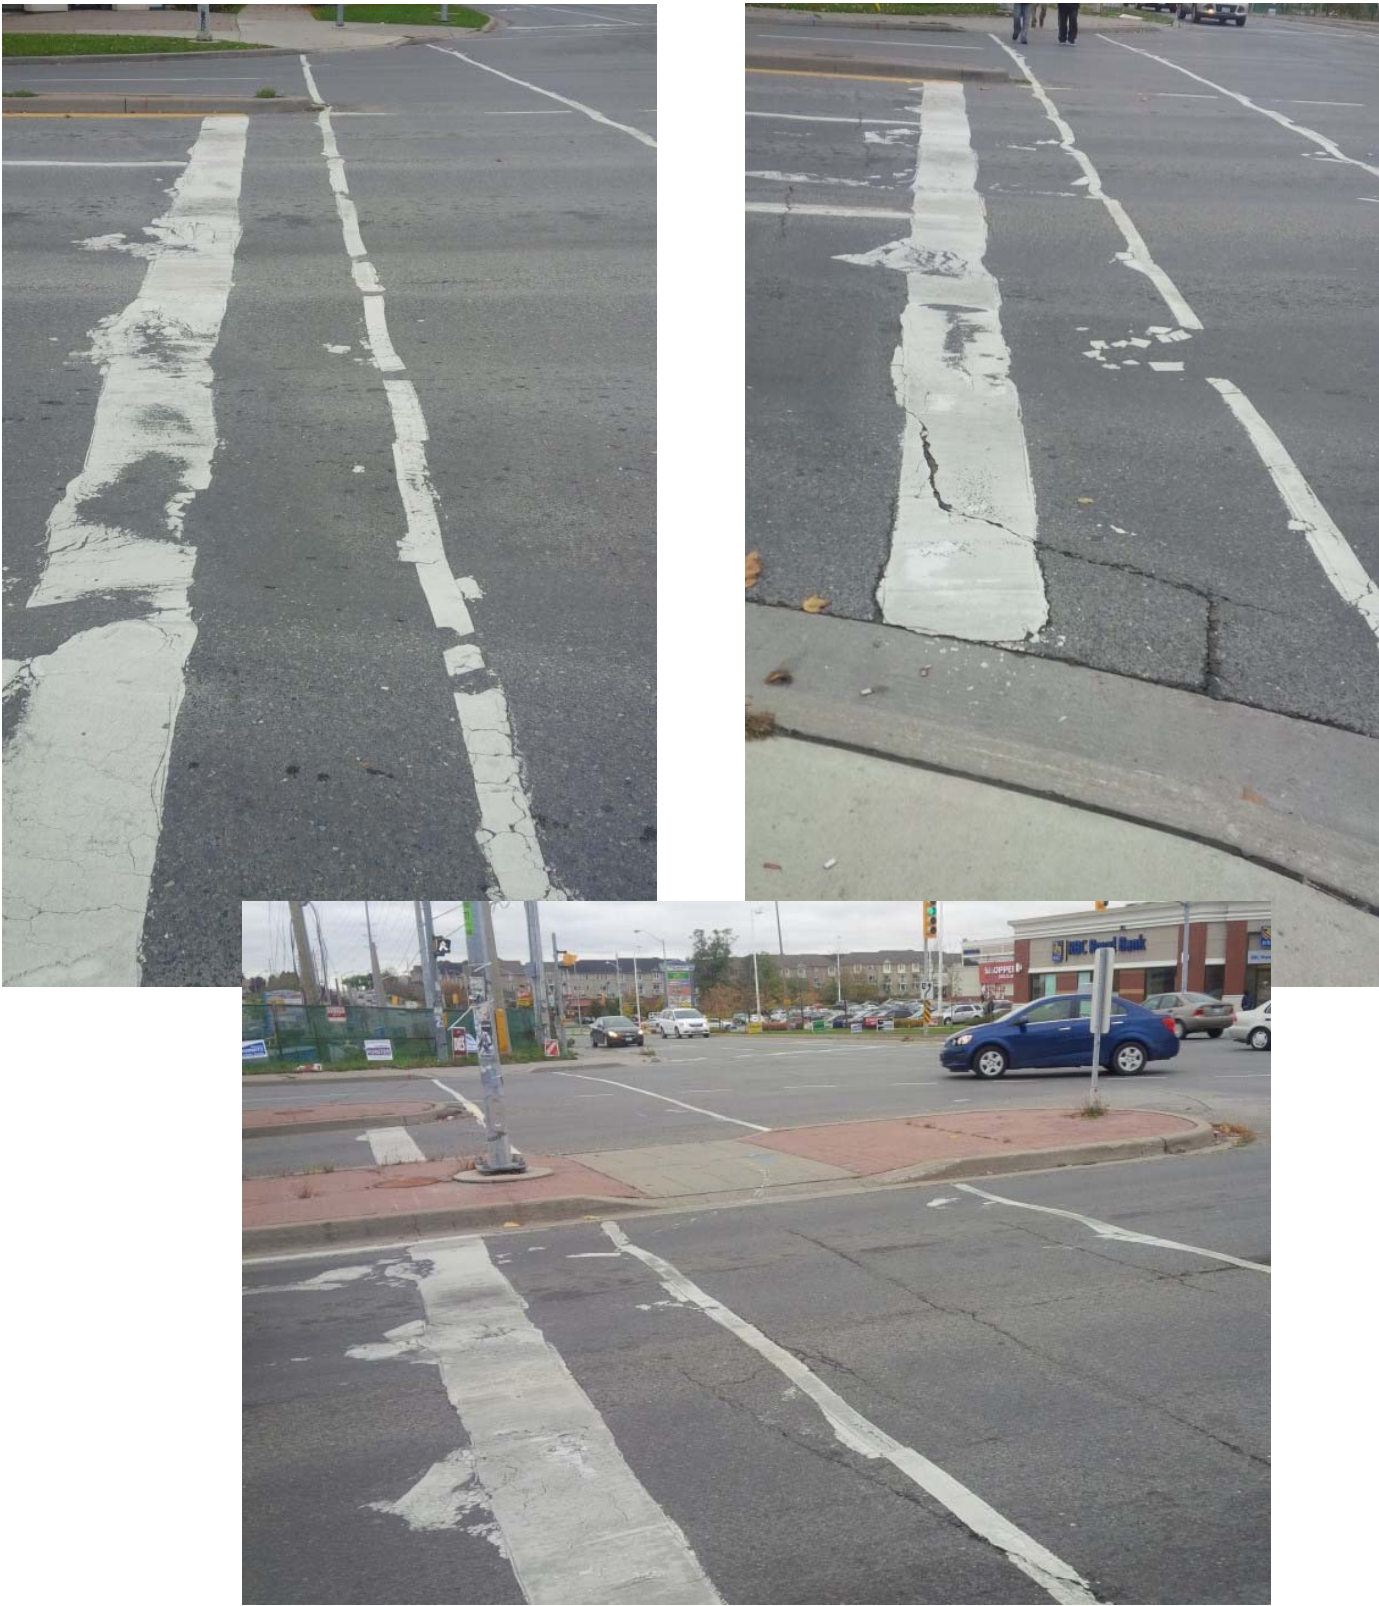
Figure 1 – Asphalt distresses at the intersection approaches (photos from 2014)

Soon after construction, the pavement experienced extensive, moderate to severe wheel path rutting and shoving and was in need of rehabilitation. These types of distresses can be attributed to a combination of factors including high truck and bus traffic, rounded or poorly graded aggregates used in the asphalt mixes, poor quality asphalt mixes (i.e. too many impurities), poor construction methods (i.e. overheating) and low asphalt Performance Grades (PG) [1]. Over time, wheel path rutting is common to

some degree at most arterial intersections throughout the Region. However, the magnitude and severity of these distresses at this intersection were greater than other typical intersections, and the distresses became evident within 12-18 months of construction. The asphalt failures were most obvious at the locations of the stop bars and crosswalks where the transverse pavement markings deformed with the shoving and rutting asphalt.

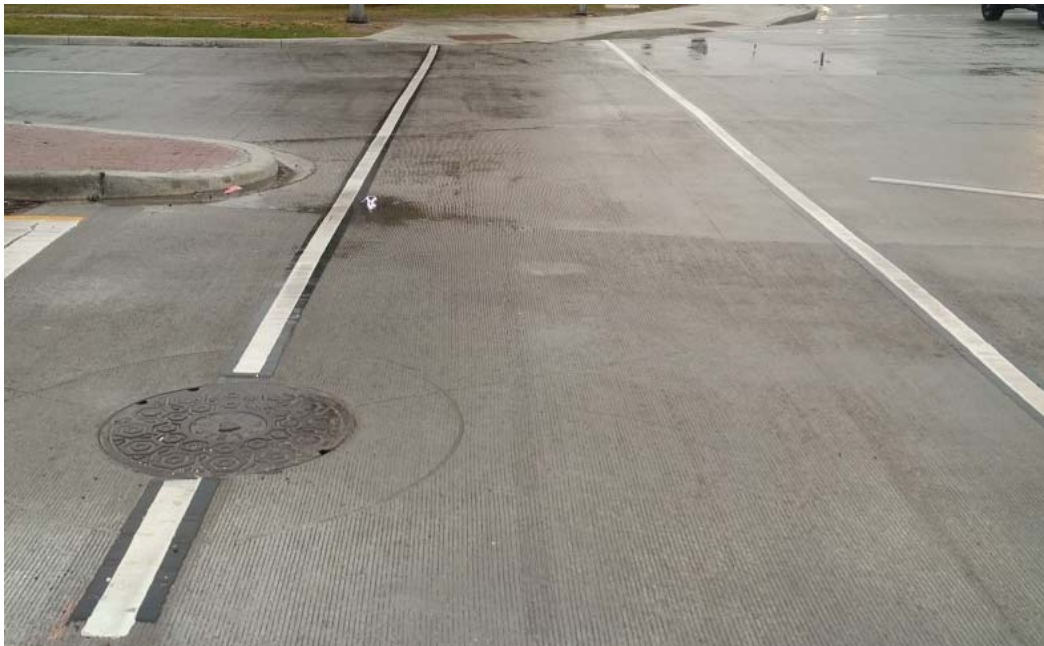
Figure 5 - Methyl methacrylate pavement markings with black backing on new concrete

On urban asphalt pavements throughout Durham Region, permanent pavement markings are generally applied using thermoplastic or field reacted polymeric materials. Thermoplastic materials rely on a thermal bond between the pavement marking and the pavement surface which is usually well established when placed on asphalt pavements [4]. Concrete surfaces are generally more porous and the thermal bond is therefore not as strong. For these reasons MTO does not recommend using thermoplastic materials on concrete pavements and for this project, methyl methacrylate was specified as the pavement marking material. Methyl Methacrylate is a type of field reacted polymeric material that is listed on the MTO Designated Sources of Materials (DSM) approved products list and recommended for concrete surface applications. Prior to placement of the material, the concrete surface was mechanically blast cleaned to ensure that all surface accumulations of hardened concrete layers or laitances and any trowel finishes were completely removed. Efforts were made to place the markings on the bare concrete surface with exposed upper fascia of the aggregate for optimal bonding. To improve the visibility of white markings on grey concrete, the design included a wider black marking to be placed behind the standard white lines for all cross walks and left turn skip lines.

The white-on-black methyl methacrylate pavement markings discussed in Section 5.3 were thicker than a single layer of thermoplastic that the Region typically uses. These thicker markings may not hold up as well over time (especially from snow plow wear) and may need to be reapplied more often.

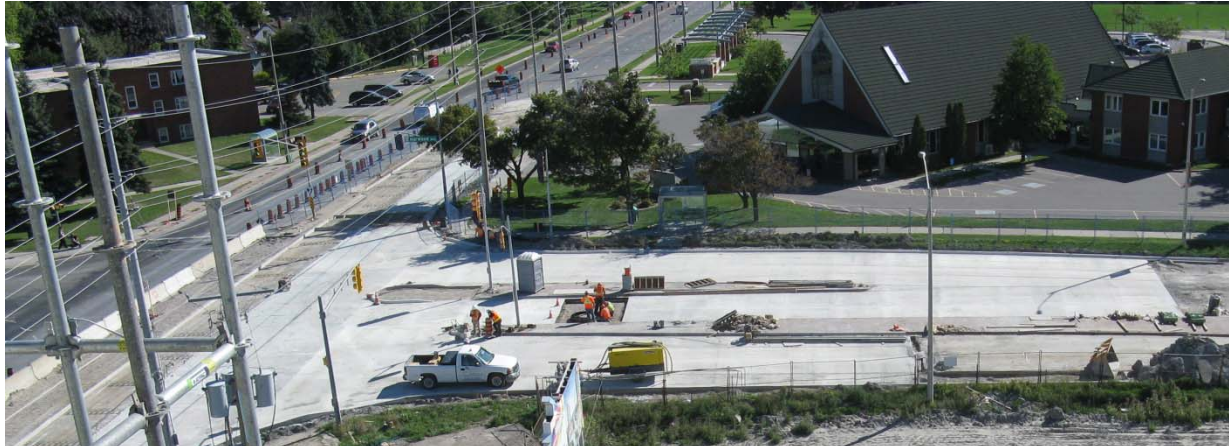
Figure 7 - Stage 2 paving

Stage 2 maintained the same partial intersection closure for the road works in the south half of the intersection. After removal of the existing asphalt and curb, the underlying granular material was proof rolled and new Granular A was placed and compacted. The preformed traffic loops were placed on the new granular base and the dowel baskets and tie bars were laid out along the proposed joint locations. For the paving operations, the contractor opted to use fixed forms and a vibratory roller screed paver. Strategic sequencing of the concrete slab construction minimized the total number of pour-days by ensuring that adjacent slabs were cured in time to serve as formwork for new pours. This saved time and allowed the contractor to efficiently work around the slotted left turn lanes and median islands. Once the concrete paving was completed, curing compound was applied immediately and the joints were sawcut within the first two hours of curing using early-entry saws. Following the concrete paving,

the new curbs were constructed. Since the pavement was connected to the new curbs with tie bars, the sawcuts in the curb were aligned with the sawcut locations in the concrete pavement to prevent uncontrolled cracking. Stage 2 took approximately one month to complete.

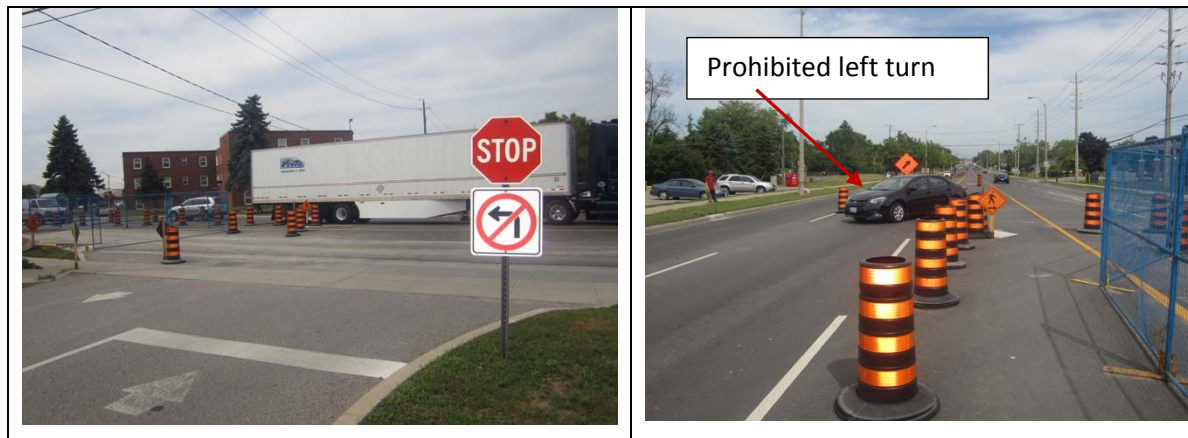
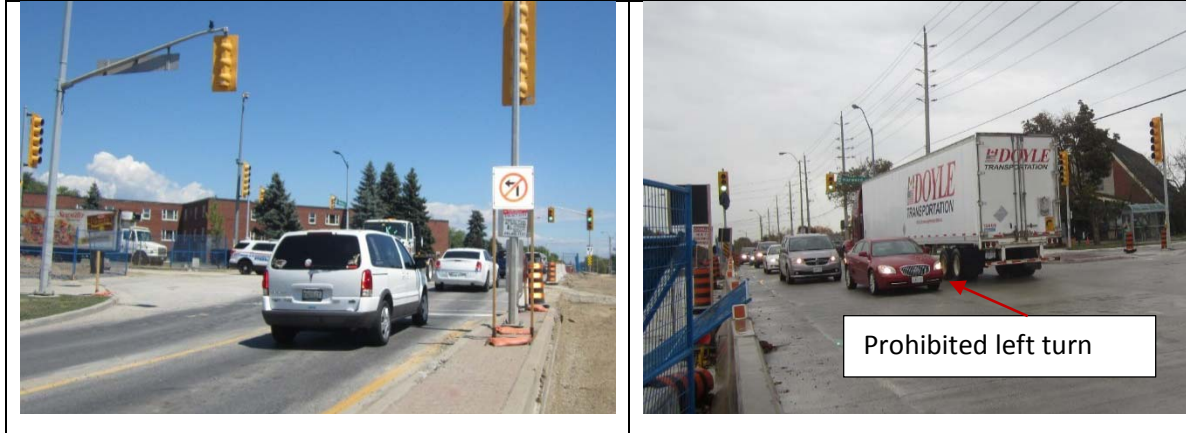
Figure 13 “No left turn” sign and left turns

Left turns were prohibited during construction to facilitate traffic flow through the intersection. Left turns were made at almost every route although “No left turn” was in place as shown in Figure 13. These prohibited left turns not only delayed the traffic, but also posed a safety concern for workers, pedestrians and other vehicles.

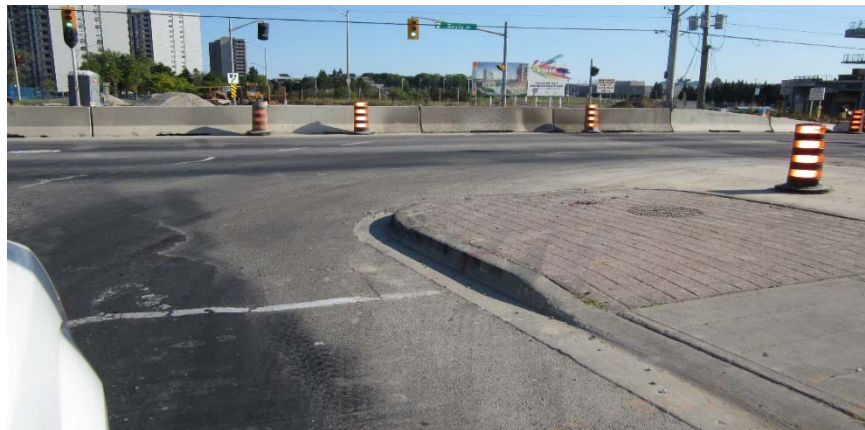
Figure 14 - Marks on the median island due to right turning vehicles

To facilitate the watermain construction, the southbound right turn lane on Harwood Avenue was closed in Stage 1. A temporary right turn lane was designated in the southbound slotted left turn lane as shown in Figure 14. Due to the geometry of the existing median island, a number of right turns were observed to run over the curb. An appropriate warning sign or temporary asphalt ramping may have prevented cars and trucks from running over the curb.

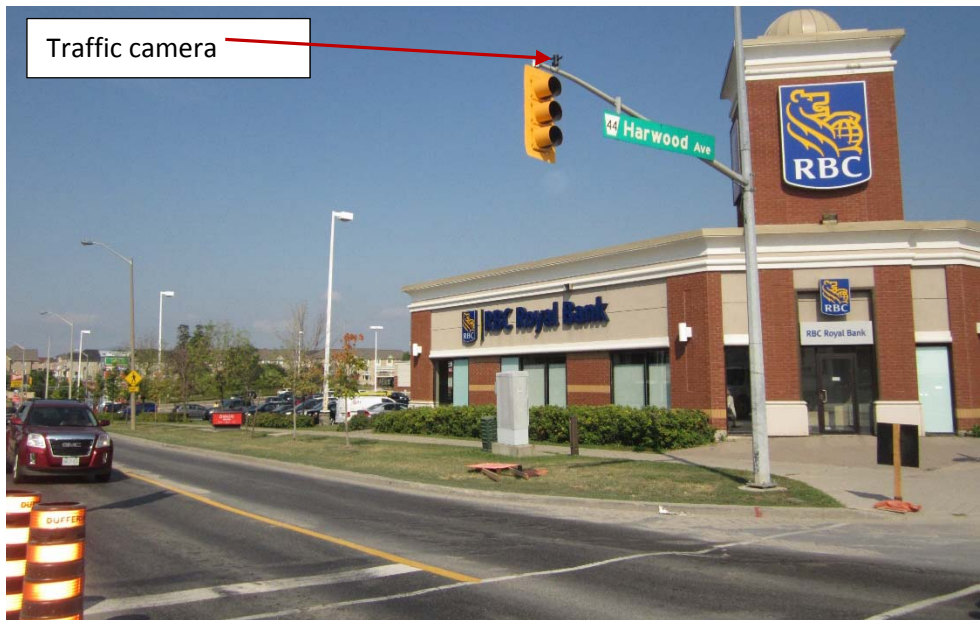
Figure 15 Traffic camera installed

As shown in Figure 15, the existing traffic signal camera was used to record construction sequences and traffic flow over the course of the project. The majority of the construction works were captured on video and all traffic movement through the site was also recorded. Following completion of the project, the video was spliced and sped up to provide a time-lapsed video of the construction works. The traffic data was ultimately used to determine the impact of construction and lane closures on traffic, which is described in the following section.

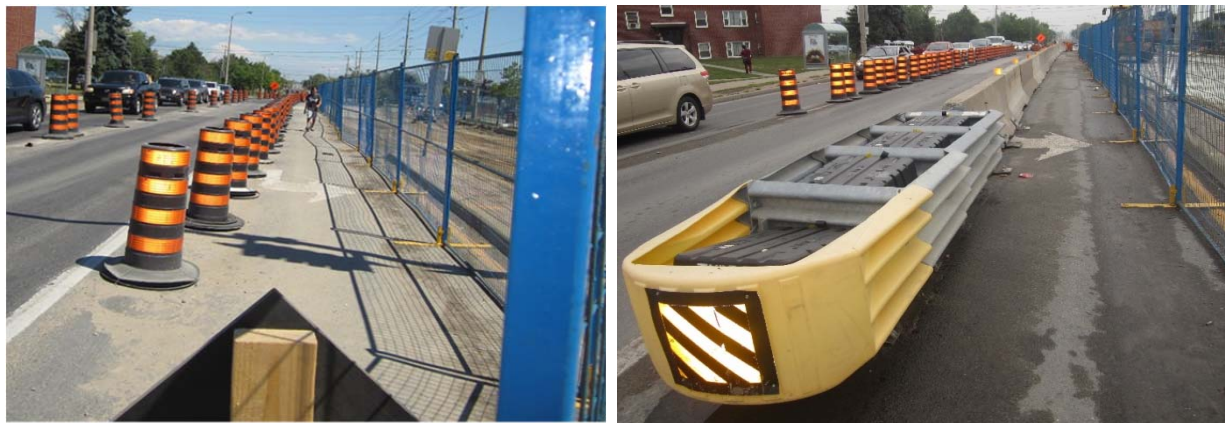
Figure 19 Traffic cones vs. concrete barriers

Construction was originally planned to occur during the summer months while school was out. Scheduling delays caused the work to continue into the school year and so pedestrian volumes were higher than anticipated. Additional crossing guards were utilized to facilitate pedestrian crossing through the intersection and around the construction area. As shown in Figure 19, concrete barriers were installed to provide better protection for pedestrians than the traffic barrels that were originally implemented.
