# **Non-Destructive Testing of Bridge Deck Using Passive Infrared Thermography and Ground Penetrating Radar**

Paper prepared for presentation  
at the Structures Session  
of the 2016 Conference of the  
Transportation Association of Canada  
Toronto, ON

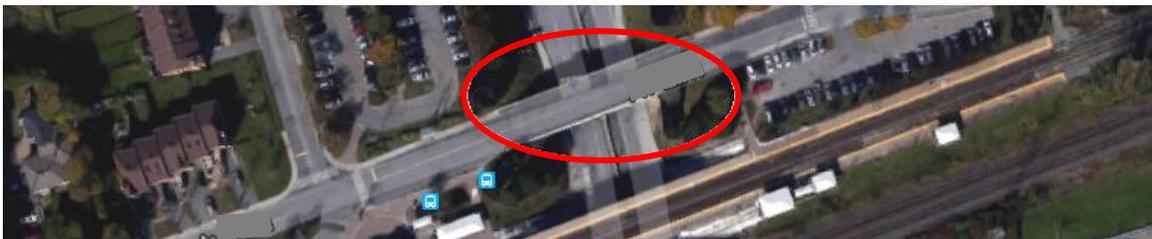
**Figure 1:** Illustration of the surveyed concrete bridge in Quebec.

Field testing was conducted in the present study on an in-service reinforced concrete bridge deck. The bridge is located in Quebec, Canada and the deck was rated as having poor condition, which make it a good candidate for a bridge deck evaluation study using thermal IR and GPR imagery to detect subsurface anomalies. The bridge was constructed in 1969, and the deck is connected directly to the supporting abutments with no provision in the form of bearings. The critical deck characteristics include a total length of 147 ft with a transverse width of 29.53 ft, which translates into 26.25 ft of drivable surface (supports one lane of traffic in each direction) with one side shoulder. **Figure 1** shows a location map of the surveyed bridge.

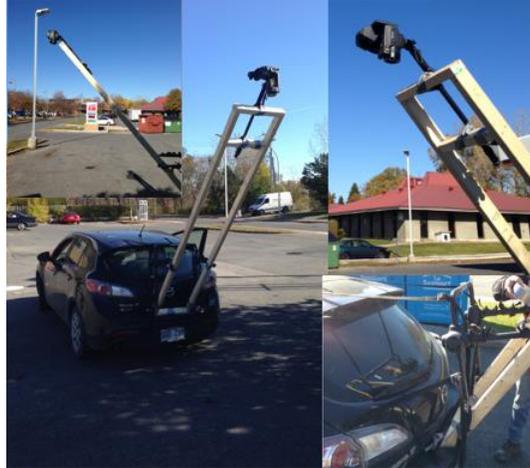
The most important parameters that must be considered before choosing an IR camera include the spectral range, spatial resolution, temperature range and frame rate. For observing objects at ambient temperature, a long wave length band (7.5–14  $\mu\text{m}$ ) are preferable to detect small thermal contrasts. The spatial resolution of an IR camera primarily depends on the object-to-camera distance, lens system and detector size. An advanced infrared thermal camera, FLIR T650sc, was utilized in this survey. The camera has uncooled microbolometer detector, 5 MP built-in digital camera, and displays thermal images with a resolution of 640 x 480 pixels. The thermal IR camera was mounted on a vehicle at a height of 8.5 ft oriented facing straight-down to the concrete deck surface. A calibrated 13.1 mm focal lens (45° wide lens) was utilized. This allows a 7 ft x 5.3 ft field of view for each image and to survey each single lane with only two passes. The vehicle was driven at low speed over the center of each pass of the bridge deck. The images were taken every 3 ft and hence, a total of 392 thermal and digital images were collected, which covers the entire bridge deck. The survey was conducted on October 27<sup>th</sup>, 2015 at 1 PM, 6 hours after sunrise. During the survey indicated, the ambient temperature was 56° F, relative humidity was 26%, wind speed was 5 mph. Bridge deck dryness was considered during data collection since surface moisture can reduce the thermal contrast on the thermal IR images. Sun direction was also considered to avoid shadows on images. The total time of data collection was about two hours. The digital images were used to separate patches and surface defects from subsurface anomalies. The Matlab image acquisition toolbox was utilized to initialize acquisition and storage of the IR data. **Figure 2** illustrates the utilized camera and the vehicle mounted setup.

**Figure 2:** The utilized IR camera (FLIR T650sc) mounted on a vehicle.

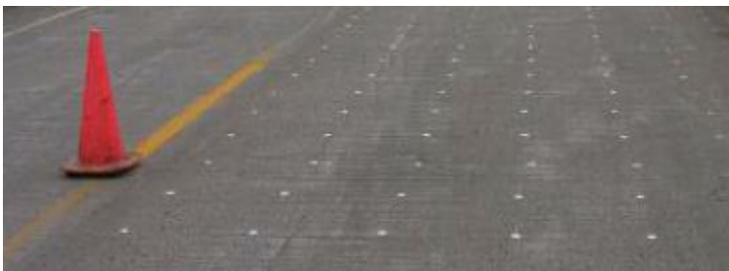
The GPR deck scan was carried out as per ASTM D6087-08 (Standard Test Method for Evaluating Asphalt-covered Concrete Bridge Decks Using GPR). The survey was done on September, 2015 by a specialized consultant, as part of condition survey program. The bridge deck was scanned with a ground-coupled radar system using a pushing cart. A grid of scanning paths with 50 cm spacing and 25 cm offset from the curb was established using water soluble paint dots. To move the machine in accurate straight lines, a survey string was used between the points of each path. The scan was conducted using the GPR machine GSSI-SIR3000 with 1600 MHz antenna frequency. The GPR machine was calibrated before scanning the bridge deck to ensure accurate measurements during the survey. Data collection was made longitudinally on the deck and hence, a total of 16 profiles were collected for the entire bridge deck (8 profiles for each direction) where each profile represented a zone width of 500 mm. The pass direction was selected so that the antenna crosses over the primary top layer of reinforcing at a 90° angle. The first scan path was done in one direction and the second in the reverse direction and so on. However, it should be noted that the profiles conducted in the reverse direction were reversed during the analysis process. Road closure was performed during the work, giving adequate access to the bridge deck. **Figure 3** illustrates the grid pattern and the utilized GPR machine.

**Figure 3:** Illustration of bridge deck grid indicating travel paths and the utilized GPR machine.

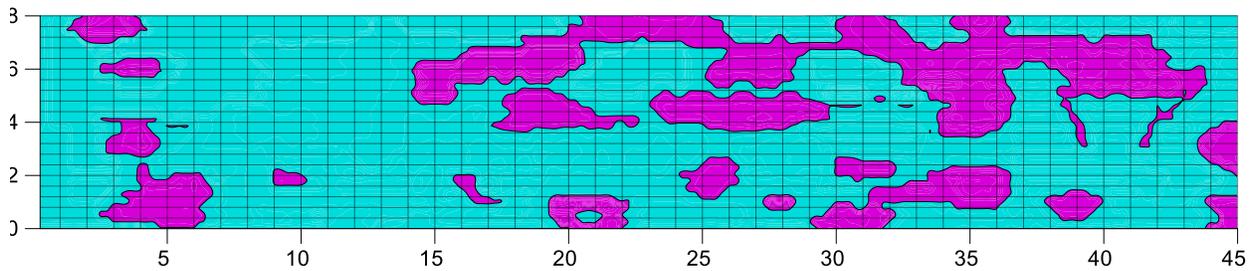
Thresholding classification using the saved temperature values was implemented in the present study to identify the defective areas in the concrete deck. Firstly, the thermal contrasts were calculated from the temperature values of the mosaicked thermogram. The max thermal contrast of the recorded data was 7.7 ° C. It was then necessary to select a threshold value for the calculated thermal contrasts that could indicate where delamination was likely to be detectable. A 1°C threshold was selected for two reasons: (1) it is 20 times higher than the sensitivity of the utilized camera such that much smaller variations in surface temperature were easily detectable; (2) it is twice the ASTM D4788-

03 requirement ( $0.5^{\circ}\text{C}$  minimum contrast between sound concrete and a defect). The pixels with a higher temperature than this threshold value were highlighted because delaminations appear with a higher temperature. Finally, the temperature values were grouped and a condition map was plotted using a commercial mapping software to construct a high contrast image, accurately delineating the location of subsurface defects. **Figure 4** illustrates the created map of the surveyed bridge deck.

**Figure 4:** IRT condition map indicating delaminated areas in the surveyed bridge deck.

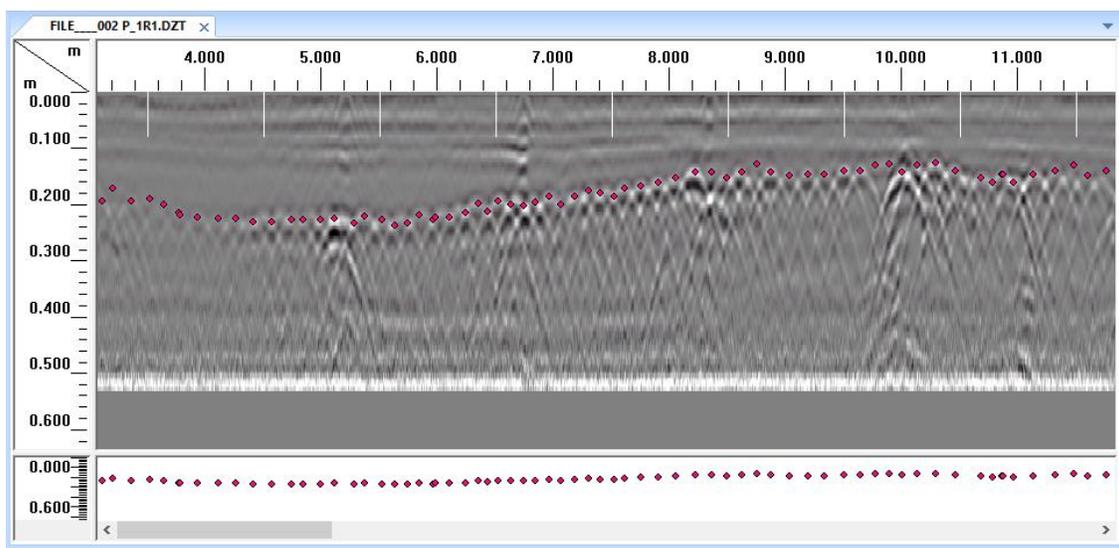
The numerical amplitude analysis method was utilized in the present study. The scanning profiles were post-processed using the commercial radar software, RADAN, to extract important information for further analysis. First, each profile was cut down to remove the extremes and just include the bridge deck length. Next, the top reinforcing steel bars were selected (peak of the parabolic shapes). When the entire bars are selected, the software generates an Excel sheet containing the scan number, amplitude, and two-way travel time for each point (bar). This step is repeated for the entire bridge deck's profiles. **Figure 5** illustrates the picked top reinforcing bars, represented as red points, in a B-scan profile.

**Figure 5:** Picking top reinforcing bars in a B-scan profile.

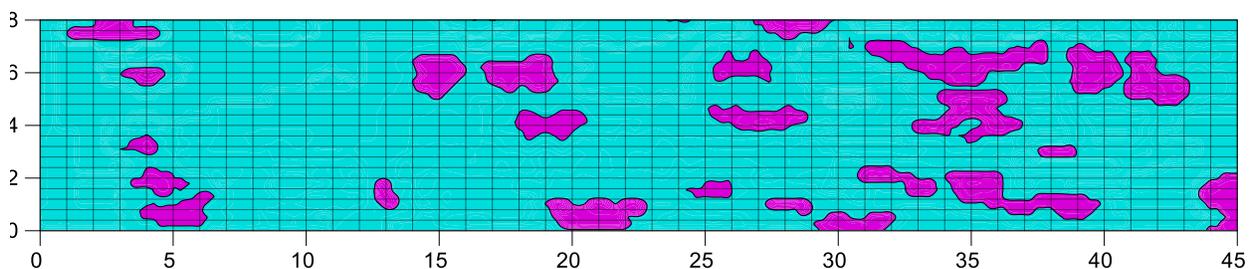
Thresholding classification was implemented in the present study to identify the defective areas in the concrete bridge deck. Upon completion of the numerical amplitude analysis and the depth correction process, it is common for the amplitudes to be contour plotted based on a selected threshold value. Martino *et al.*, (2014) developed a model based on a correlation between GPR and half-cell potential to find a threshold for GPR that can differentiate sound from corroded areas. The model was developed based on the observation that the histogram of a sound bridge deck's amplitude is compacted and symmetric and has almost a normal distribution, while for the corroded bridge deck is quite spread out and skewed to one side. A linear regression formula was used to calculate the corroded area, which is equal to skew multiplied by the mean of the amplitude values. After the percentage of total corroded area was calculated, GPR threshold was determined by trial and error to have almost the same area of corrosion. The final output was an Excel file containing information on the selected reinforcing bars (co-ordinates and amplitude). Then, the amplitude values were grouped and a condition map was plotted using a commercial mapping software to construct a high contrast image, accurately delineating the location of corroded areas. **Figure 6** illustrates the created map of the surveyed bridge deck.

**Figure 6:** GPR condition map indicates location of corrosion in the surveyed bridge deck.
