Proposed Paper for submission to the TAC 2021 Conference – Transportation Structures

Concrete Petrography: An Essential Component of Cost-effective Decision Making for Infrastructure Renewal

Fred Shrimer, P.Geo., FGC
Senior Geologic Resources Geoscientist, Golder Associates Ltd.

Michael Maher, Ph.D., P.Eng.
Senior Materials Engineer, Golder Associates Ltd.

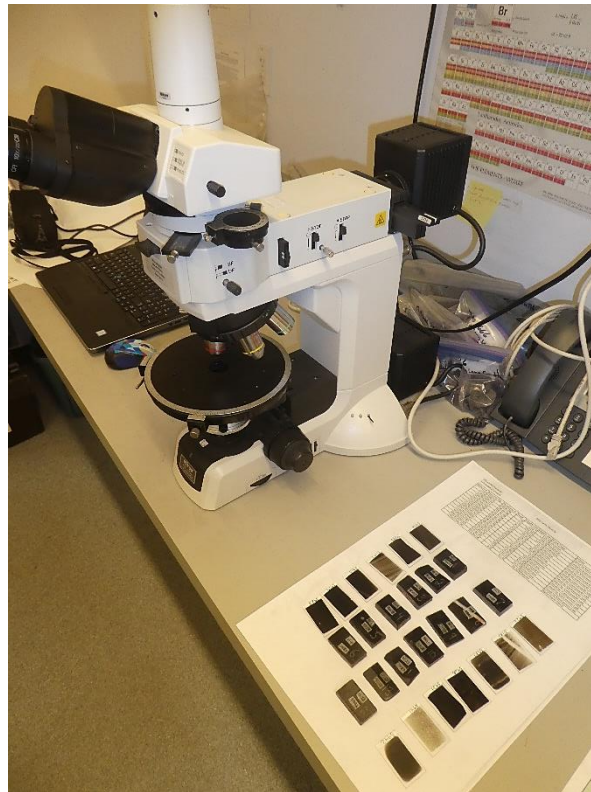
Figure 1: Polarizing microscope used in petrography.

Typically, thin-section mounts are prepared of the concrete as well, to enable an in-depth examination in the polarizing microscope (Figure 1). The size and number of thin-section mounts will depend upon the nature of the examination, the size of the sample, and the nominal maximum size and amount of coarse aggregate.

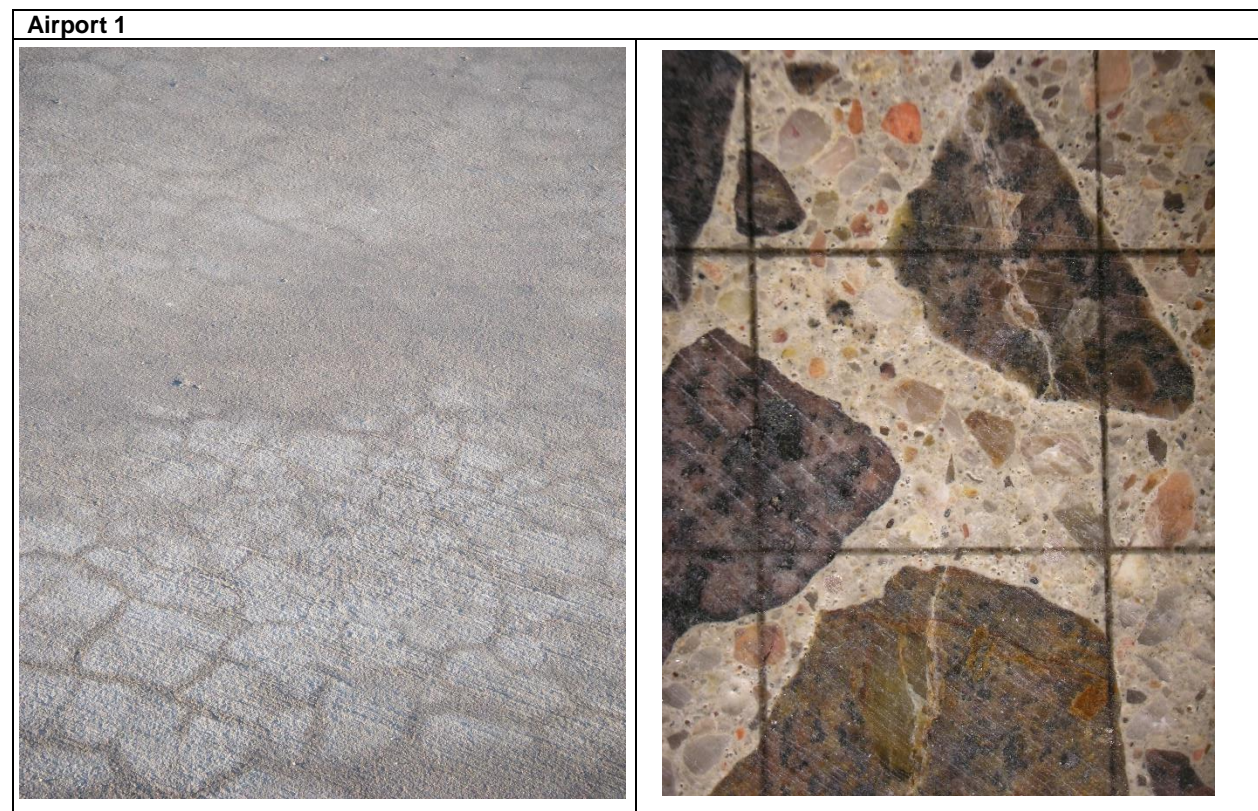
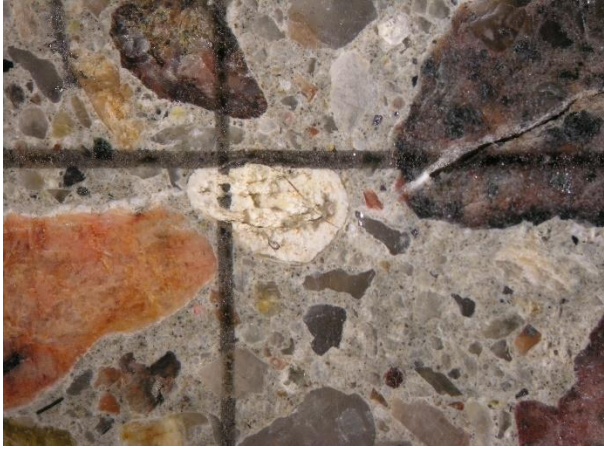
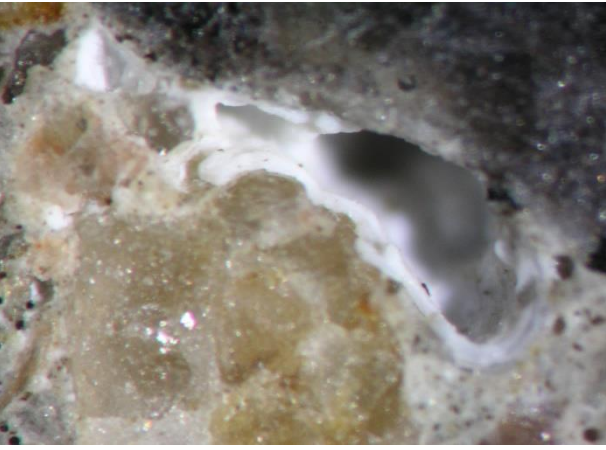
Taxiway pavement concrete exhibiting extensive map cracking. Area measures about 2.5 m across.	Detail of lapped core face showing 10 mm-square grid used for Damage Rating Index (DRI) test. Image illustrates ASR-gel-filled cracks extending through aggregate particles and into adjacent paste.

DRI sample showing partly consumed aggregate at centre, and ASR-gel-lined crack extending through reaction rimmed aggregate particles into paste. View is about 15 mm across.	Detail showing an ASR-gel-lined cavity in concrete next to a reactive aggregate particle. View is about 4 mm across.

Figure 2: Airport pavement concrete damaged by alkali-aggregate reactivity.

This airport pavement exhibited widespread occurrence of map cracking and typical ASR-discolouration along crack traces (Figure 2). Numerous cores were obtained and examined.

DRI values for the US airport pavements ranged from a low value of “8” to a high value of “427”, which correspond to classifications of “negligible” or “minor” ASR severity and associated damage to “significant” as shown in Table 1.

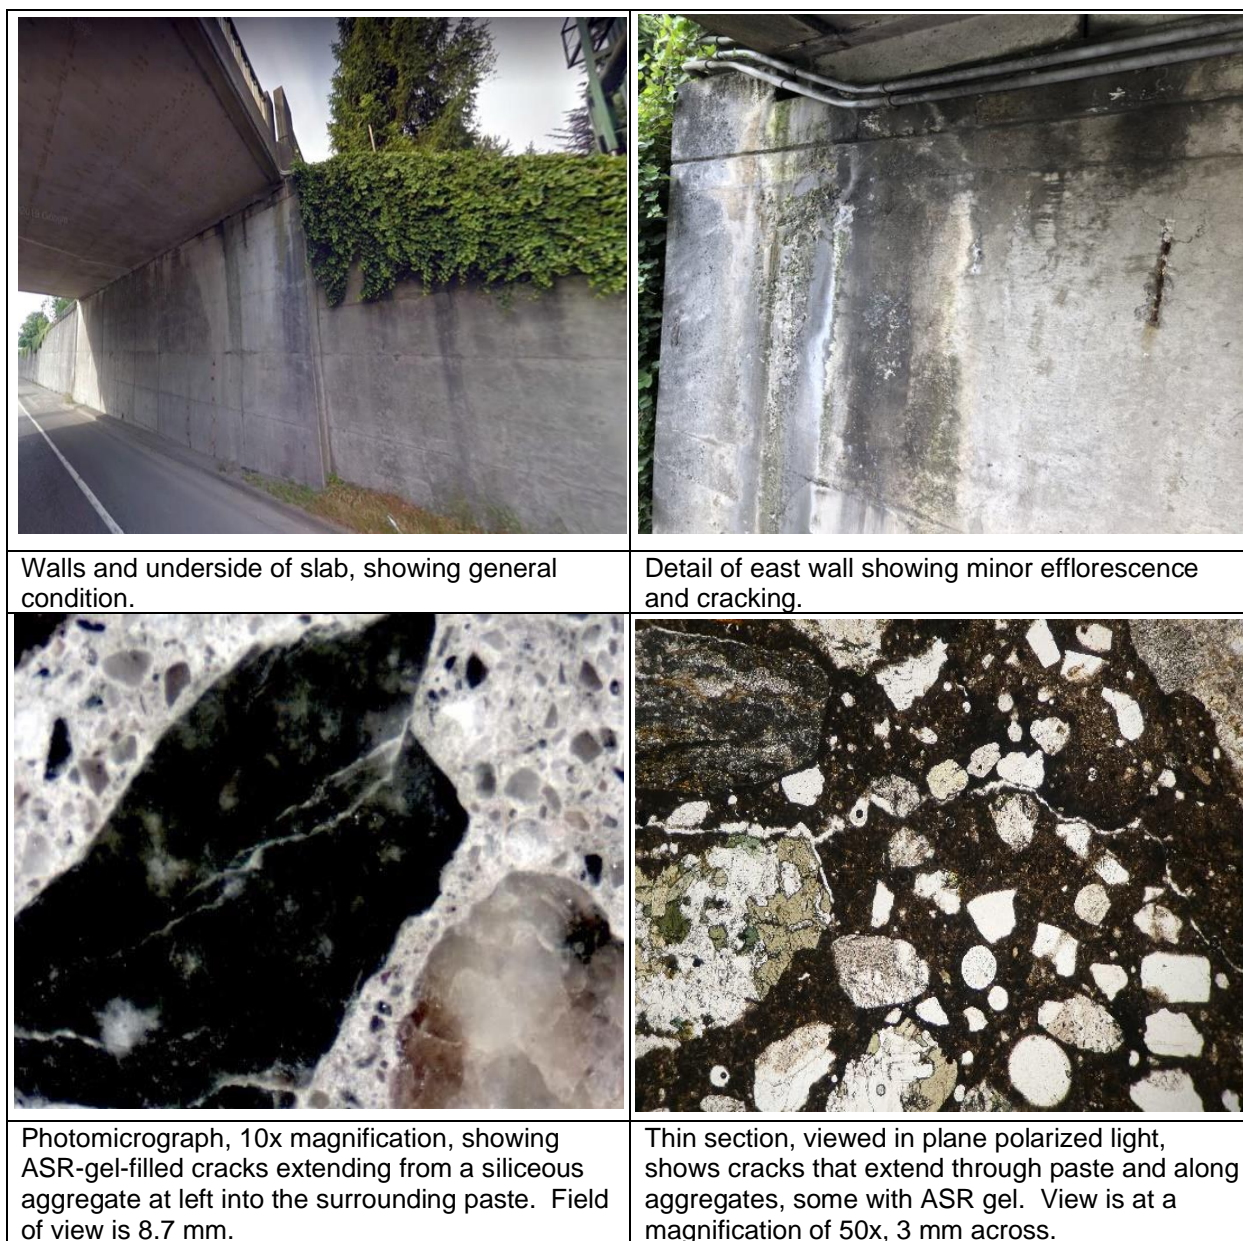
Figure 6: 65-year-old overpass concrete with minor ASR damage allowing continued serviceability.

In the field survey, the overall condition of the concrete elements was found to be good, with only minor concrete deterioration noted in limited amounts (Figure 6).

The Petrographic examination noted that there was some evidence that ASR had affected the concrete (Figure 6), but the severity of the reaction and the amount of damage associated with the reaction had not been quantified, other than a conclusion that it was not severe.

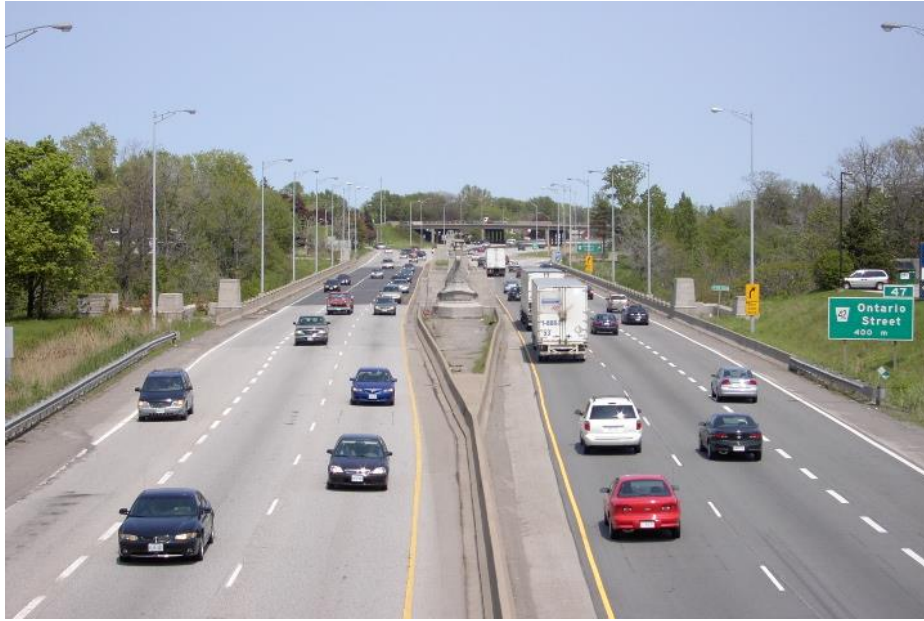
Figure 9: Section of QEW to be widened.

The Queen Elizabeth Way through St. Catharines (Figure 9), Ontario was originally constructed in 1937 as a concrete highway with two lanes in each direction and a grass median. Over the years it was improved and overlaid with hot mix asphalt and became a composite pavement. In 2004 an investigation was undertaken to allow a 7-kilometer section of the highway to be upgraded to six through lanes. The design traffic volumes were over 100,000 vehicles per day with 17% commercial traffic.

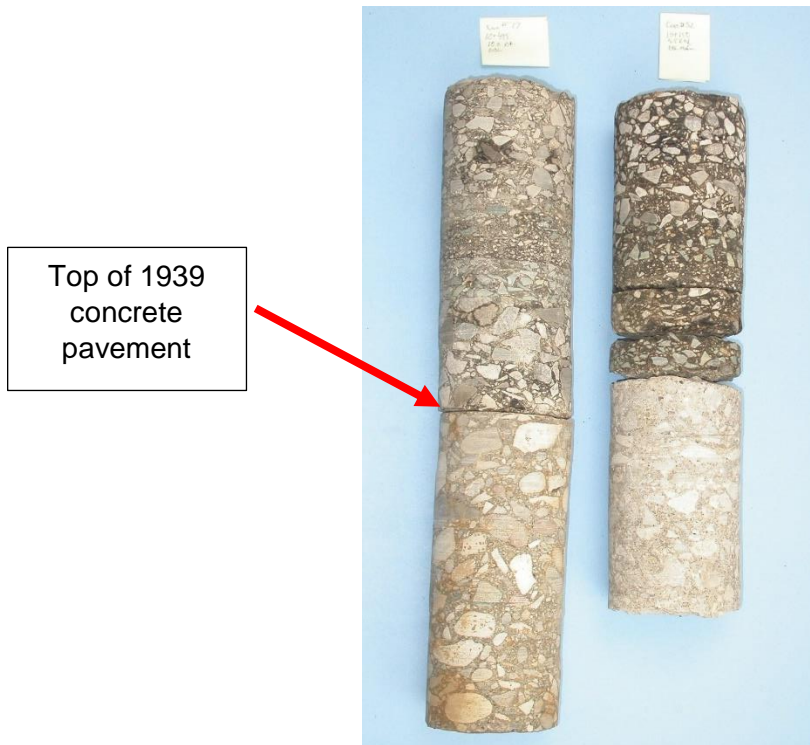
Figure 10: Cores through composite pavement showing very good quality 65-year-old concrete.

The recovered concrete cores were examined visually (Figure 10) and select cores were examined petrographically. The majority of the concrete examined was of very good quality with well distributed fine and coarse aggregate, no evidence of deleterious reactions from alkali-silica reaction, no evidence of freeze-thaw damage or salt scaling. The measured compressive strengths were an average of 68 MPa. Ultimately, over 80% of the old concrete was considered suitable to remain. The areas to be reconstructed were mainly the result of poor joints and other performance issues not related to the concrete quality.

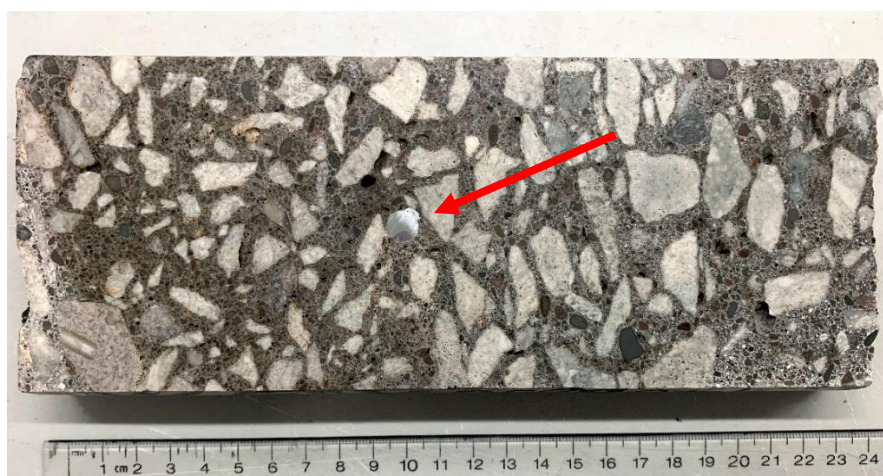
Figure 11: Prepared concrete core with clean uncorroded mesh

The four-lane highway section was constructed as a 230 mm thick jointed plain concrete pavement in 1963 and subsequently overlaid with hot mix asphalt. Petrographic examination of the concrete in recovered cores supplemented FWD and GPR surveys to evaluate the condition of the concrete slabs and joints. The average concrete strengths were 55 MPa. The aggregates in the cores were all well-graded and the concrete was generally dense and well-consolidated. The steel mesh was fresh and uncorroded (Figure 11).
