Geotechnical Challenges During the Construction of  
Denison Road East Railway Grade Separation

of the 2015 Conference of the  
Transportation Association of Canada Charlottetown, PEI

## **Technical Paper**

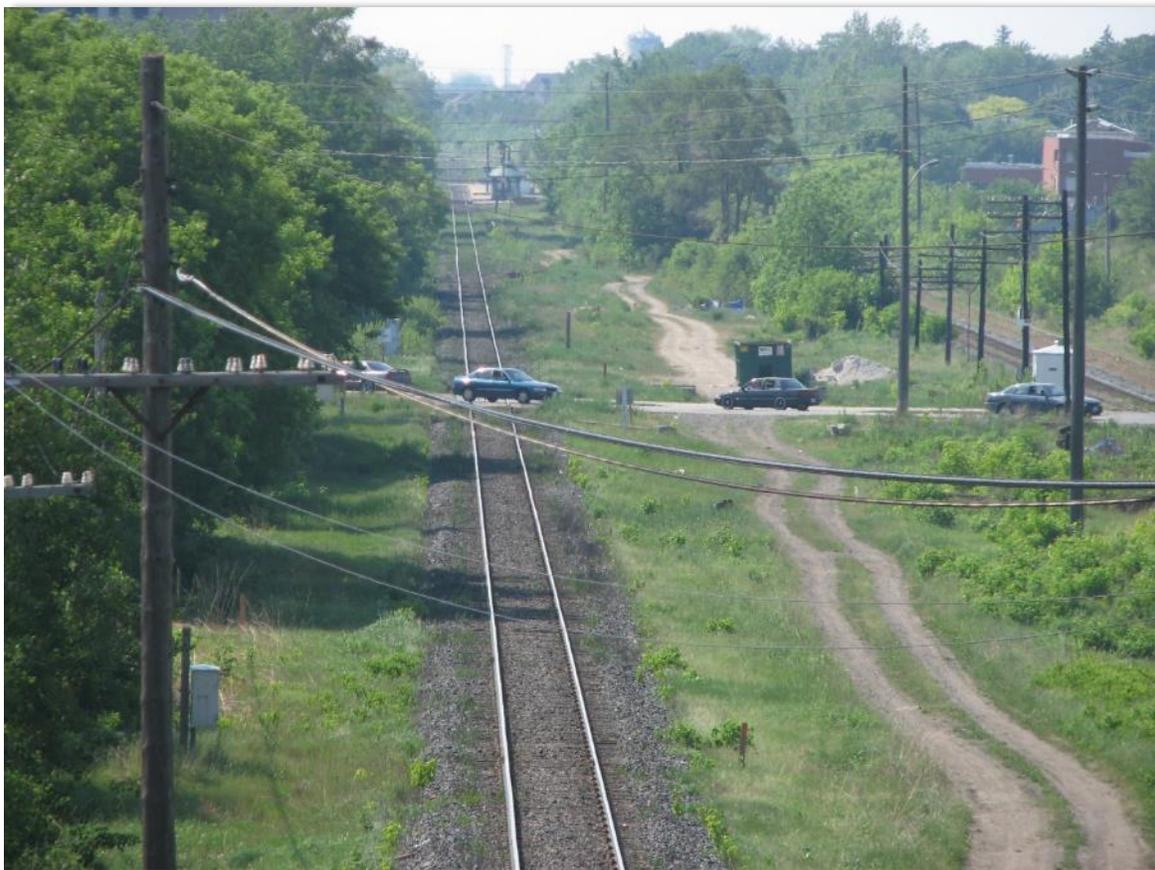
Photo #1 – Level gate-controlled railway crossing

Prior to the project, Denison Road had intersected two CP tracks and one CN track at a level gate-controlled crossing (as shown in Photo #1). The recommendations of the Environmental Study Report recommended a rail over road grade separation having the capacity for two lanes of road traffic and up to seven rail tracks at this location.

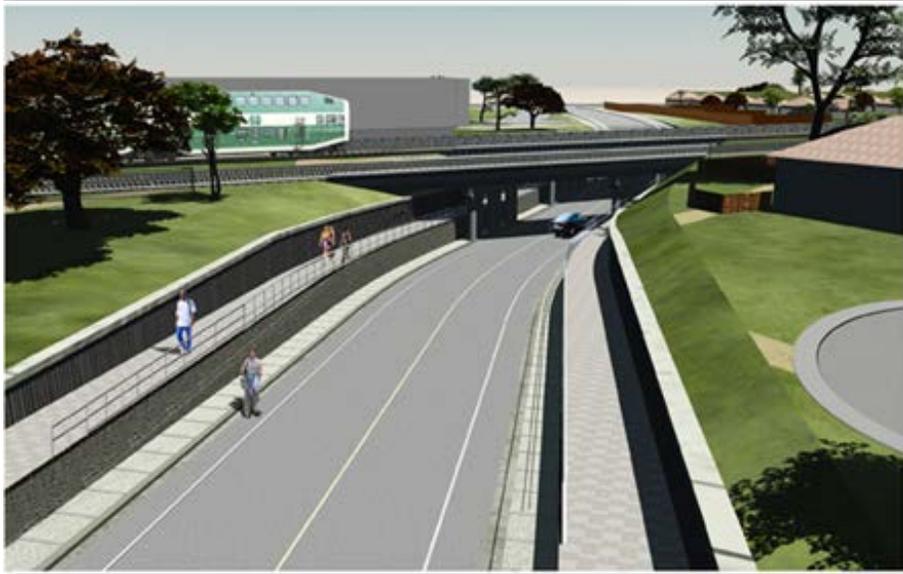
*Figure 1 - Conceptual Rendering*

With this proposal, both lanes of Denison run below the centre span; with cut slopes, retaining walls and sidewalks passing underneath the end spans. Figure 1 provides a conceptual rendering of the finished grade separation.

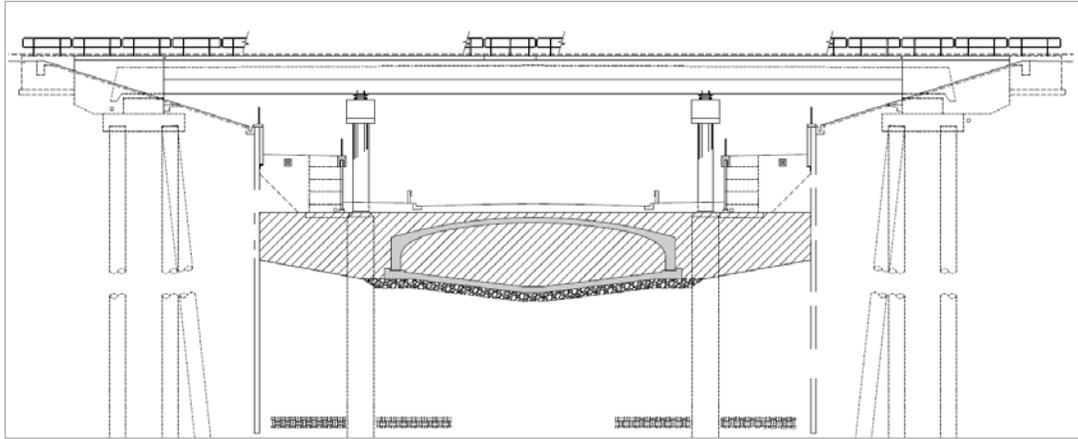
*Figure 2 – West Sectional Elevation*

Once the railway traffic was supported by the new bridge structures, the work to construct the grade separation could proceed. The staging for the excavation work below track level was even more complex than the staging at track level due to the unique subsurface soil and groundwater conditions as further described in this paper. Refer to Figure 2 for a cross-sectional view of the grade separation.

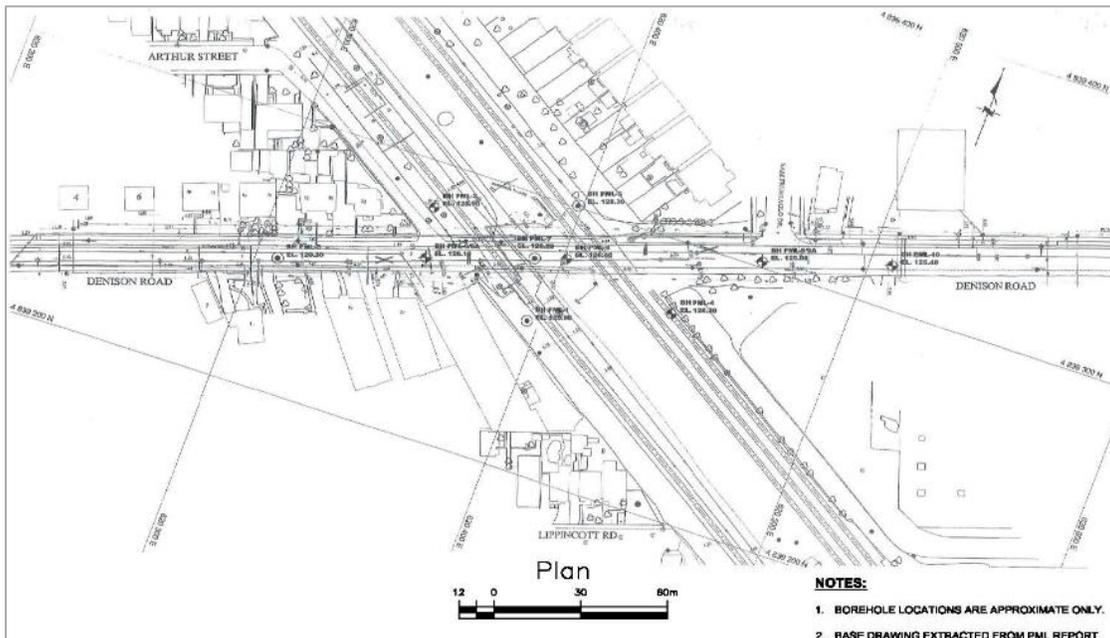
*Figure 3 – Borehole Location Plan*

During the geotechnical investigation, a total of twelve boreholes were drilled to depths ranging from 7 to 29 metres. All boreholes were located within a 200 metre long section along Denison Road in the vicinity of the proposed bridge. In all boreholes, the subsurface conditions that were encountered typically consisted of topsoil/pavement/surficial fill overlying compact to dense sand to gravelly sand, overlying loose to compact silt, which is underlain by soft to very stiff silty clay to silty clay till. Grey weathered shale bedrock was encountered in some of the boreholes. The groundwater level was found to be between 4.1 and 4.6 metres below existing ground surface. The borehole location plan (Figure 3) and a stratigraphic profile (Figure 4) are presented below.

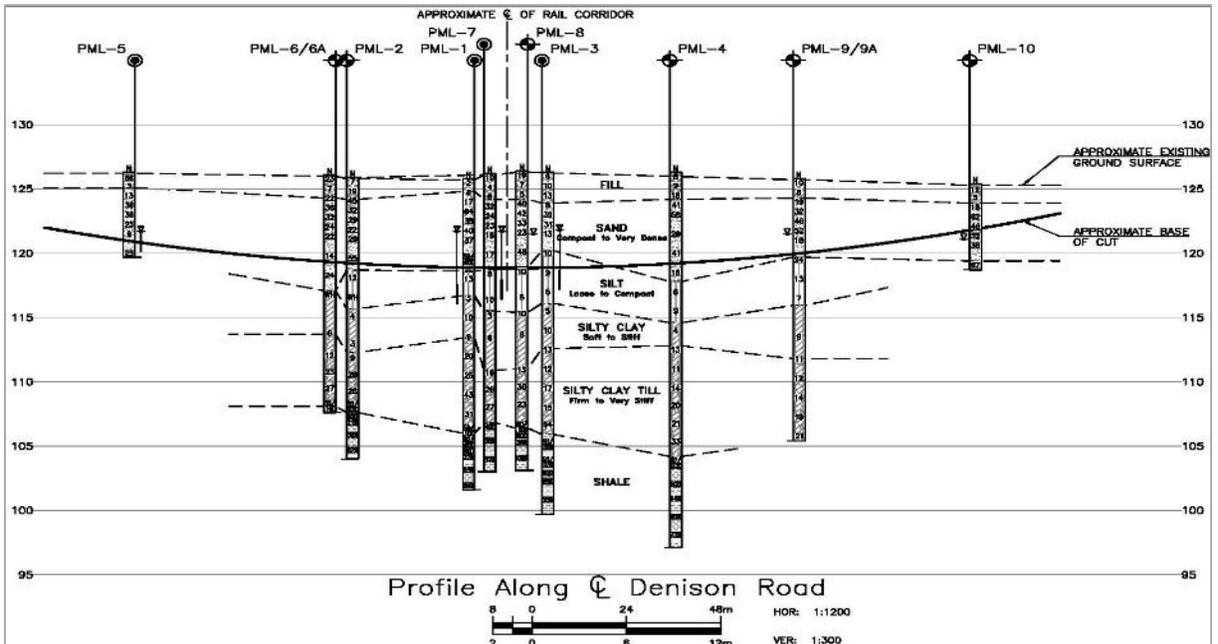
*Figure 4 – Stratigraphic Profile*

The original surface grades were at approximate Elevations 126 to 127 metres. In view of the existing site and subsurface conditions, and the proposed permanent cut configuration with the deepest base of cut at approximate Elevation 118.5 metres, consideration was given to using augered caissons (drilled shafts) socketed into the shale bedrock to provide foundation support. Steel H-piles driven to refusal within the very stiff to hard till or weathered shale were technically feasible but were not permissible due to vibration and noise concerns, and not preferred by RVA's engineers. The soils to be exposed below the base of the cut were too weak to support spread footings. Therefore augered caissons were ultimately selected for the bridge foundations.

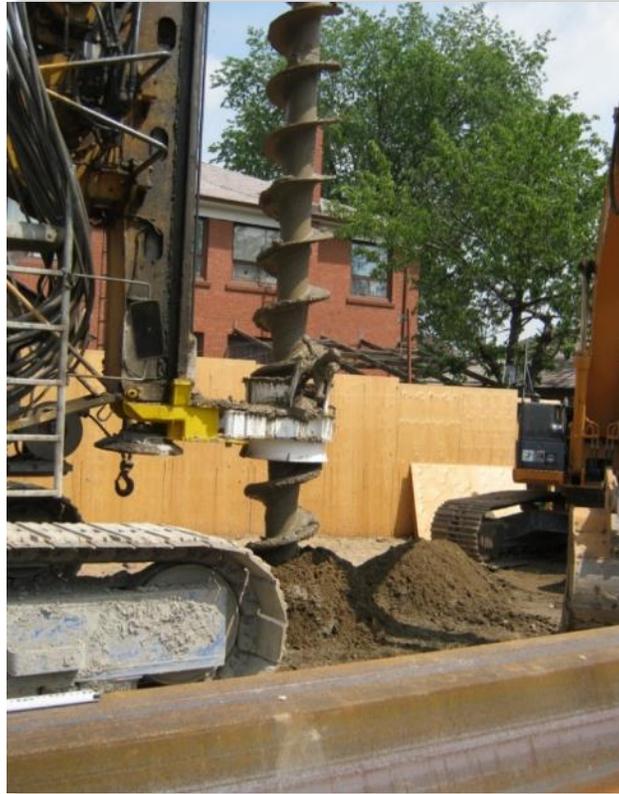
Photo #2 – Pre-augering prior to installing sheetpiles

During initial sheet pile installation, vibration was induced and settlement of the nearby structures was noted. The sheetpile installation was done by using a vibratory hammer. To minimize vibration and to prevent settlement, a trial pre-augering test prior to installation of the sheetpiles was recommended. The purpose of this was to determine the magnitude and distance of attenuation of vibration from the sheetpile installation, and associated vibration induced ground surface settlements. Based on our observations, the sheetpiles penetrated the upper silts and sands without inducing much vibration to the adjacent ground; however, once the sheetpiles encountered the glacial till and bedrock, the vibration was amplified and induced adjacent ground settlement. The following procedure was recommended:

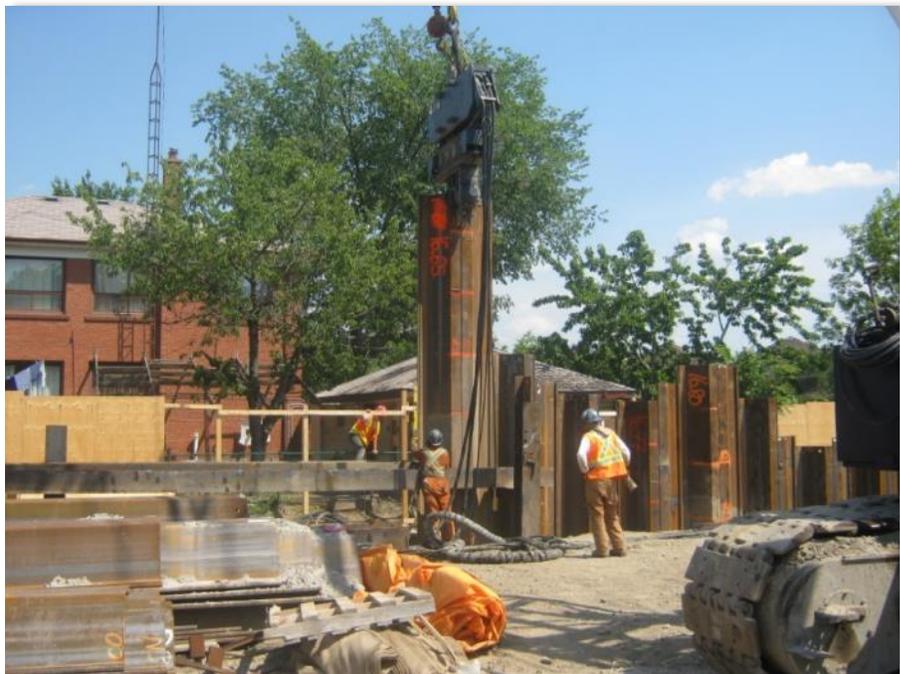
Photo #3 – Installing sheetpiles after pre-augering

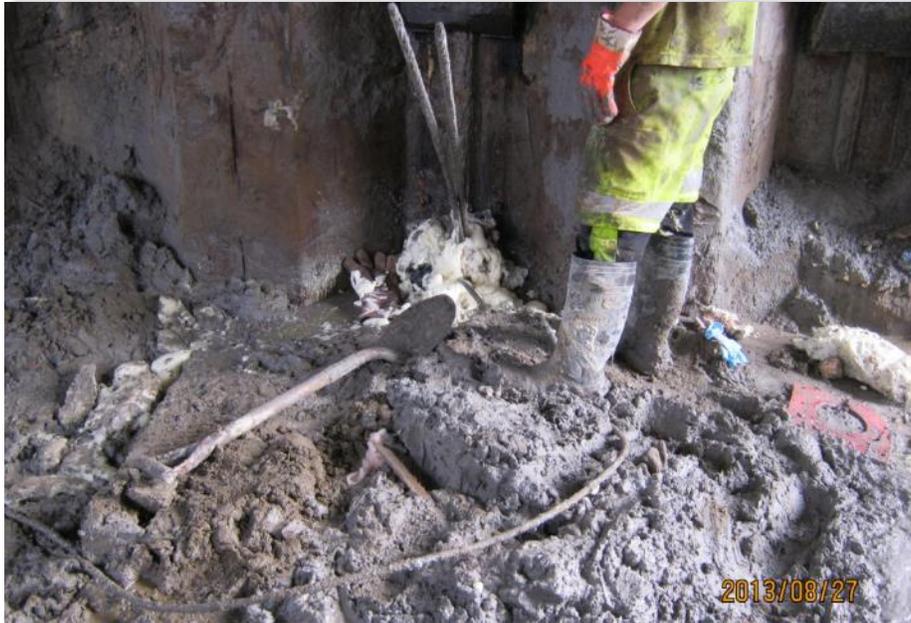
Photo # 4 – Foam application to prevent loss of fines

Elevation 119.7 m near the Metrolinx's structure. This level generally coincides with the sand-silt interface depicted in the boreholes. Foam injection (Photo 4) was implemented to remediate this condition where limited success was achieved. Another method which was introduced was the triple grout method (Photo 5). This method was also met with marginal success.

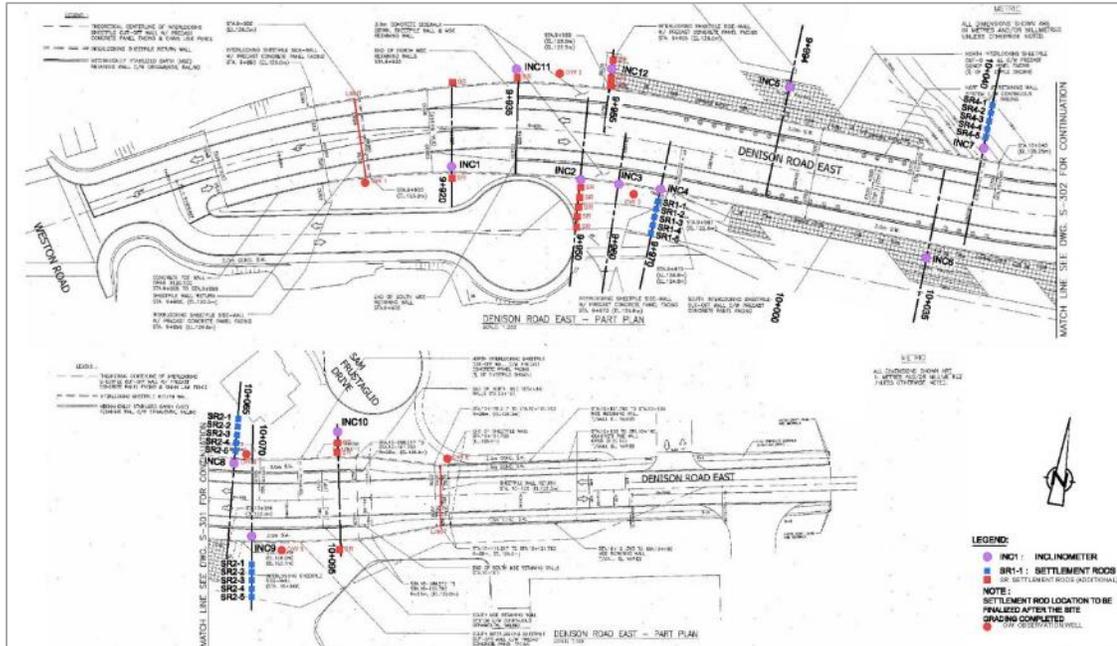
- Settlement rods at selected accessible locations adjacent to the excavation on both the north and south sides.
- Water level observation wells to monitor groundwater level drawdown and recovery.
- Building monitoring points, crack gauges and track settlement markers would continue to be maintained and monitored.

Instrumentation was implemented in sections and for sufficient duration until such time that tieback installation within any sections was completed. These instruments would be monitored on a daily basis during dewatering.

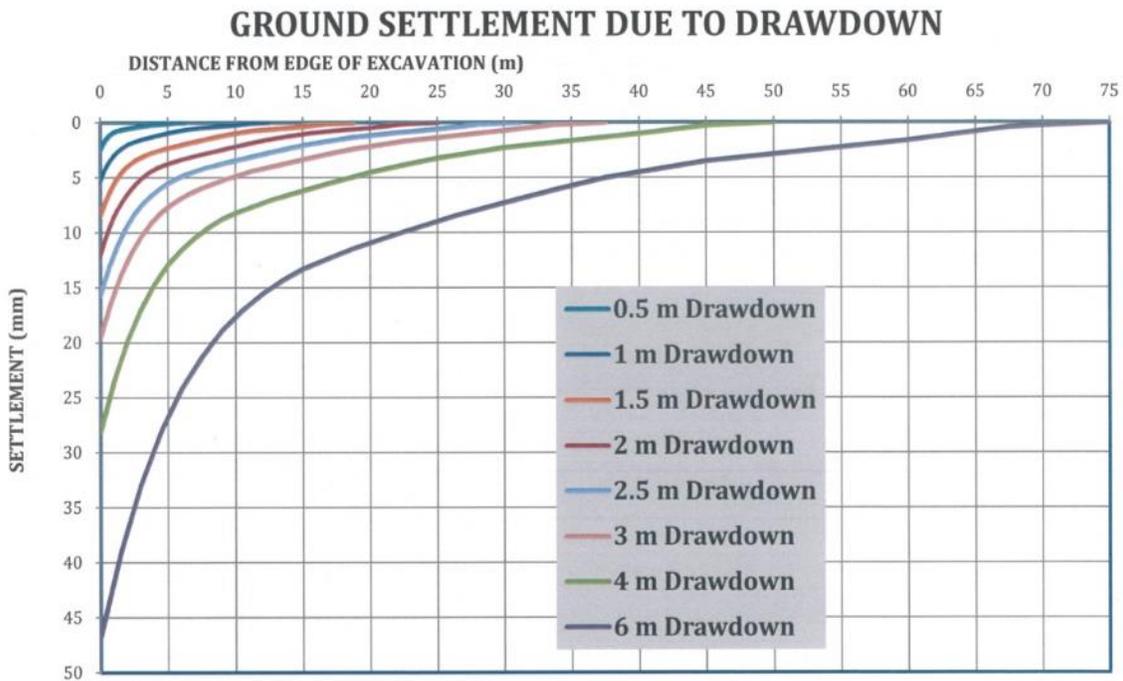
The following design graph was prepared to show the estimated ground settlement due to drawdown under steady state conditions.

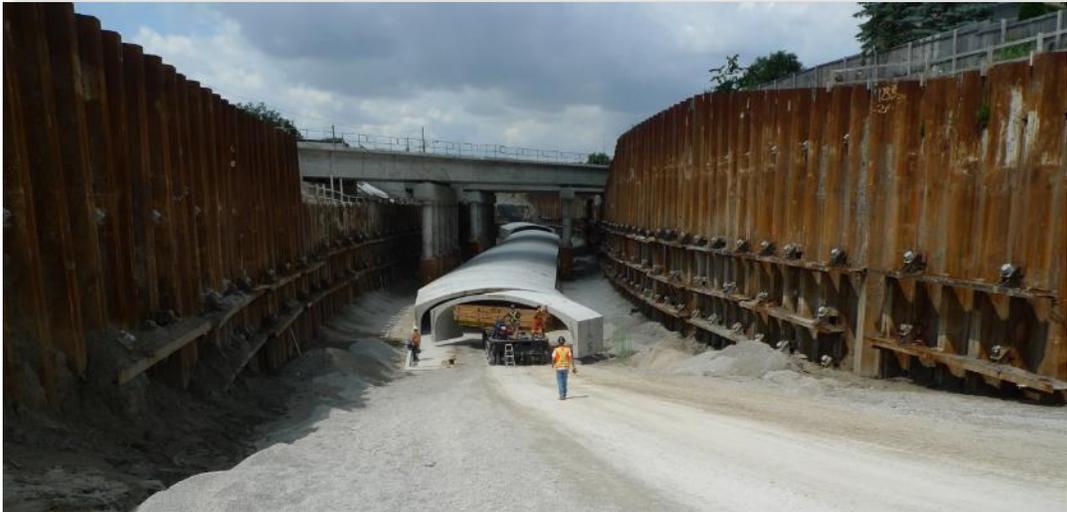
Photo #6 – Completed sheetpiling, subsequent excavation and storm retention tank

The sheetpile installation was successfully completed despite the challenges of the site's unique subsurface conditions. Refer to Photo 6 which shows the walls supporting the excavation face to allow the subsequent road excavation and storm retention tank construction.

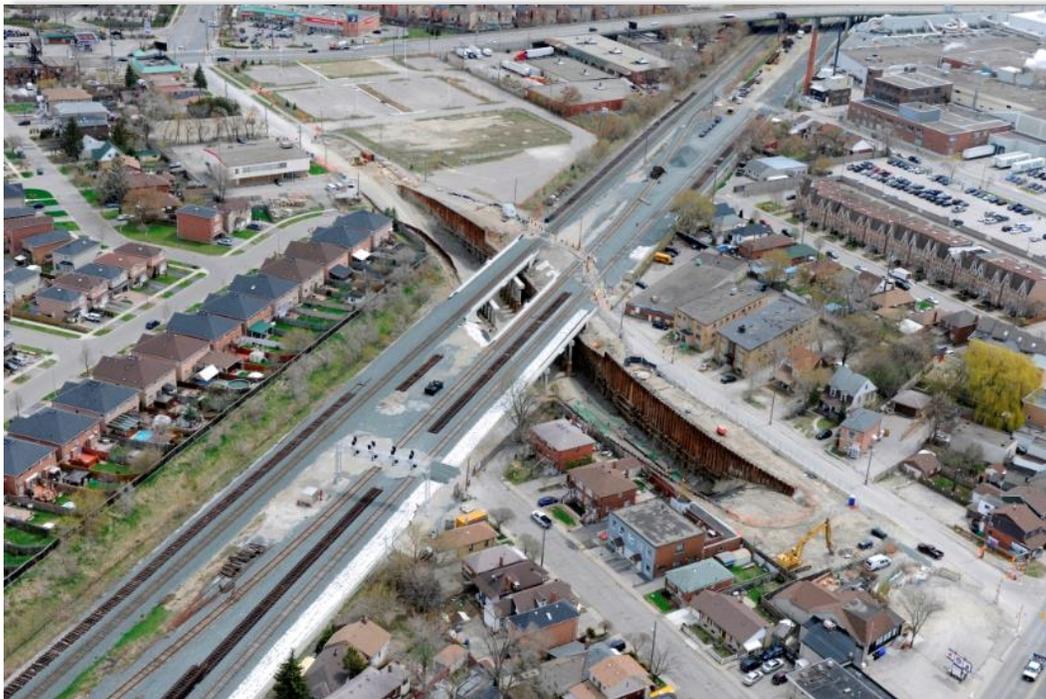
Photo #7 – Aerial photo of grade separation construction

The Denison grade separation successfully overcame a number of significant engineering challenges to provide improved traffic flow while simultaneously improving pedestrian flow through the surrounding neighbourhood. The bridge structures are now in service and serving the Union Station and Pearson Airport Express Line (refer to Photo #7).
