# **New Twist for Stabilized Roads**

Prepared by  
**Douglas Wright**  
**Ministry of Transportation**  
**Province of British Columbia**

Paper prepared for presentation  
at the  
**Preserving Low-Volume Roads Session**

2007 Annual Conference of the  
**Transportation Association of Canada**  
Saskatoon, Saskatchewan

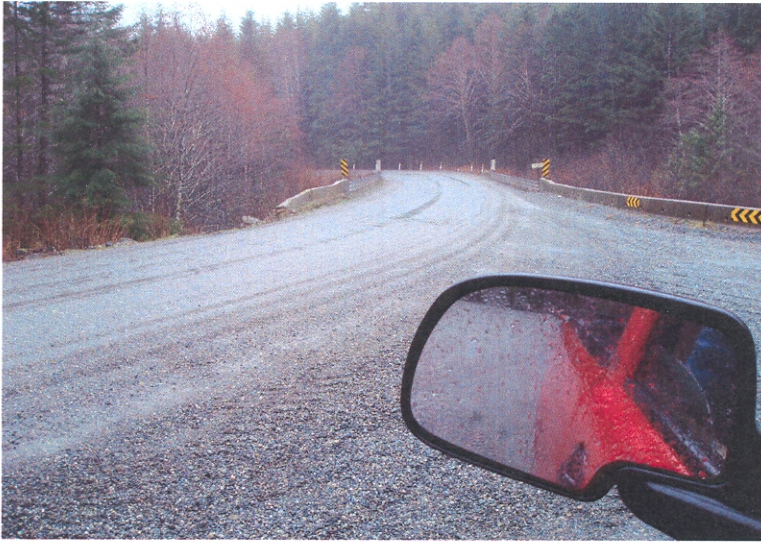
**Smooth Surface – Original Cross-section has been maintained**

Stolz Creek-March 2007

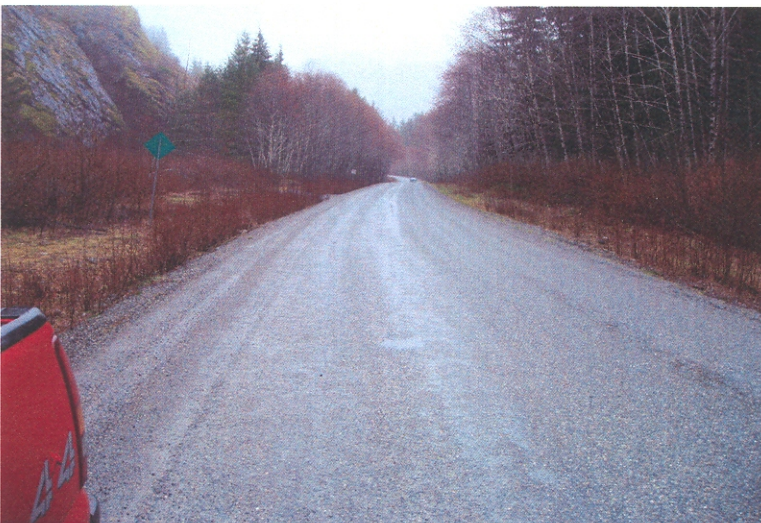
Leagh Creek-March 2007

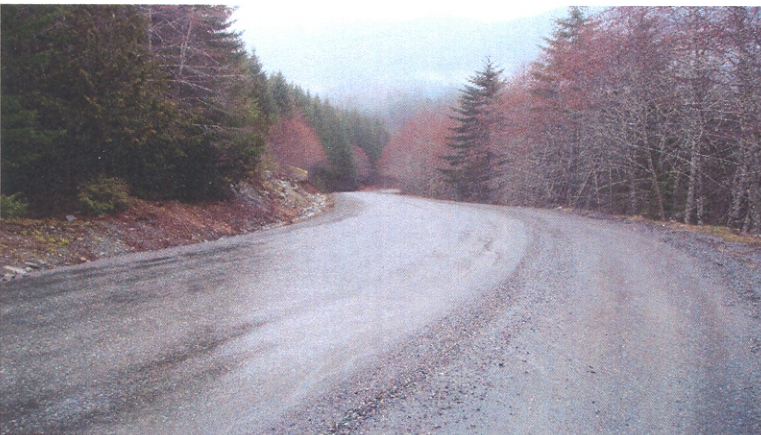
Gold River-Hill-March 2007

MoT experience confirms that aggregate gradation is a factor that will influence MgCl absorption. Gold River Hill as an example continues to carry very heavy loads but the maximum MgCl absorption was 3.4 litres per square metre during the application process.

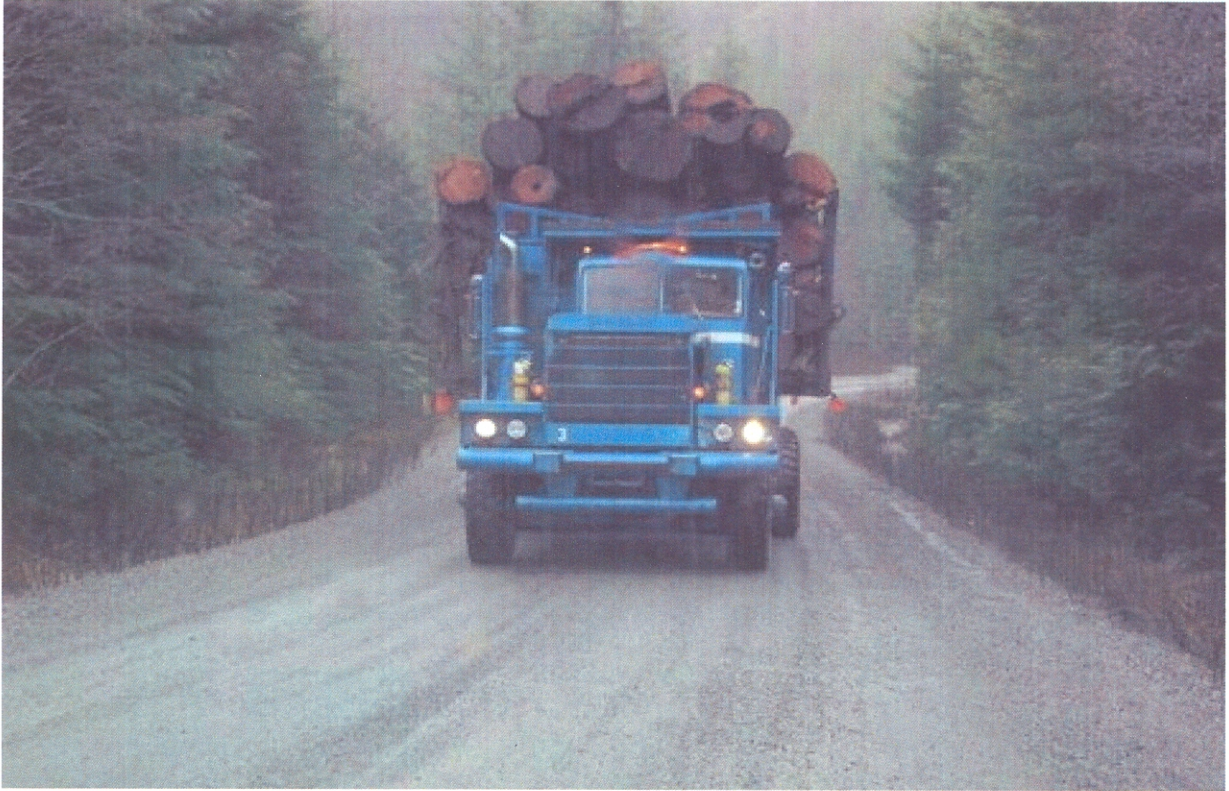
**a better view of “the End Product”**

Conuma Hill - March 2007: 17 to 19 % grade - Heavy winter sand on surface keeps the folks on the road in the winter months.

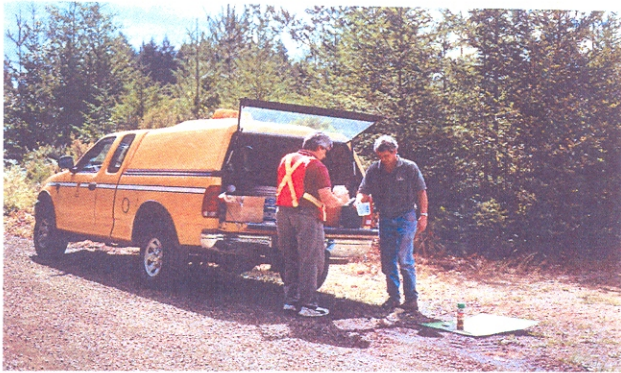
## Evaluating The Cationic CSS 1

- Measuring

CSS 1 diluted (0.6 litres water to 0.4 litres CSS 1 water, at an application rate of 1.5 litres mixed product per square metre) was the maximum product quantity and dilution factors that could be applied to satisfied the above mentioned criteria. Asphalt penetration in all cases was limited to about 4 mm.

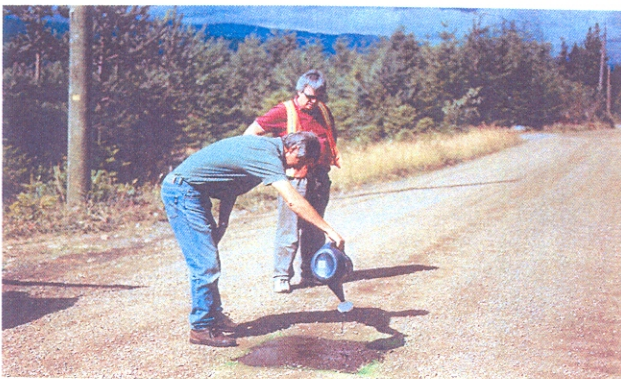
- Applying

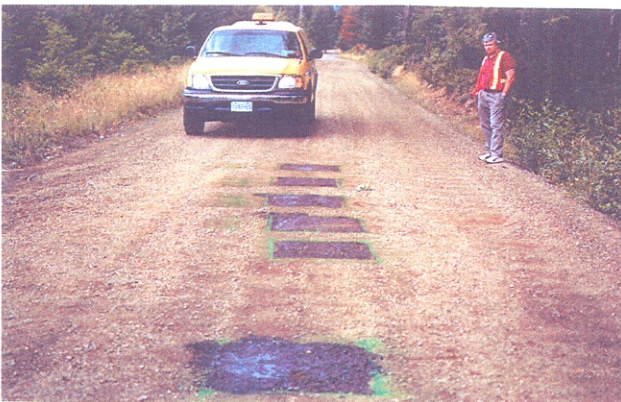
- A few Test Sections

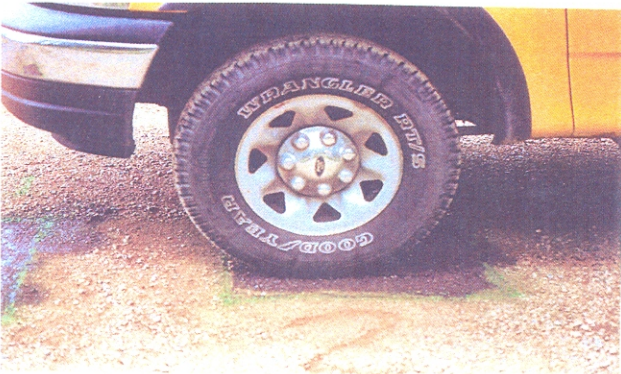
- Stickiness

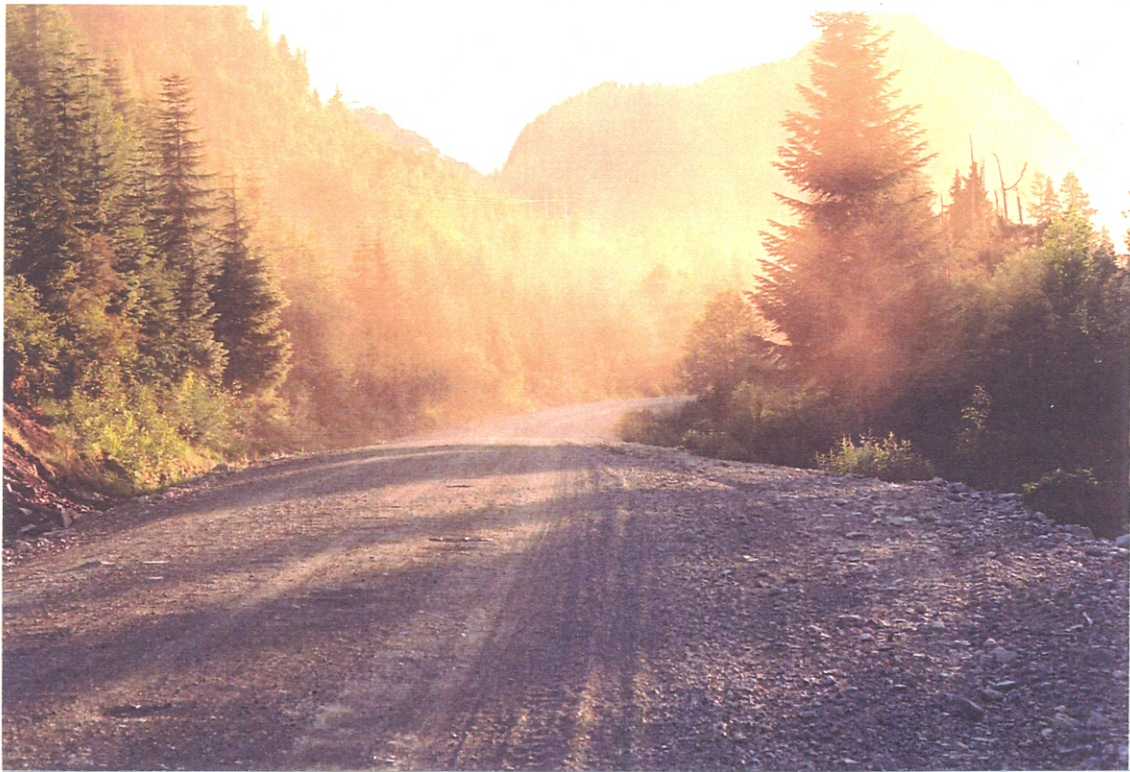
Typical section of the Tahsis Road – Dust, potholes, washboard and loose gravel

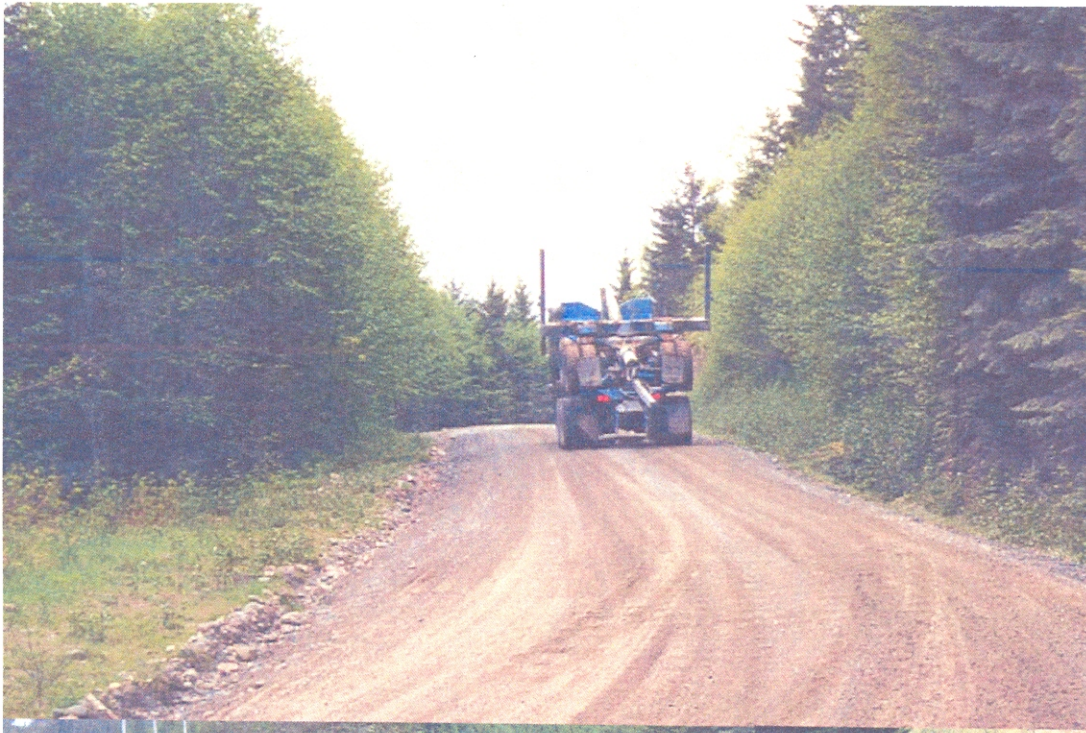
A section of the Tahsis Road treated with  $MgCl$  - One of Western's logging trucks headed for a load

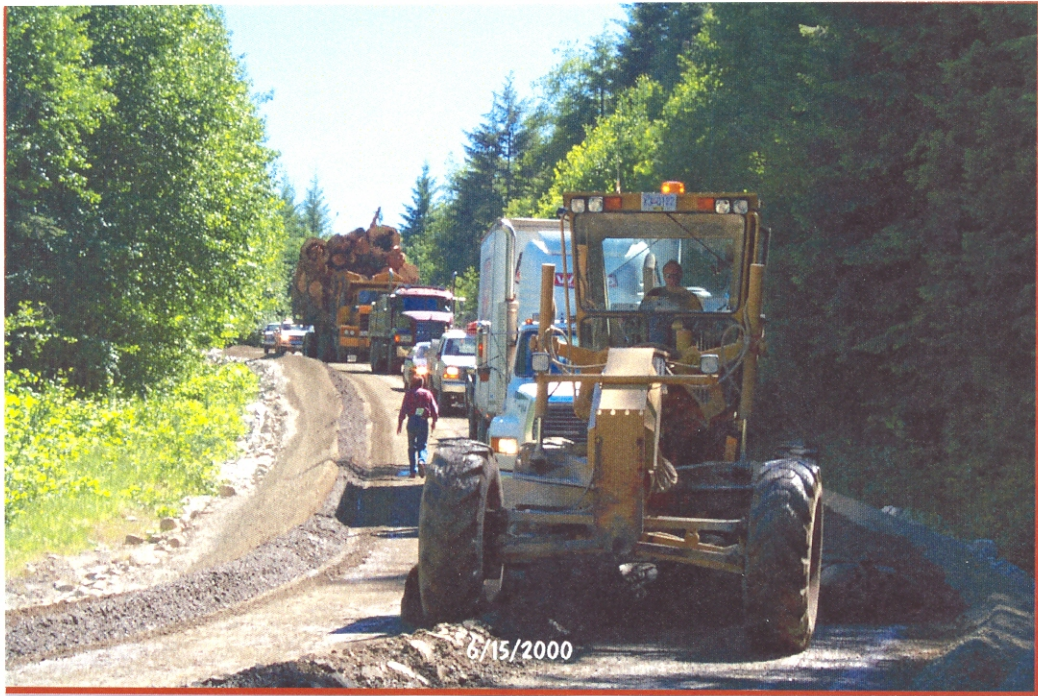
Grading in the MgCl - Freight truck, gravel truck and loaded logging truck on return trip

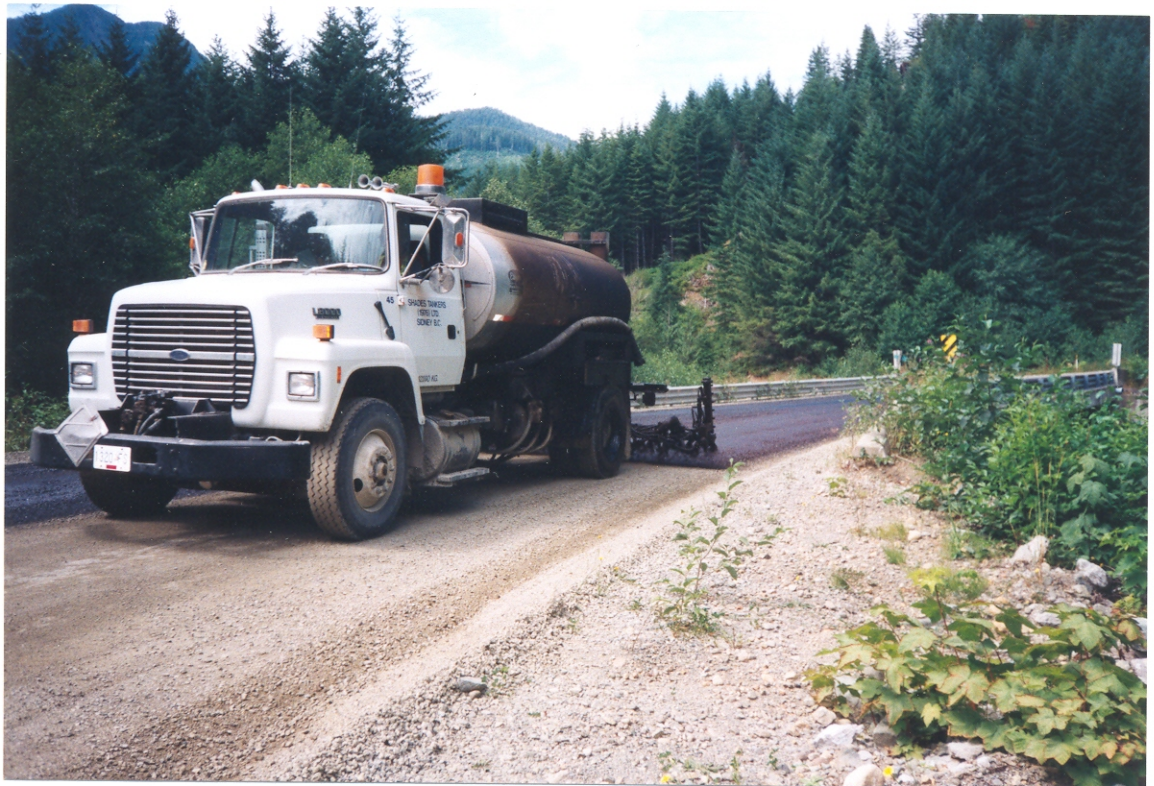
Spraying the Cationic Prime

In preparation for applying the Cationic CSS 1, the glazed finish of the MgCl surface required scraping with a grader. Small windrows of gravel were left on the road shoulder to catch and prevent any surplus run-off from entering ditches. The CSS 1 and water were mixed in the distributor truck for twenty minutes. A single lane of traffic was closed and the mixed product was then applied to one lane of the prepared surface and allowed to cure for approx 25 minutes. Mot staff had already opted to modestly reduce product application rates from earlier test results to ensure over application of product was not achieved. Mix ratios applied to the road therefore leaned towards a little richer mix of 0.7 water to 0.5 litres CSS 1 which when combined, were applied at a rates of 1.3 to 1.4 litres per square metre.

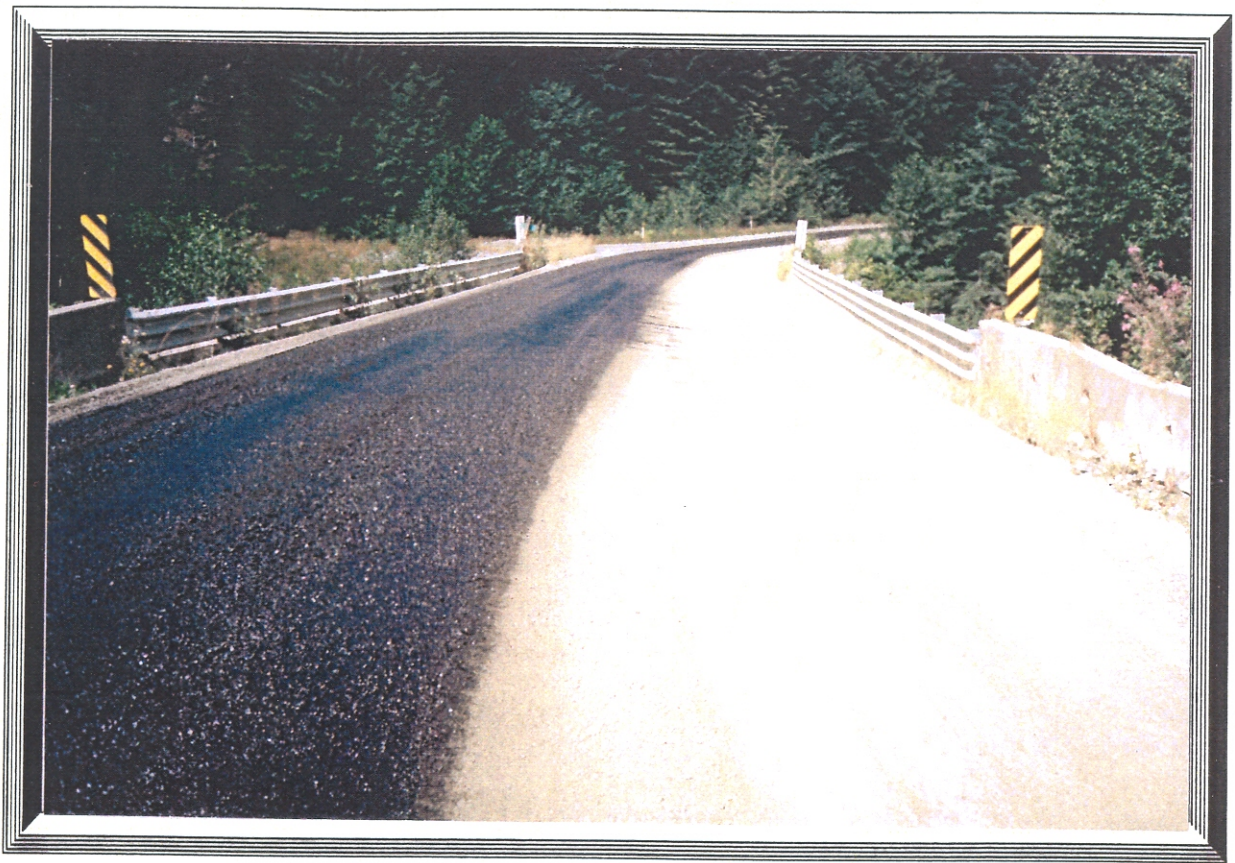
CSS1 (on the left) applied over MgCl stabilization. Application was a mixture of 0.5 litres CSS1 and 0.6 litres water per square metre.

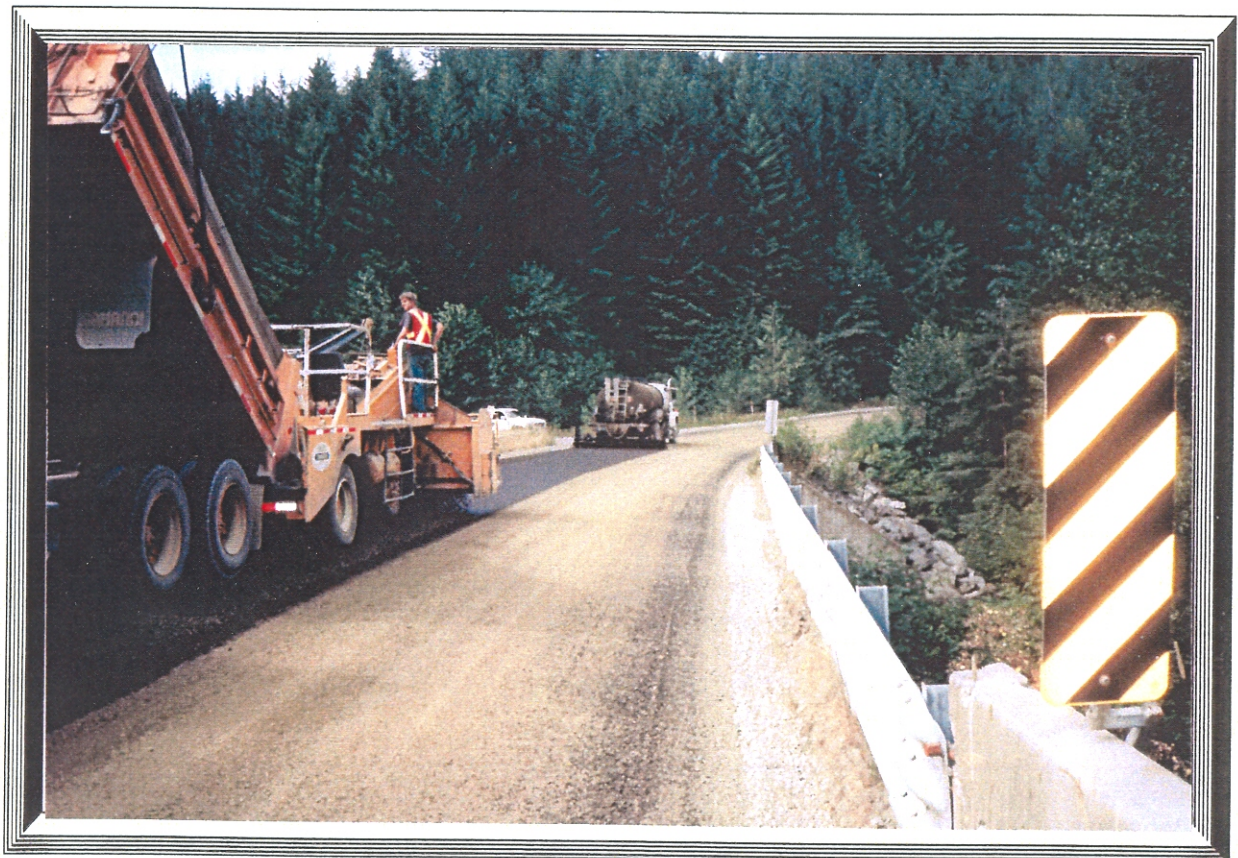
On the right a sand cover applied over the CSS1 that permits single lane traffic to be maintained. On the left, Shades Tanker Services applies bottom lift Class A Graded Aggregate Seal.

Blinding Sand was applied using a conventional winter sanding unit. Pick-up of the prime by public vehicles was not a problem provided we were patient enough to wait for a cured road surface. In some cases, longer curing times were required prior to adding Blinding Sand. This was at least partially a function of ambient air temperature, moisture in the road and the amount of shading from overhanging trees.

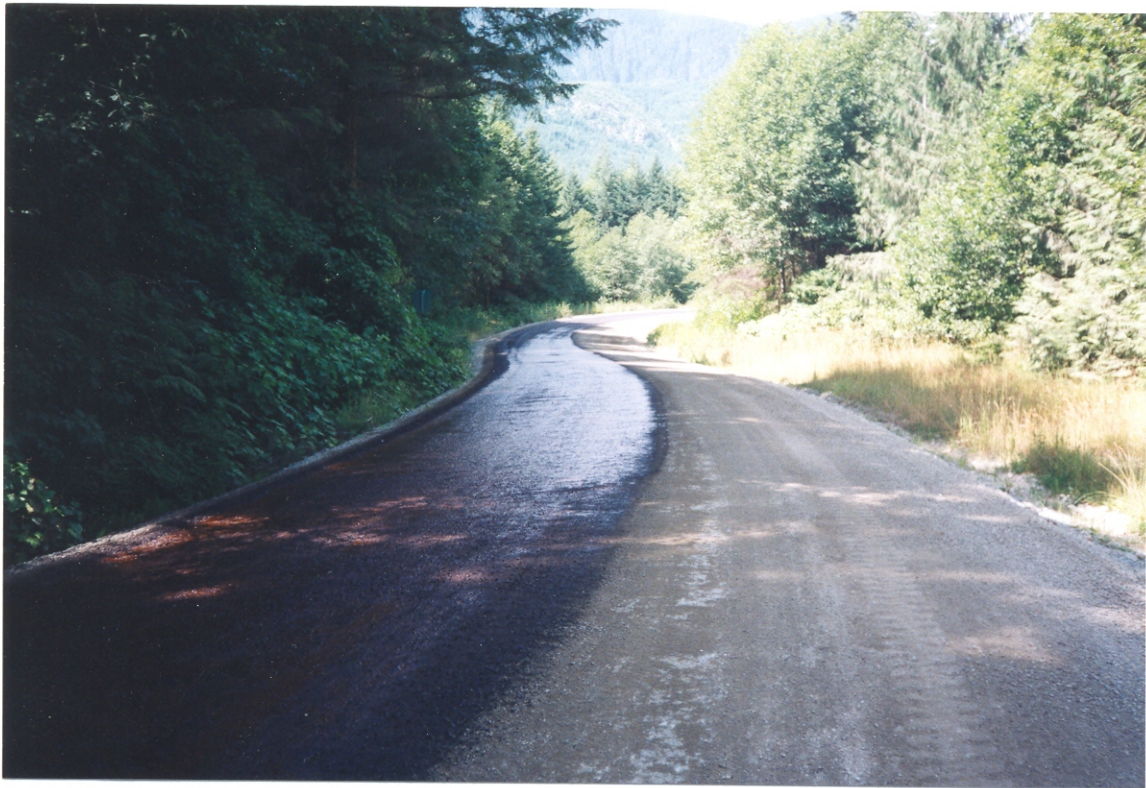
The dreaded early morning shaded section. After 20 minutes the product is still liquid and not cured.

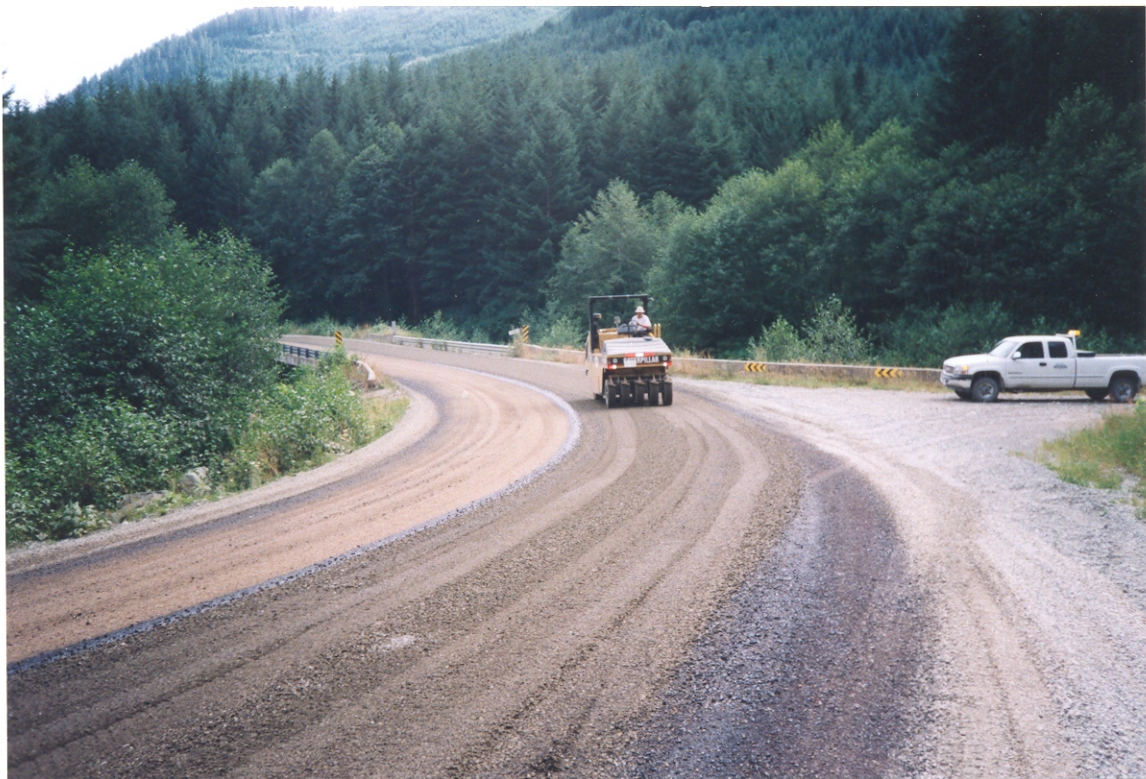
Rolling the first lift of Graded Aggregate Seal. On the left, the sand over the CSS 1 sealed section is quiet dry and being rolled smooth by the traveling public.

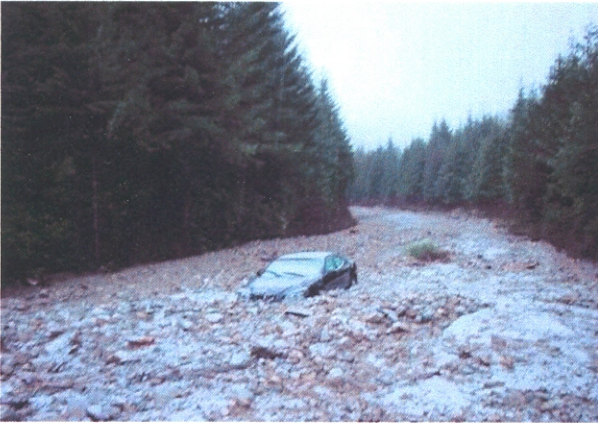
Tahsis Road blocked by flood debris  
November 2006

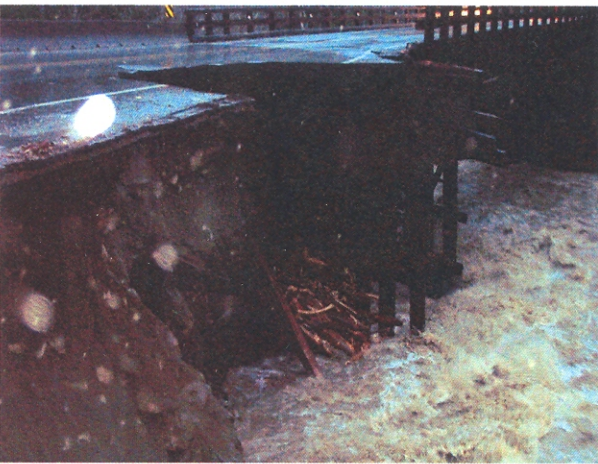
Heavy Rain destroys bridge approach  
November 2006
