Incorporating a new wicking geotextile in northern, low volume highways to mitigate pavement edge cracking

Paper prepared for presentation
at the *Innovation in Geotechnical and Materials Engineering* Session

of the 2017 Conference of the
Transportation Association of Canada
St. John's, NL

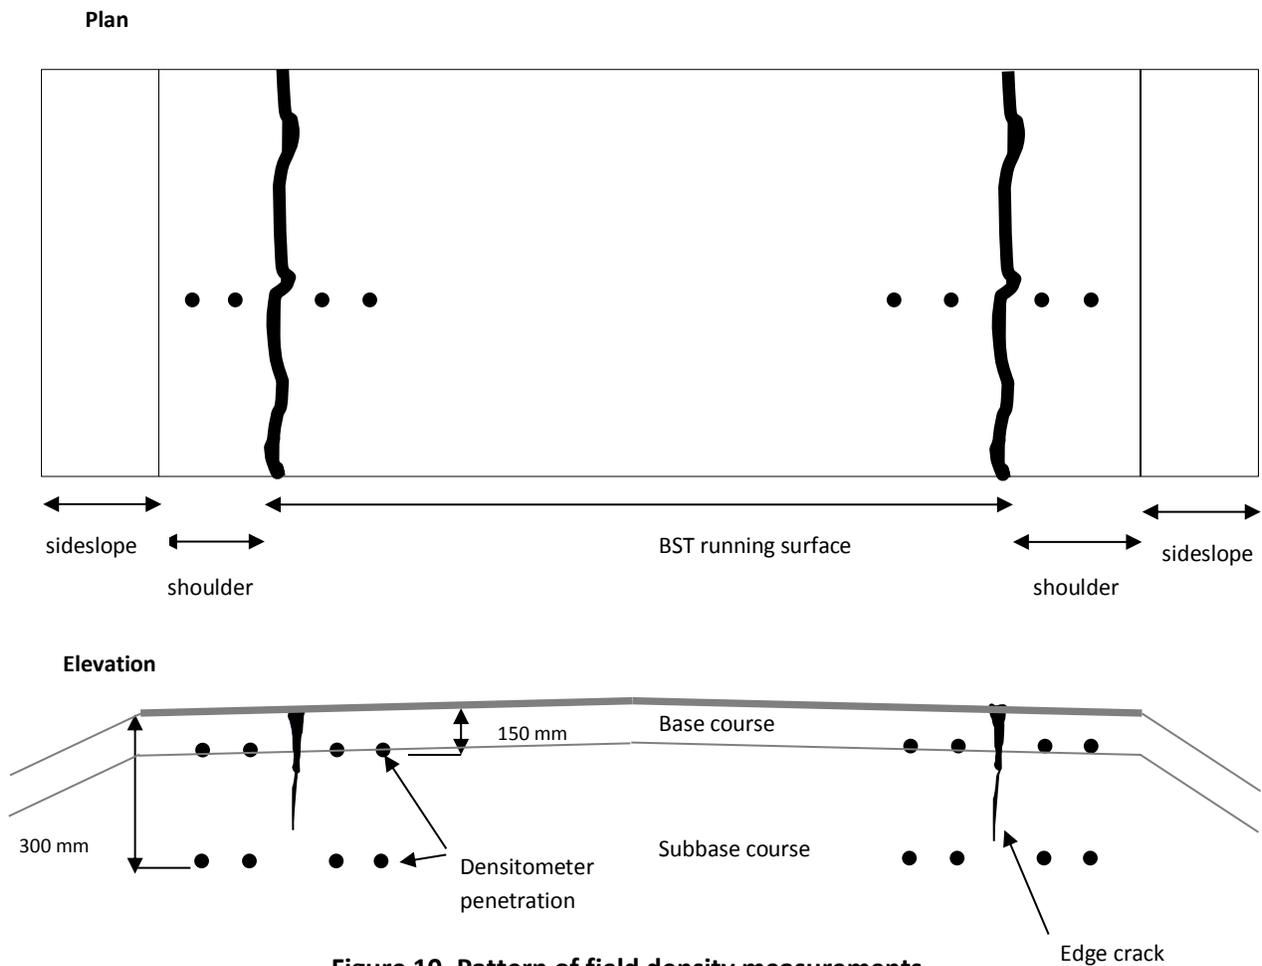
Density measurement with the nuclear density gauge provided information on soil density, percentage of compaction as well as moisture content. Figure 11 summarises the results of the field density survey. The average dry density for each test was normalized relative to the dry density of a reference point, which was taken to be the measurement point closest to centreline, on each side of the road, at the same depth. (These reference test points are coloured red in Figure 11). Normalizing the field densities highlights the progression of decompaction from the running surface to the edge crack and to the road shoulder.

Two trends were observed in the data from the field density study:

- Materials outside of the edge crack were less dense than inside (i.e., closer to the road centre). Base materials were as much as 8% less dense outside of edge cracks, whereas the uppermost 150 mm of subbase material was as much as 45% less dense outside of edge cracks.
- The level of compaction in the road increased from the surface downwards. Comparing the reference points of site 4, the base course dry densities were 85% to 90% of the corresponding subbase dry densities. Km66+275 showed a negligible difference for the reference densities on the cutslope side of centerline; however, because of very high subbase densities the base course was only 55% of the subbase reference density on the steep slope side.

The most advanced state of edge cracking was noticed on the fill slope side of the road section located at km 66.275. Both site 4 and the site at km 66.275 had dramatically reduced soil densities (55%-59%) outside of edge cracks in the top of the subbase. The road at km 66.275 had a deeper fill and steeper sideslope than at km 40. At this time, it is difficult to correlate the level of compaction with sideslope. However, there is strong evidence that there is a relationship between a roadbed's level of compaction and its porosity and ability to soak up precipitation. Less dense roadbed materials have a more open

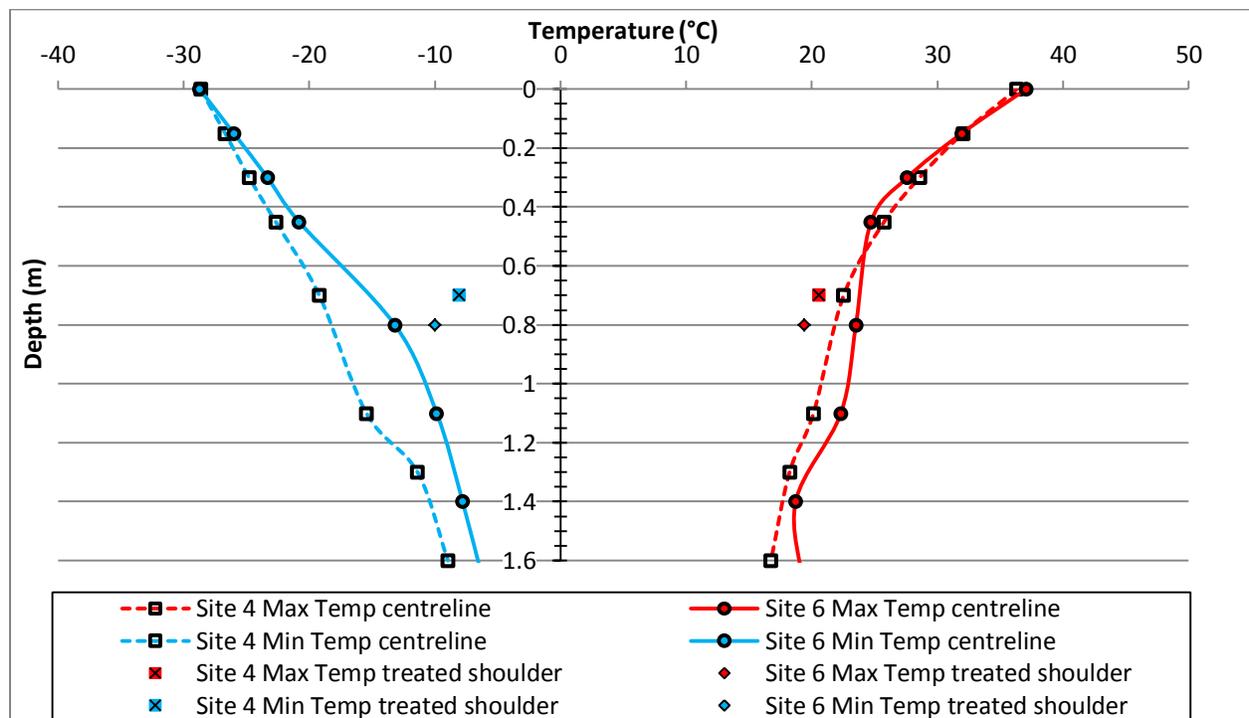
Figure 12. Centreline and shoulder temperature ranges with depth, sites 4 and 6, 2016.

The maximum and minimum temperature profiles presented in Figure 12 show a wide range of temperatures occurred at the test sites during the study period. The maximum variation occurred near the road surface, and this variation grew less with depth—forming a ‘trumpet’-shaped curve. The maximum air temperature range was 37°C to -29°C, and was recorded by the ambient thermistors at the dataloggers. Because the maximum temperatures at the 1.6 m depth exceed 0°C it is apparent that the road is not underlain by permafrost. Although the maximum and minimum ambient temperatures were comparable for the two sites, the site 4 roadbed temperature extremes were almost all cooler than those at site 6.

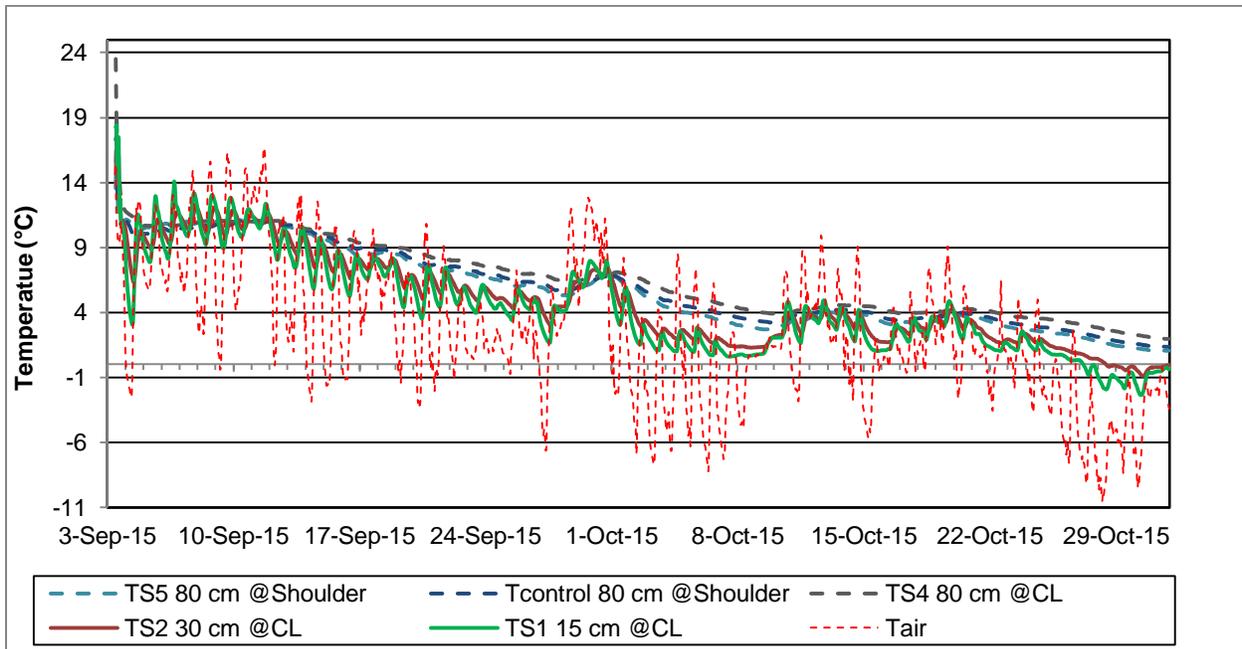
Figure 13. Temperature data, site 6, fall 2015.

Figure 13 presents temperature results at select depths for site 6 during fall 2015. As anticipated, there was greater temperature variation at shallow roadbed depths where solar heating and ambient cooling bring about rapid changes in the roadbed. The road shoulder had consistently cooler temperatures than at centreline during fall 2015. This is attributed to the road shoulder having lower soil densities and wetter soil conditions, but may also be caused by the road surface receiving more direct solar input.

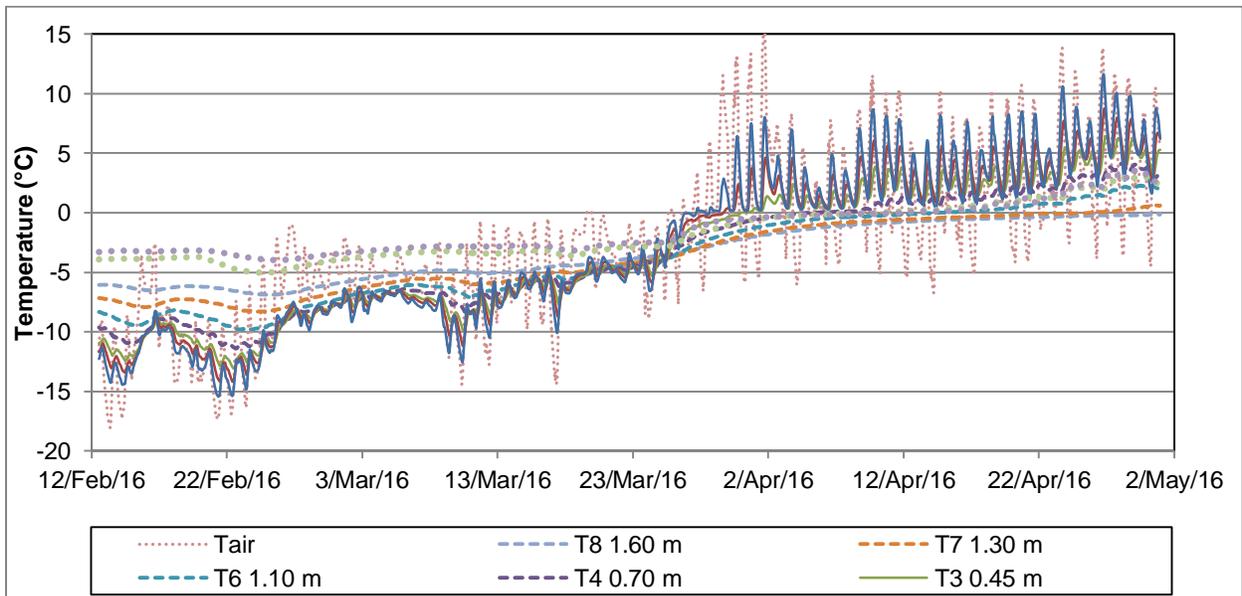
Figure 14. Temperature data, site 4, spring 2016.

Figure 14 presents results for the same site 6 thermistors, for winter and spring 2016. Similar to Figure 13, Figure 14 illustrates that shallow roadbed depths have higher sensitivity to air temperature variation, and also shows top-down freezing and thawing events. It is important to note that the road surfaces at sites 4 and 6 were unpaved for the periods shown.

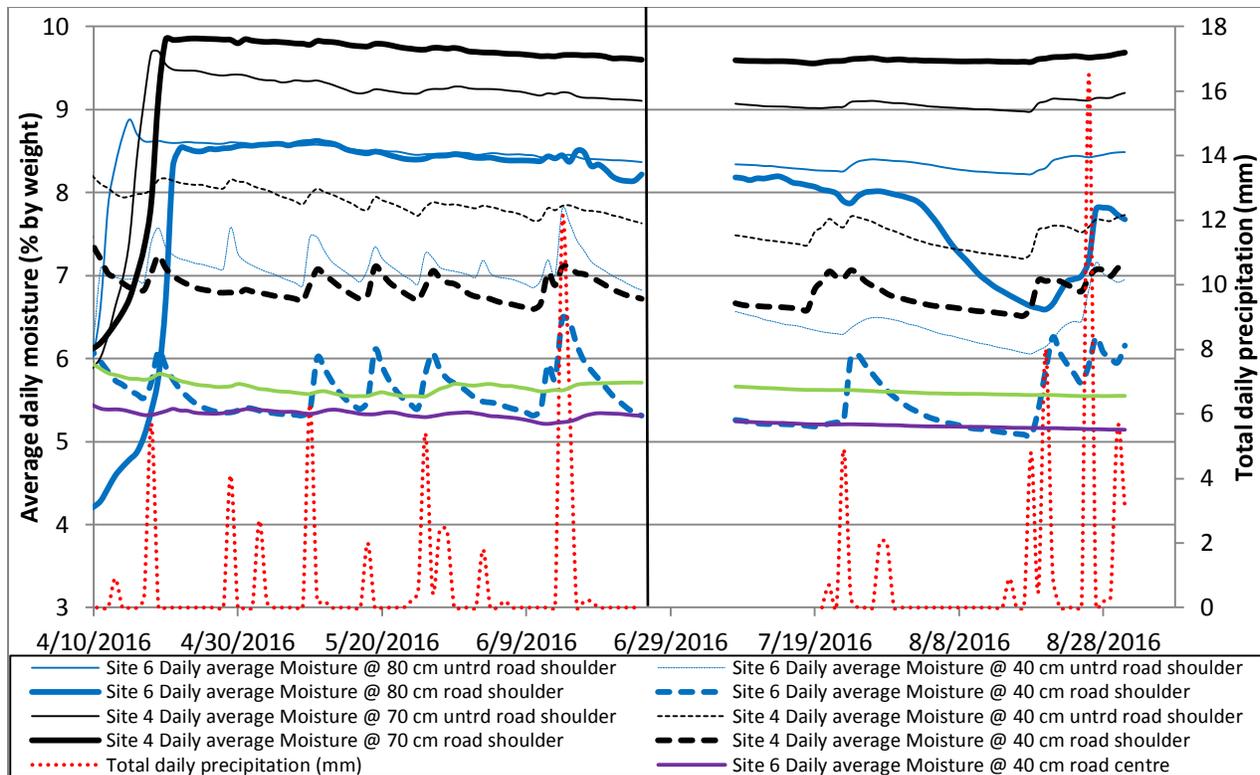
Figure 19. Comparison of precipitation and road moisture, sites 4 and 6, spring and summer 2016.

During spring and summer, the test site roadbeds above the geosynthetic experienced recurrent, rapid increases and decreases in moisture content (Figure 18). Moisture changes were, on average, 0.12% greater in the drier roadbed of the treated shoulder than in the wetter, untreated shoulder (May to September). The treated shoulder also drained away these increases in moisture more quickly than did the untreated shoulder. In order to better understand these events, a comparison with precipitation data was made. Precipitation data for the summer period were from Environment Canada's weather station located at Watson Lake airport (the Environment Canada weather station closest to sites 4 and 6). Figure 19 compares summer moisture contents at sites 4 and 6 with summer precipitation events. There was strong agreement between the precipitation events and increases in moisture above the geosynthetic. As anticipated, the agreement was weaker for moisture content under the geosynthetic.
