Ten Years of Edmonton's North East Roads Program

Marlis Foth, P.Eng., M.Sc., Director Open Space Planning and Design, City of Edmonton
Hugh Donovan P.Eng., Supervisor Research & Development, City of Edmonton

At the 2017 conference of the
Transportation Association of Canada
St. John's, NL

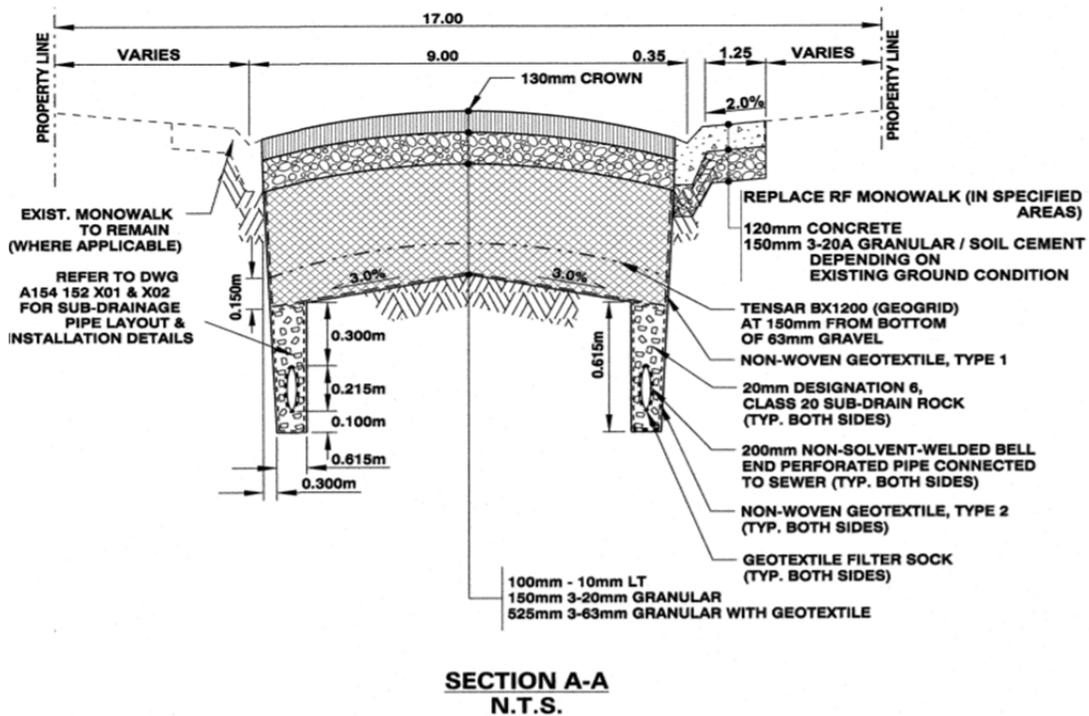
intended that the Cematrix would also serve as an insulation material from frost heave and spring weakening of the existing wet subgrade soils. The proposed structure involved the excavation of the existing materials and the replacement structures as indicated in Table 1. Differing residential and collector structures were proposed based on the appropriate traffic volumes. The collector structure had an additional 60 mm of asphalt and an additional 50mm of 3-63 recycled base. Wick drains were proposed under the Cematrix at the periphery adjacent to the curb and gutter. Figure 6 shows the Cematrix sub-base installed. After the Cematrix was placed a rain event occurred and the water migrated under the Cematrix causing it to be pushed up and it began to float. This can be seen in Figure 7. The Cematrix was removed and replaced with the standard granular structure developed for the area and has had no issues since the work was performed.

Figure 7 Cematrix Floating after Rainfall
