Comparison of Ground Penetrating Radar Deck Surveys to
Conventional Level 2 Deck Testing Results

Christopher L. Barnes, Ph.D., P.Eng., Senior Materials Engineer,
Wood Environment & Infrastructure Solutions
Junaid Iqbal, P.Eng., Bridge Materials Engineer,
Technical Services Branch, Bridge Engineering, Alberta Transportation

Paper prepared for presentation at the
SES - Innovations in Transportation Asset (s) Data Collection Session

of the 2018 Conference of the
Transportation Association of Canada
Saskatoon, SK

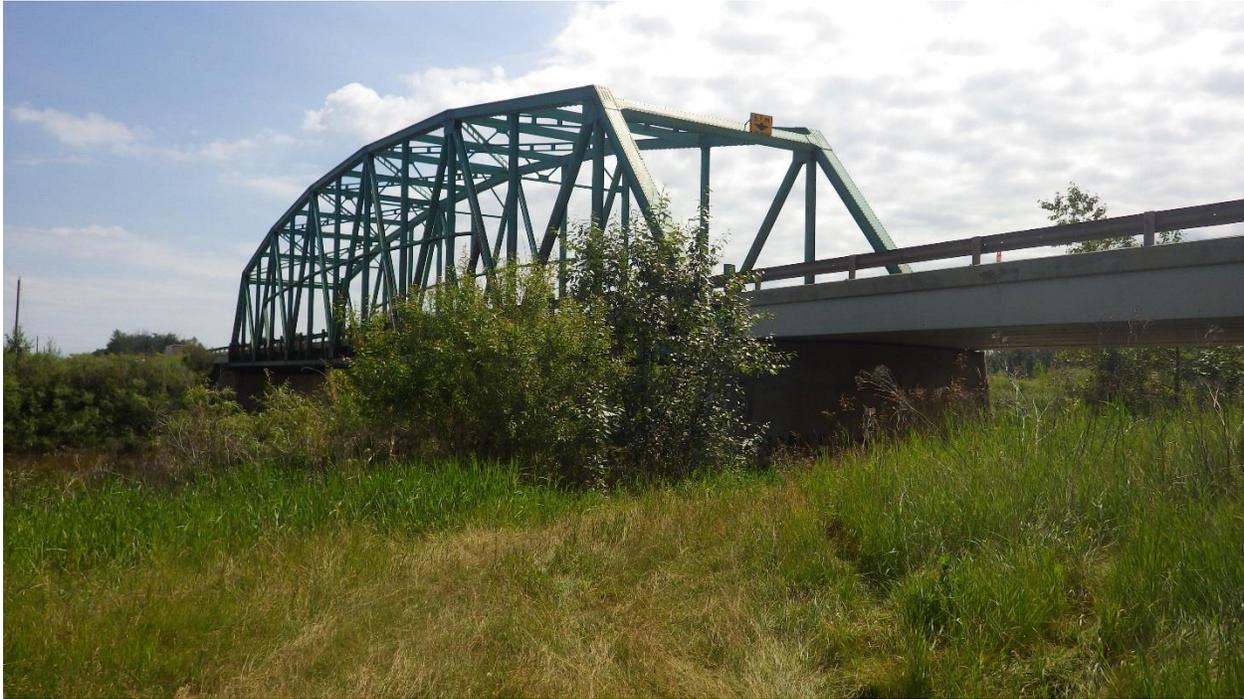
A photo of the Pembina River Bridge is provided in Figure 1. The existing substructure remains from the original construction which occurred in 1935. The superstructure consists of three spans that were reconstructed/replaced in 1977. The main span is a 76.2 m long steel overhead through (TH) truss, while the approach spans are pre-stressed concrete Type RD box girders of 16.8 m and 18.3 m lengths. Each RD girder was approximately 1.22 m in width and is fabricated with a grout pocket on each interior web which is used to tie adjacent interior girder to one another, providing structural and electrical continuity through the deck. The cast-in-place concrete deck on the TH span consists of 12 panels, each 6.35 m in length, with each panel point located at a node in the bottom chord of the truss. The deck was constructed without a skew, and has a clear width of 7.3 m bounded by reinforced concrete curbs. The upper flanges of the RD girders comprise the reinforced concrete deck in the approach spans. The RD approach spans have a protective High Density concrete OverLay (HDOL) and the entire deck is chip seal coated. The TH span was constructed without a protection system. Review of historical data indicated that the deck has never been rehabilitated. The uppermost reinforcement in the RD approach span girders are 13 mm diameter steel reinforcing bars with a specified concrete cover of 45 mm, plus 50 mm of HDOL. The uppermost reinforcement in the TH deck consists of 20M galvanized steel reinforcing bars with a specified concrete cover of 57 mm.

Figure 1. BF 13166-1 Pembina River Bridge.

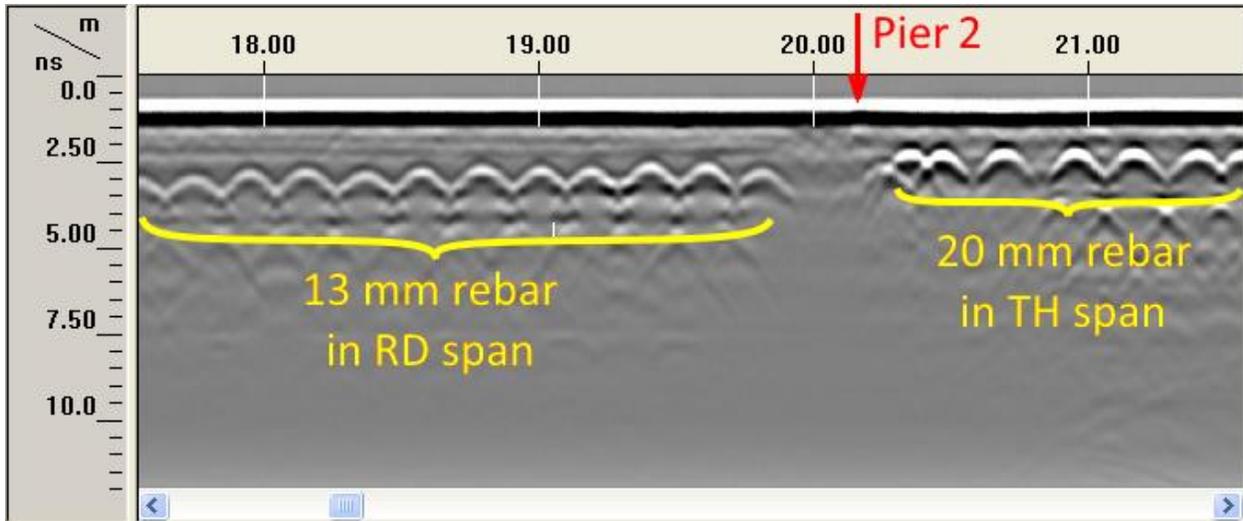
vertical curb face and the bridge rail posts. Figure 3 shows an example of the rebar reflections recorded in the RD span and TH spans adjacent to Pier 1. A difference in intensity of the reinforcing bar reflections between the two deck spans is due to the different size reinforcing bars used in each. The deck condition and cover survey was based on 7,292 and 1,022 rebar reflections measured from the deck and curbs, respectively. This represents over 11 times more data on the deck and over 5 times more on the curbs compared to the CSE testing, and over 162 times more on the deck and over 56 times more data on the curbs compared to pachometer based cover measurements. GPR surveys provide complete contiguous surveys of the bridge deck condition and as-built cover distribution that are statistically robust compared to conventional techniques, yet require less time and effort in the field to complete.

Figure 3. GPR data rebar reflections in RD and TH spans near Pier 1 in Pembina River Bridge.

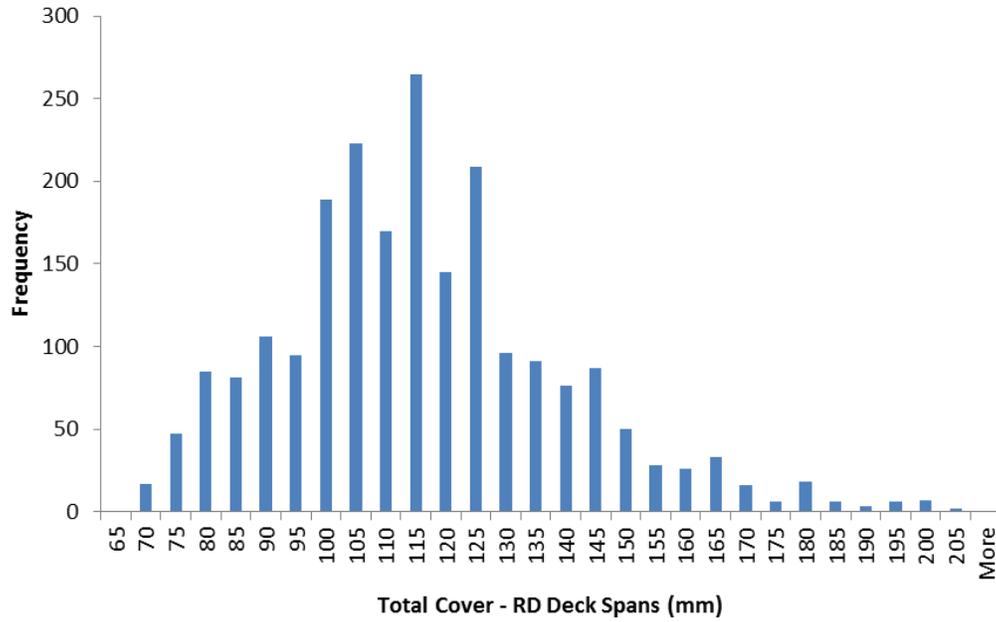
The variability in the as-built cover thickness appears to be relatively high within the RD spans and relatively low in the TH span according to Figure 8. These differences are also observed via the width of the as-built cover thickness histograms for the RD and TH spans, as provided in Figure 9 and Figure 10, respectively. Figure 11 and Figure 12 also provide histograms of the curb cover for the RD and TH spans, respectively. Noting the relatively low minimum cover thickness values and a high degree of variability in the as-built curb cover, a correlation between shallow cover and areas of elevated GPR signal loss or chloride along the curbs does not appear to exist when comparing Figure 5 b) and Figure 8. This lack of correlation also appears to demonstrate the effectiveness of the curb sealing program in protecting the curbs from corrosion, particularly where shallow cover exists. The areas of elevated corrosion risk observed along the curbs in Figure 5 b) likely coincide with transverse cracks in the curbs.

Figure 9. Histogram of as-built total cover thickness estimated for RD deck spans.

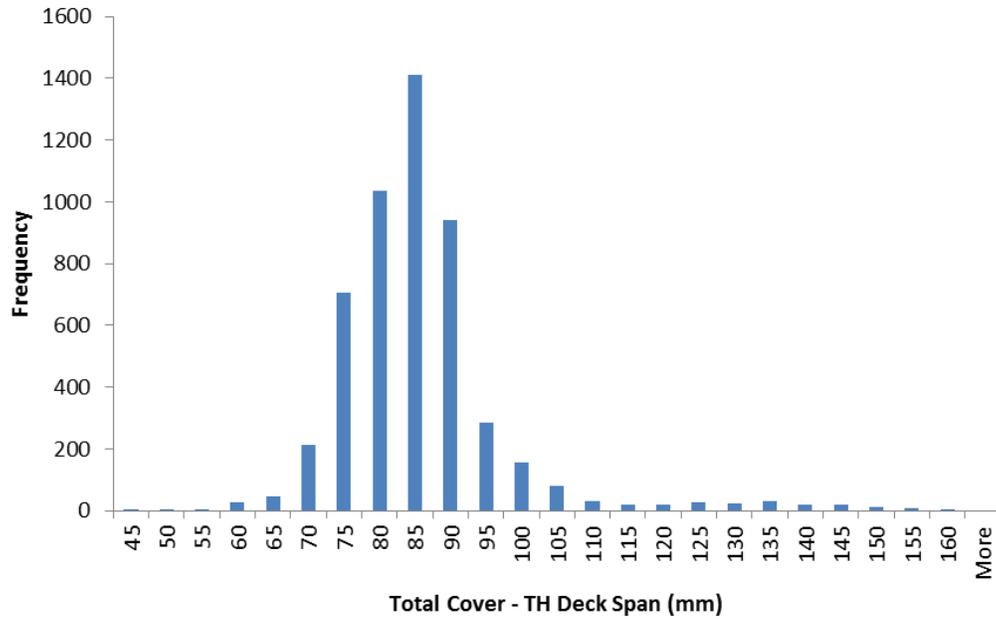
Figure 10. Histogram of as-built total cover thickness estimated for TH deck span.
