Use of Link Slabs in the Highway 17 Over Battle River Bridge Rehabilitation

Kelvin DeGrow, Team Lead Bridges, Stantec Consulting Ltd.

Paper prepared for presentation
at the Transportation Structures (PS) Session

of the 2020 Conference of the
Transportation Association of Canada

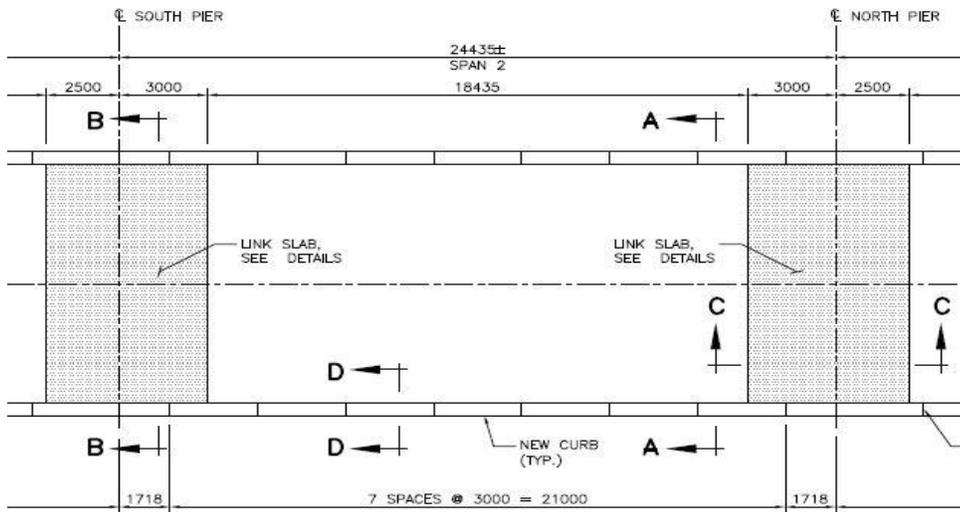
Figure 3 -Debonded areas of the Deck at Link Slab Locations.

Part of the design of a link slab is to ensure that the link slab is not made composite with the girders near the joints where the link slab is located. In the areas adjacent to the piers, the deck is to be debonded from the girders. A typical area of the deck where the rehabilitated deck is not to be made composite with the girders is shown in a portion of the design drawings for the bridge shown in Figure 3.

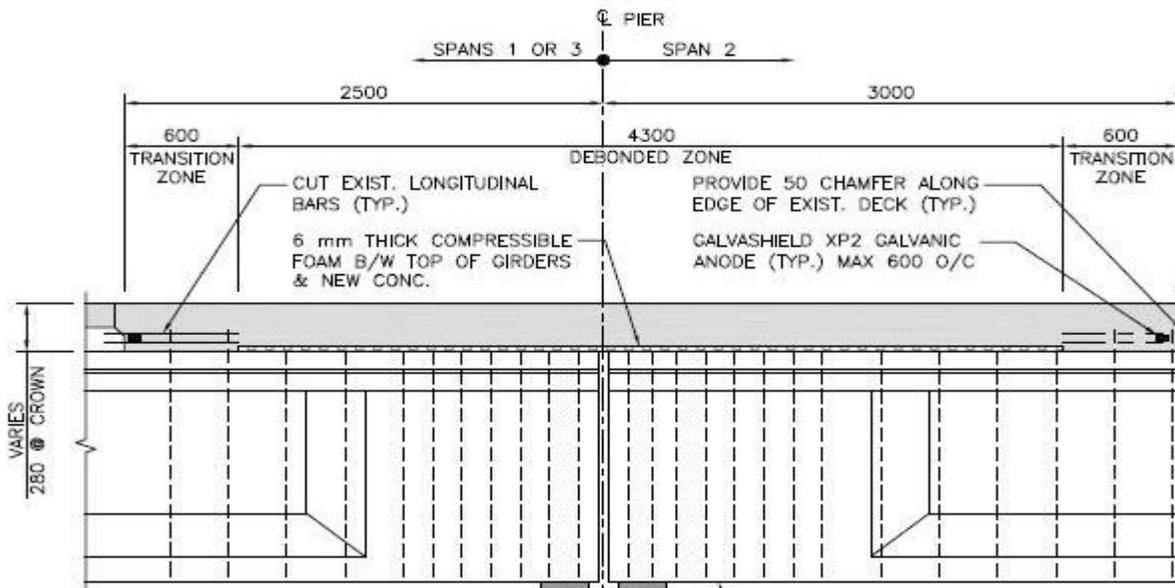
Figure 4 – Debonded Details

A detail on how the deck was separated from the concrete girders is shown in the detail from the design drawings shown in Figure 4.

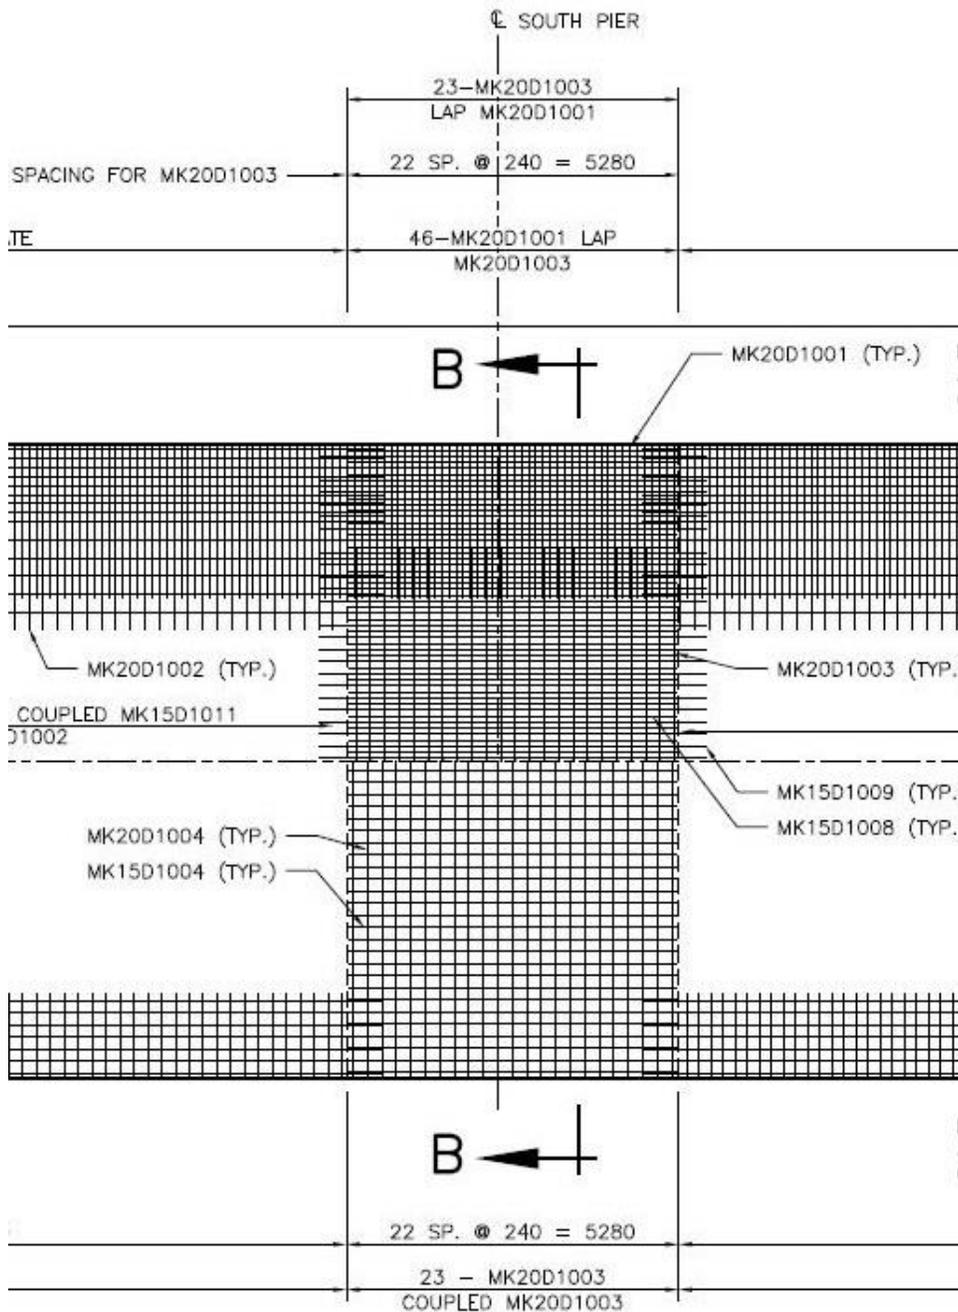
Figure 5 Reinforcing Details for the Link Slabs

Reinforcing details for the new link slabs were determined to try to limit the crack width to a maximum of 0.25 mm. Traditional reinforcing steel could not limit this crack width without large amounts of reinforcing in the deck. Other methods to help reduce the crack width to below the 0.25 mm limit were investigated and include:

The concrete mix designs were evaluated after the tender was awarded and the design was modified to accommodate the concrete supplier, the two owners of the bridge and the steel fibre supplier. A mix which incorporated the Novocon CHE 0960 steel fibres added to the concrete at a rate of 40 kg per cubic metre of concrete would provide the necessary resistance to limit the crack width of 0.25 mm. With this addition of the steel fibres, the reinforcing details for the link slabs from the design drawings is shown in Figure 5.

The top portion of Figure 5 shows the reinforcing for the top mat of the steel in the deck and the bottom portion of Figure 5 shows the reinforcing for the bottom mat of reinforcing steel in the deck.

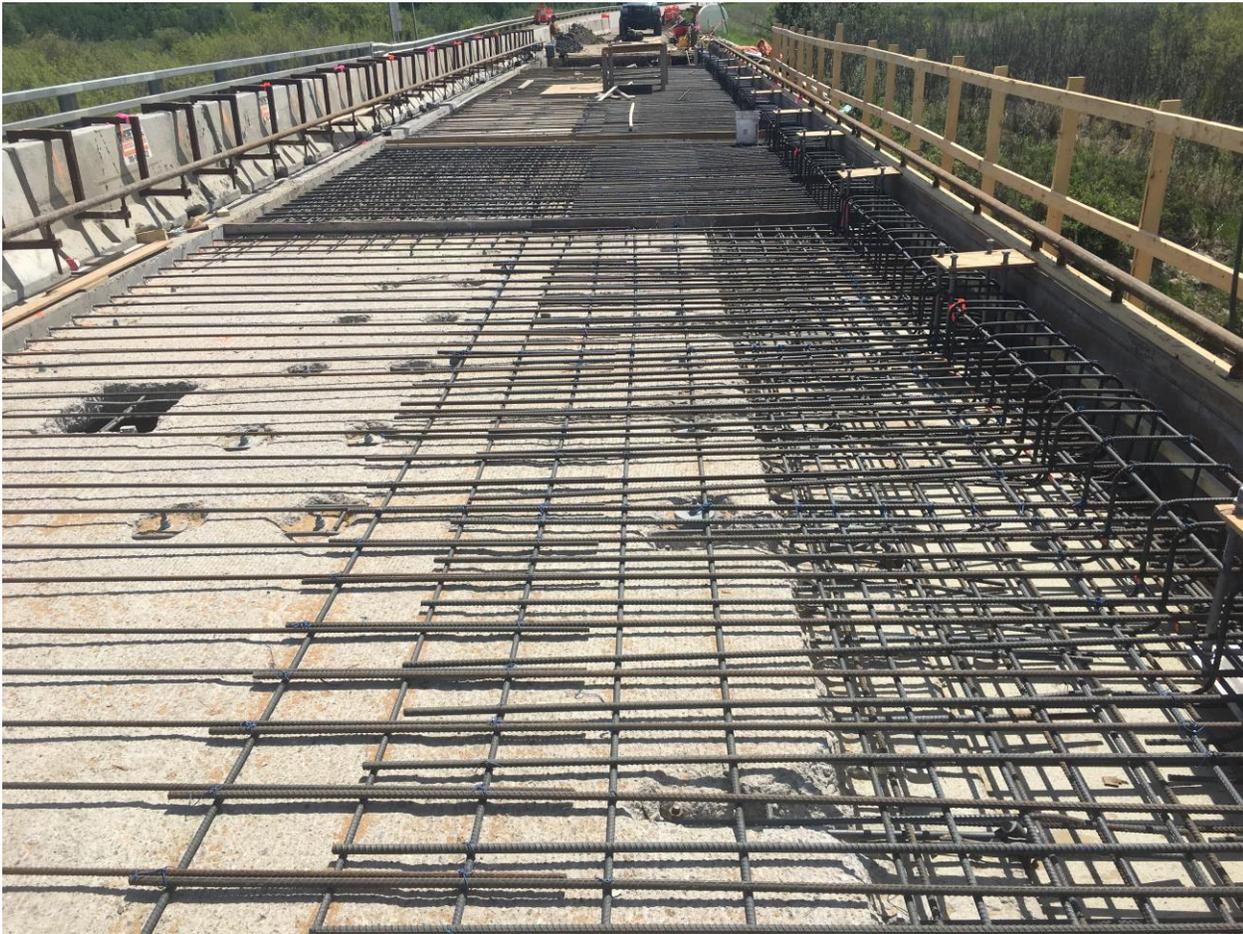
Figure 7 - New Top Mat Reinforcing of the Bridge Deck

Comparison between the reinforcing used in the link slabs and the in the new reinforcing steel in the top mat of the new deck can be seen in Figure 7.
