**Discussion of a Selection of Construction Issues Associated with the
Waverley Underpass and other Manitoba Infrastructure**

T.A. Epp, Structural E.I.T., Dillon Consulting Limited

Paper prepared for presentation at the Structures Session
of the 2019 TAC-ITS Canada Joint Conference, Halifax, NS

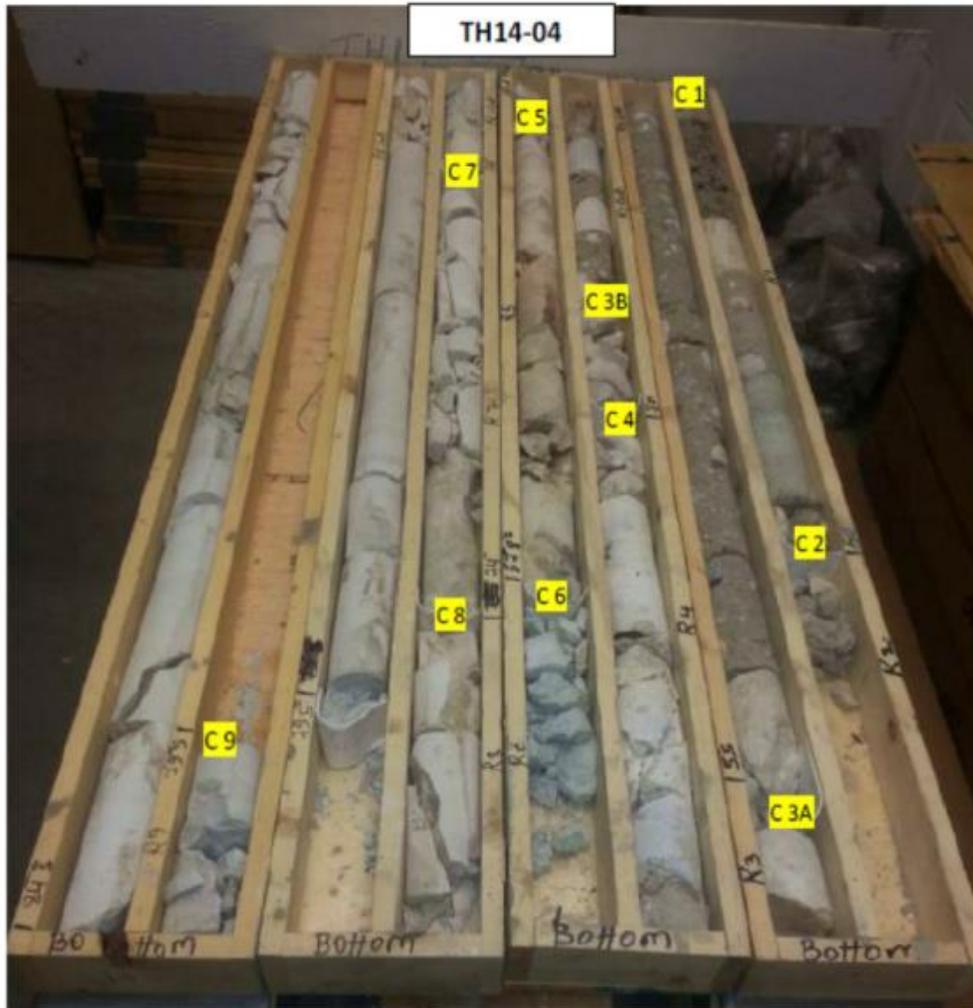
Figure 2 – Rock Cores and Associated RQDs for Deep Test Hole TH14-04

The three deep test holes were advanced past the till roughly 6 m into the underlying limestone bedrock which forms an artesian aquifer. The bedrock formation is a Paleozoic Carbonate rock formation known as the Upper Carbonate Aquifer. The depth to bedrock surface was about 18 m below existing grade or approximately at elevation 215.5 m. A layer of hard clay (shale) infill was encountered within the bedrock at an approximate elevation of 212 m or 21.5 m below existing grade. The hard clay infill zone was 0.3 m thick at 3.5 m below bedrock surface in one test hole and 0.8 m thick at 2.6 m below bedrock surface in another. The top 5 m of the bedrock formation was observed as highly decomposed and based on the calculated RQD values for the recovered rock cores, the rock quality was very poor to fair. Low RQD values were generally calculated over the entire length of rock cores indicating very poor to poor rock quality. Uniaxial compressive strength tests completed on three samples of rock cores recovered indicated compressive strengths of 114, 121 and 194 MPa, respectively. The recovered rock cores and associated RQD values from one of the deep test holes are presented in **Figure 2**.

Based on the finding of the three test holes advanced into the bedrock the top 5 m of the bedrock is dominated by very poor to poor quality rock as previously discussed. Socket length, at least at the location of these test holes, should be expected to be developed below elevation 211.0 m and measures to maintain socket wall stability and groundwater control should be anticipated. The geotechnical subconsultants advised that depth to sound bedrock should be expected to vary across the site and it should be recognized that the presence of the heavily fractured rock and infill material above the socket length may require that a permanent steel casing be left in the ground so that the integrity of the shaft is maintained. In this regard, the basis for measurement and payment for the rock socket installation should be established in the contract preparation stage to recognize that the bedrock conditions at some rock socket locations may require unanticipated extra effort and materials for their completion. The payment mechanisms ultimately utilized for the caisson construction are presented in Section 4.0.

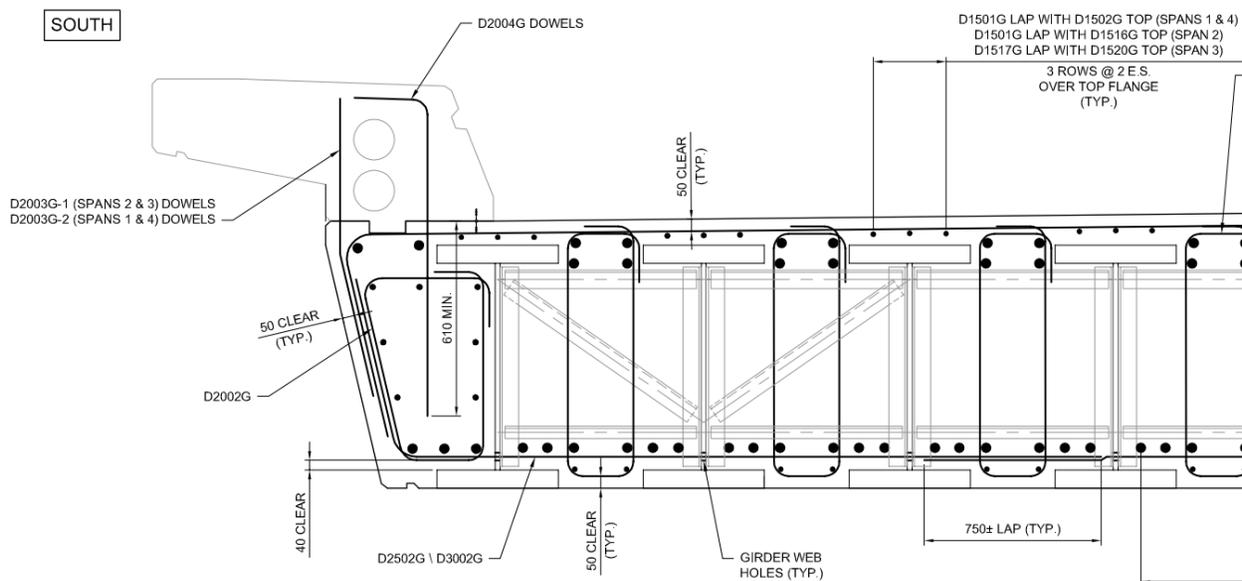
Figure 9: Superstructure Concrete Infill Reinforcement Layout (Partial Section)

During the fabrication of the HDG reinforcing steel, a series of pre-treatment methods were employed including visual inspection, caustic degreasing, sulfuric acid pickling, and zinc-ammonia chloride fluxing, after which, zinc galvanizing was applied in accordance with CAN/CSA Standard G164 and ASTM A767M-16 to a retention equal to a Class II level (610 gm/m²). The HDG reinforcing steel was chromate quenched immediately following galvanizing in accordance with the project’s specifications; this fabrication process was consistent for all HDG reinforcement on the project including 15M, 20M, 25M, and 35M rebar sizes. It’s noted that in the superstructure alone, all four rebar sizes were present as shown in **Figure 9**. The general pre-treatment and surface protection process was consistent for each bar sizes.
