Interesting Solutions for a Culvert Rehabilitation Project in a Sensitive Urban Watershed

Jason Stahl, P. Eng., Project Engineer, Amec Foster Wheeler

Paper and Presentation for the Emerging Environmental Technologies Session

of the 2017 Conference of the  
Transportation Association of Canada  
St John's, Newfoundland

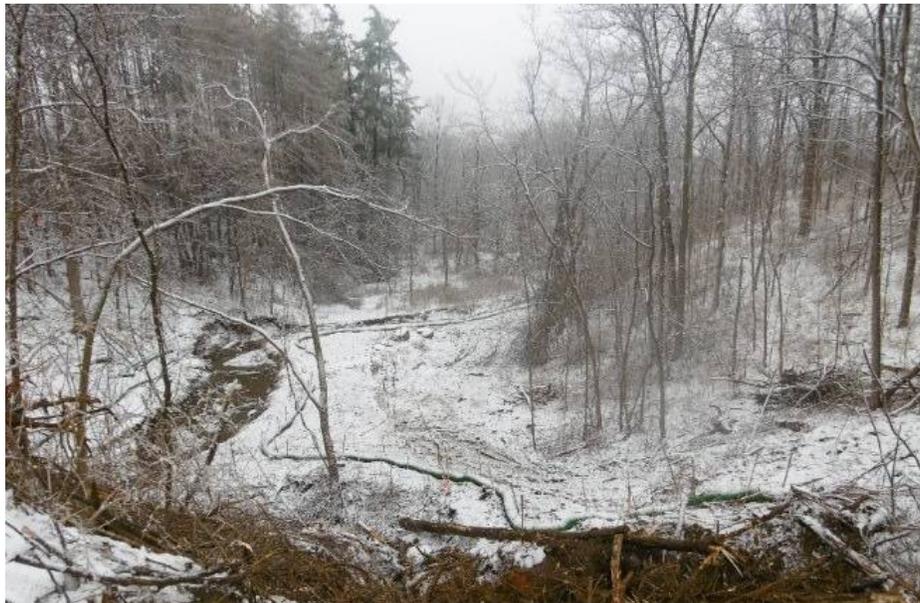
The existing culvert consists of a 14m +/- deep structure with three distinct segments. The first segment (length = 20m) consisted of a 75 year +/- old masonry structure which crosses under an old road platform just north of Bovaird Drive (known as old Highway 7). The second segment (length = 20m) consisted of a cast-in-place concrete box culvert. Finally, the third segment (length = 60m) is a larger cast-in-place concrete box culvert. Both the first and second segments were found to be structurally deficient and required removal and replacement. In addition, a 2m drop within the culvert between the segments was impeding fish passage.

*Figure 2 - Creek valley pre-construction*

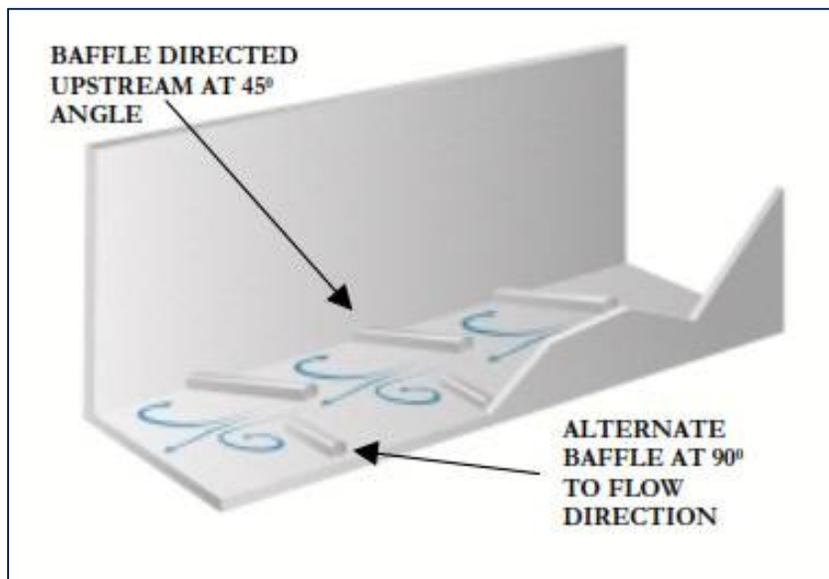
Secondly, the downstream watercourse provided habitat for many fish species. There were no species-at-risk identified, however, CVC and MNRF expressed a need to improve fish passage through the culvert and into the upstream reaches. As noted above, most of the fish present downstream were large-bodied fish. The design team, in consultation with MNRF concluded that fish movement upstream would be improved by constructing fish baffles within the existing culvert. The fish baffles, constructed out of marine grade timber, would provide 'rest points' at regular intervals (see Figure 8). In addition, the pool - channel transition upstream of the culvert was designed to accommodate fish passage by constructing pools with a depth equivalent to or greater than the height of the step. This has been found to allow the fish to develop sufficient momentum in the pool to clear the step. During low flow periods, the pool depth and equivalent step was designed to be 0.4m +/- . During more significant flow periods, the pool depth increases and the step height decreases, improving the ability for fish movement to be successful.

Figure 8 – Graphical depiction of fish baffle configuration (Source: <http://www.ontariostreams.on.ca/PDF/OSRM/Chapter%206%20Fishways.pdf>)

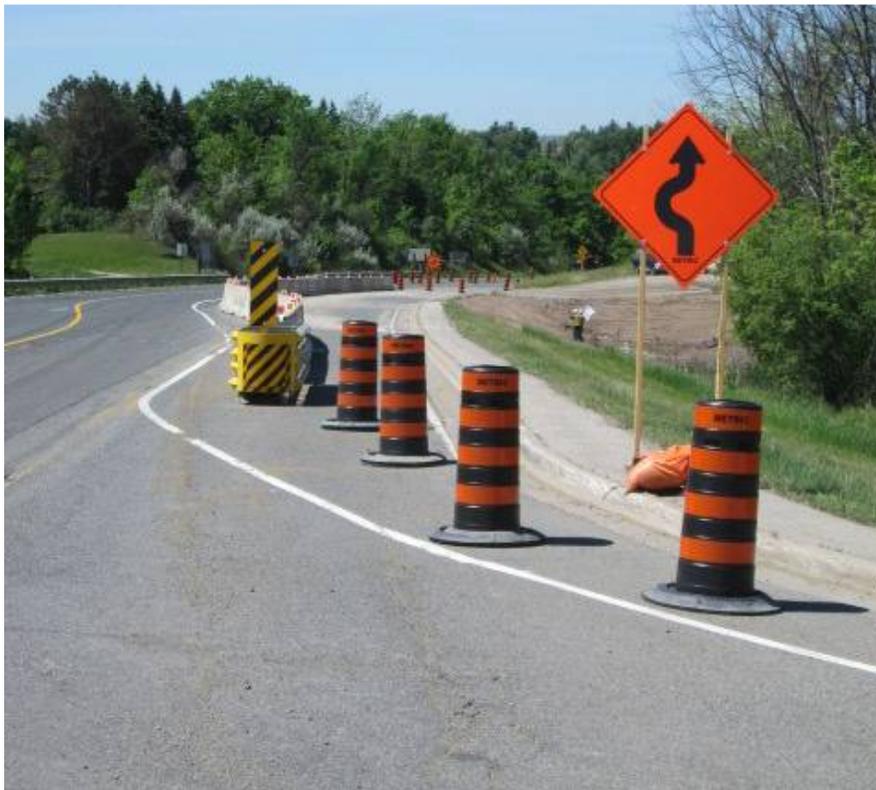
*Figure 12 - Bovaird Drive with staging implemented*

Given the close proximity of the deep excavation to the existing roadway, roadside protection was required. To minimize the height of roadside protection (to 6m +/-), while maintaining traffic, a staging plan was proposed which closed one lane eastbound (the truck climbing lane), and shifted traffic away from the excavation partly onto the gravel shoulder, which was paved to facilitate the lane shift. Two lanes of traffic (one in each direction) were maintained for the duration of construction.

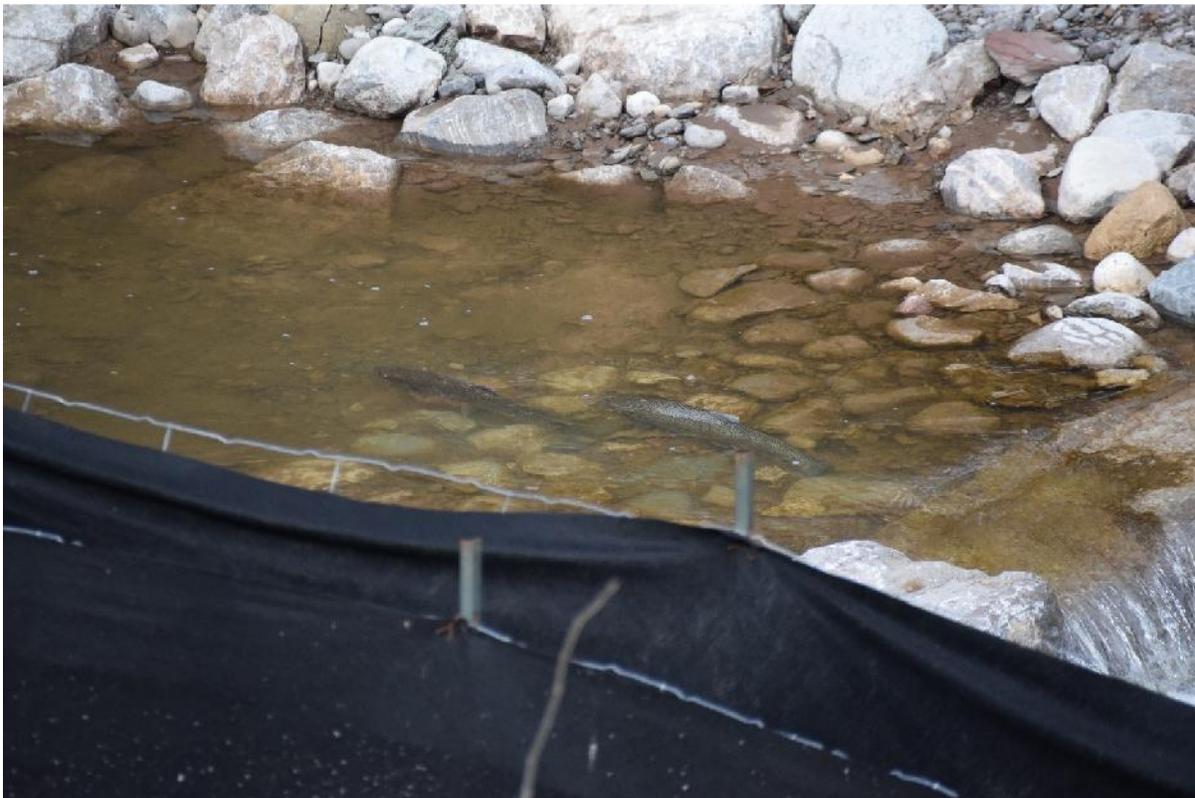
In April 2017, the efforts by the team proved successful. A number of large-bodied rainbow trout were found spawning in the pools recently reconstructed, and some distance upstream of the culvert. The habitat constructed and the reaches upstream likely have not had fish present for over 100 years, and monitoring will continue to observe the habits of these new residents to the watercourse.

*Figure 13 - Fish observed in newly constructed pools in April 2017*
