Assessment of Aged Bridge Bearings: Use of Automated Monitoring Equipment to Complement Traditional Inspection Techniques

Paper prepared for the session Transportation Structures 2024 Transportation Association of Canada (TAC) Conference & Exhibition Vancouver, British Columbia

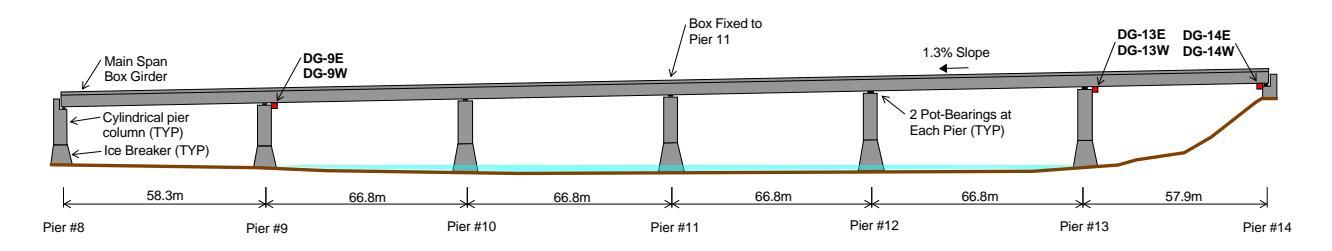
Figure 2. Longitudinal Profile of Florenceville Bridge Main Span with Locations of Deformation Gauges Identified, not to scale (Bryden et al., 2022).

Two deformation gauges were installed at pier 9 (DG-9E and DG-9W), two deformation gauges were installed at pier 13 (DG-13E and DG-13W), and two deformation gauges were installed at pier 14 (DG-14E and DG-14W), as shown in Figure 2. Each deformation gauge was mounted on a steel bracket (on the pier column) and to the underside of the main span box girder; sensors were carefully oriented along the box girder's longitudinal axis to measure longitudinal displacement at the bearing. All deformation gauges consisted of Geokon model 4420 vibrating wire sensors with an operating range of 150mm. The sensors also record temperature (alongside deformation) and are calibrated by the manufacturer and are accurate

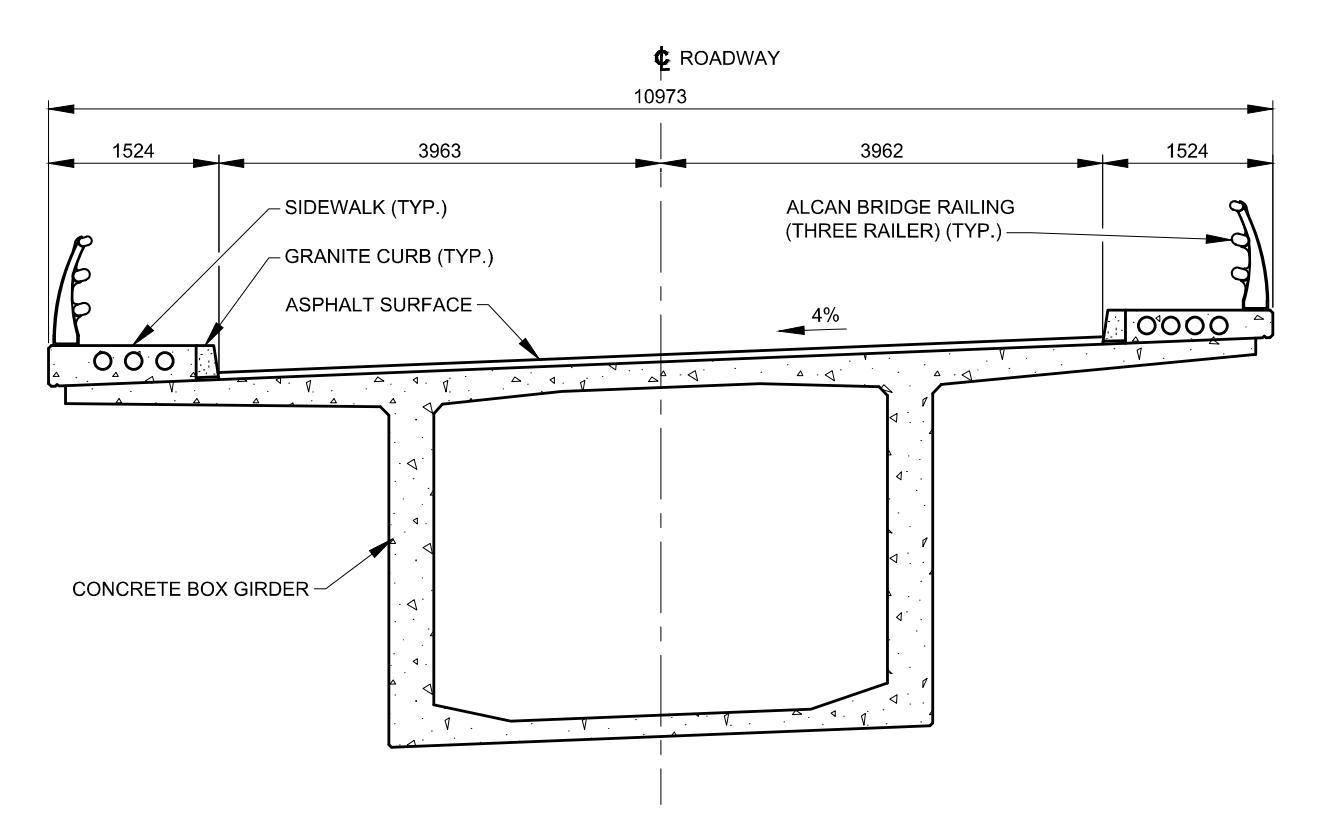
Figure 3: Cross Section of Main Span Box Girder at the Florenceville Bridge (EXP, 2021a).
