## Corrosion Evaluation of Bonded Post Tensioning

Paper prepared for the session Transportation Structures  
2025 Transportation Association of Canada (TAC) Conference & Exhibition  
Québec City, Québec

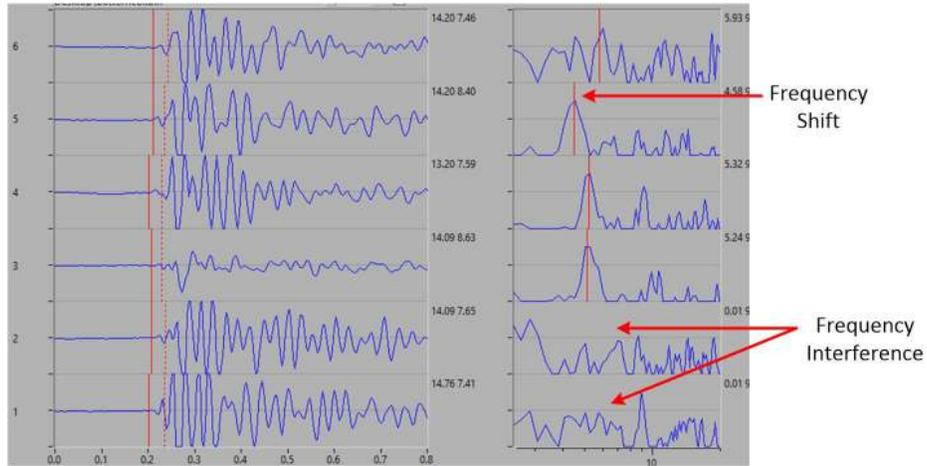
grouting defects in internal tendons. IE measures the resonant frequency of an induced stress wave over the PT tendon. If the PT duct is voided or has a change in material properties due to soft grout, the path of the wave increases, lowering the resonant frequency. PV measures the velocity of the compressional and shear wave as it passes between the array of sensors and can be used to confirm the presence of grouting defects. In a fully grouted duct, the waves will pass through the duct, and their velocity will not be affected. A partially grouted duct or a duct with soft or incompetent grout will affect the wave's travel time between the sensors. Figure 3 and Figure 4 show typical examples of PV and IE data collected on fully grouted and voided ducts.

Figure 4. Typical Scan Results from Post-Tension Ducts that Have Suspected Defects

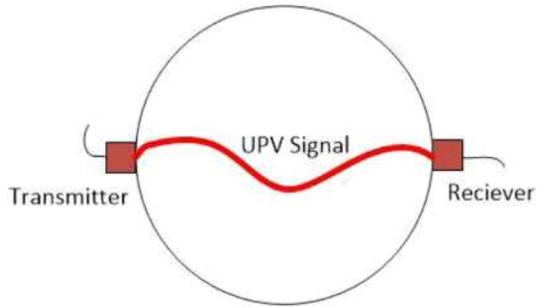
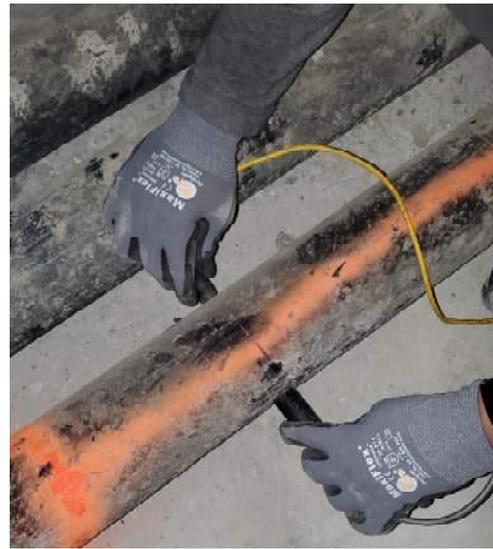
This testing can also be performed on external tendons (Figure 5). Here a transmitter placed on one side of the duct sends an ultrasonic PV signal to a sensor placed on the opposite side. As with the internal tendons, the measured distance between the transmitter and receiver is compared to the actual diameter of the duct. A measured diameter greater than actual indicates the presence of potential grouting defects.

Figure 5. Testing of External Tendons

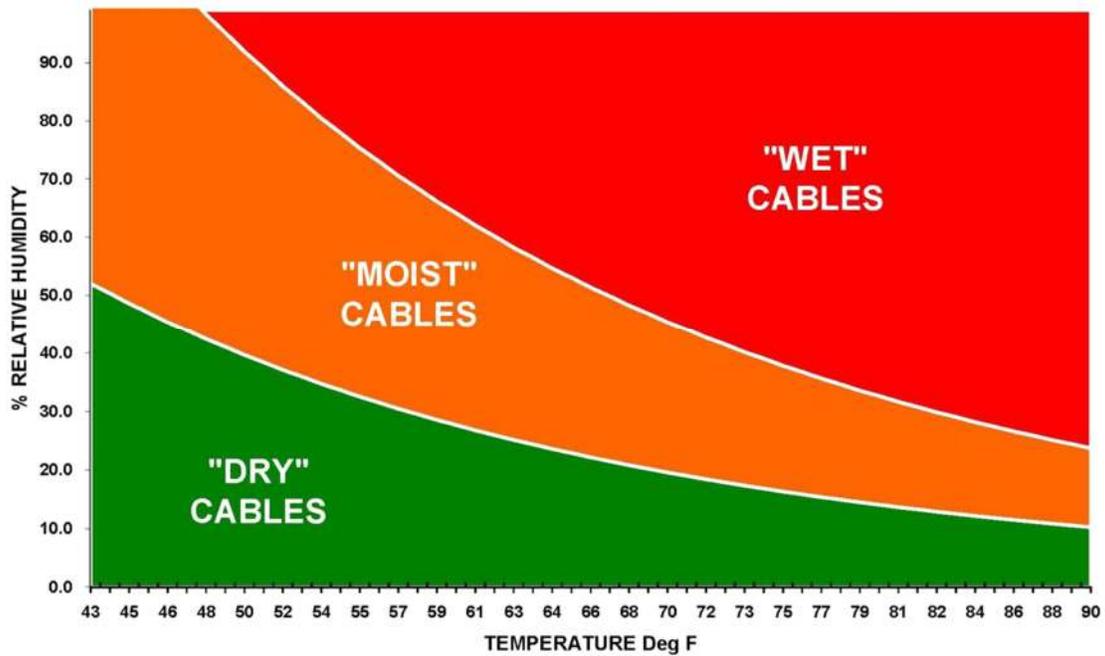
Similar to borescope inspection, moisture testing is a minimally destructive testing method that can be used on both internal and external PT systems. This test method measures the temperature and the relative humidity of the air present inside the duct, which can then be related to corrosion risk. In this test method, inlet and exhaust ports are installed along the tendon, and the inlet port is connected to a flow meter and a supply of compressed dry gas (Figure 7). As the dry gas is pushed into the tendon, it forces the air inside the duct through the exhaust port. The exhaust port is connected to another flow meter and a moisture meter that records the temperature and relative humidity of the air. The results are then plotted on a chart that relates these parameters to corrosion risk (Figure 8).

Figure 8. PT Moisture Testing Plot

Risk of Corrosion

- "Wet" – High
- "Moist" aka "dry/wet" – Medium
- "Dry" – Low
