Strategic Drainage Reconfiguration to Remediate a Landslide Affecting Saskatchewan's Highway 914

Paper prepared for the session SO - Testing, Modelling and Innovation for Roadway/Embankment Materials and Geotechnical Engineering 2024 Transportation Association of Canada (TAC) Conference & Exhibition Vancouver, British Columbia

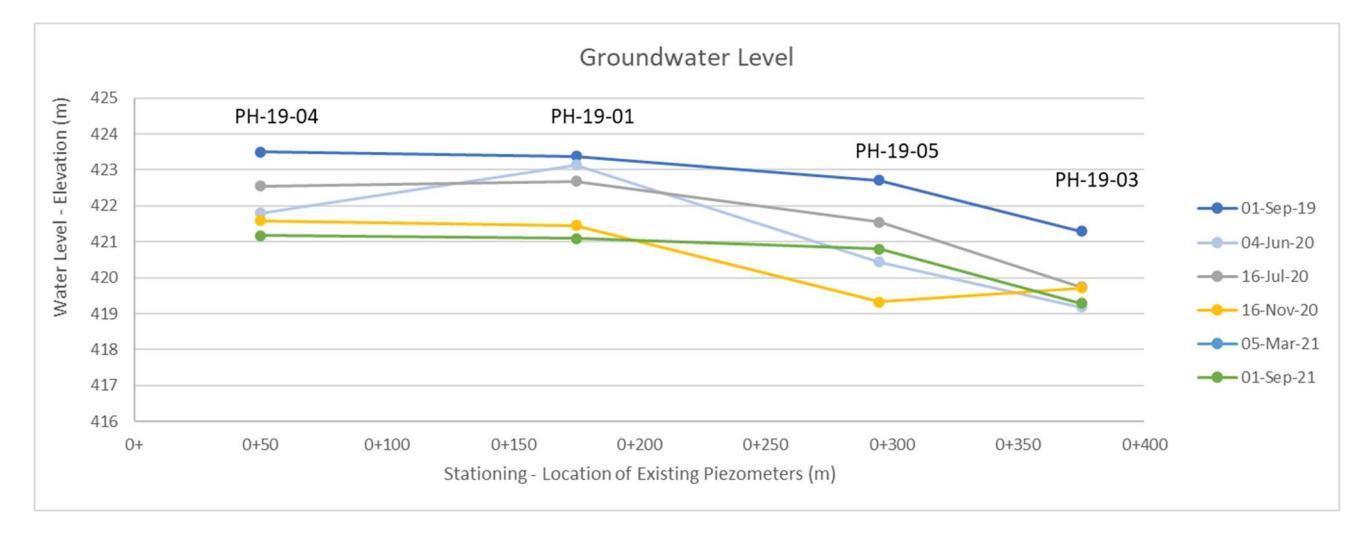
Water level readings from piezometers installed on site can be seen in Figure 9 and Figure 10 below, which display the groundwater level, and the water level below depth of casing for piezometers PH-19-01, PH-19-03, PH-19-04, PH-19-05, respectively:
