2014 Manitoba Southwest Region Bridge Flood Response and Recovery

Paper Prepared for Presentation
at the Structures Session

of the 2015 Conference of the
Transportation Association of Canada
Charlottetown, PEI

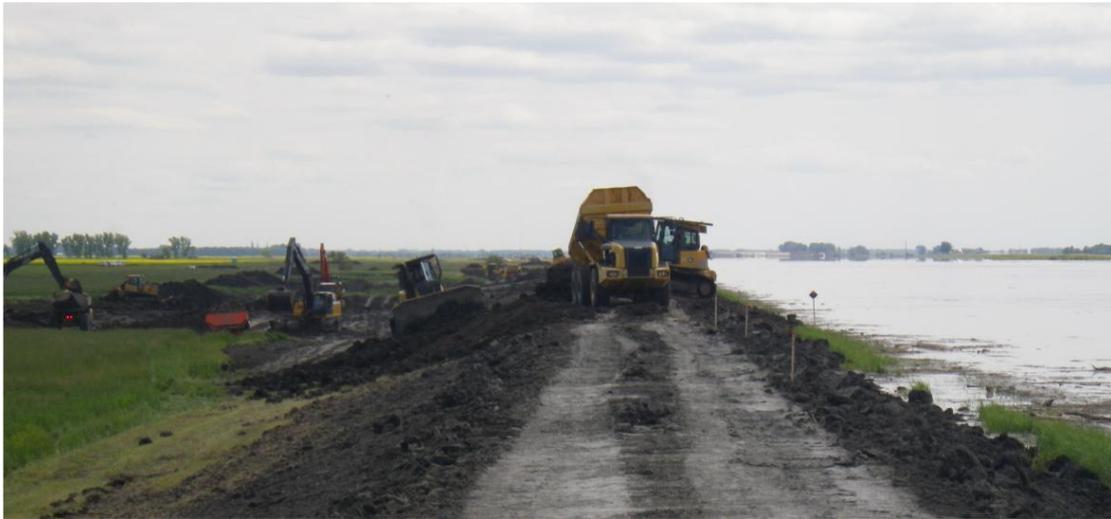
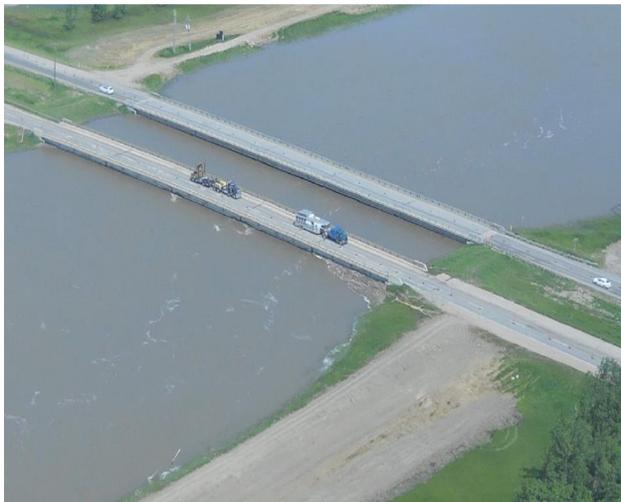
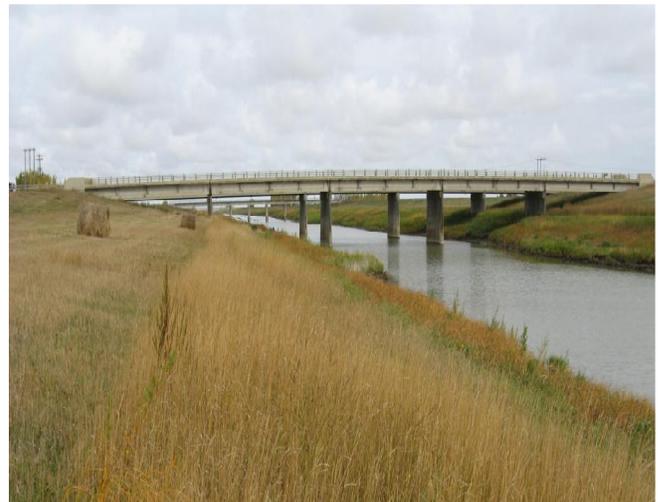
Figure 4: (top photo) Emergency Dike Raising Works Completed at the Portage Diversion During the 1st Week of July 2014, (bottom photos) Trans Canada Highway Bridges over Portage Diversion, Showing Water Level Difference Between 2014 Flooding (left) and Typical Summer Water Levels (right)

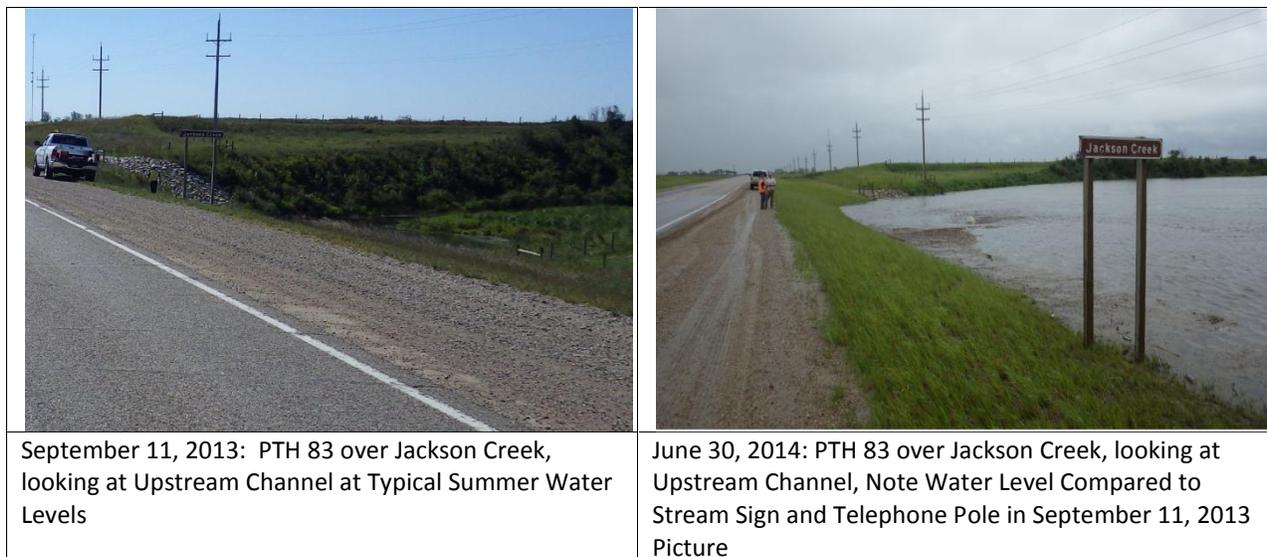
July 2, 2014: PTH 2 over Jackson Creek, Embankment and Roadway Erosion Damage at Precast Culvert Site

Figure 6: 2014 Southwest Flooding Culvert Photos (on pages 12 and 13)

1. Roadway and embankment erosion damage at PTH 2 over Graham Creek (cast in place concrete box culvert) and PTH 2 over Jackson Creek (precast concrete pipes) occurred when the culverts and roadway were overtopped and inundated during peak flows (see photos in Figure 6). However, these sites were able to be repaired in under 5 days, from the time the damage was caused to repairing the embankments with granular backfilling to reopen the road and re-establishing scour protection. A granular wearing surface was utilized on a temporary basis until final repaving could be completed.

2. PTH 83 over Jackson Creek had a ~4 m head differential from the inlet to the outlet (see photos in Figure 6); only minor embankment erosion at the inlet headwall and scouring at the inlet and outlet due to the flow turbulence occurring due to the flood event. This structure was able to remain open to normal traffic operations during the flood event and only required minimal remedial works to re-establish the embankment around the culvert and scour protection at the site.

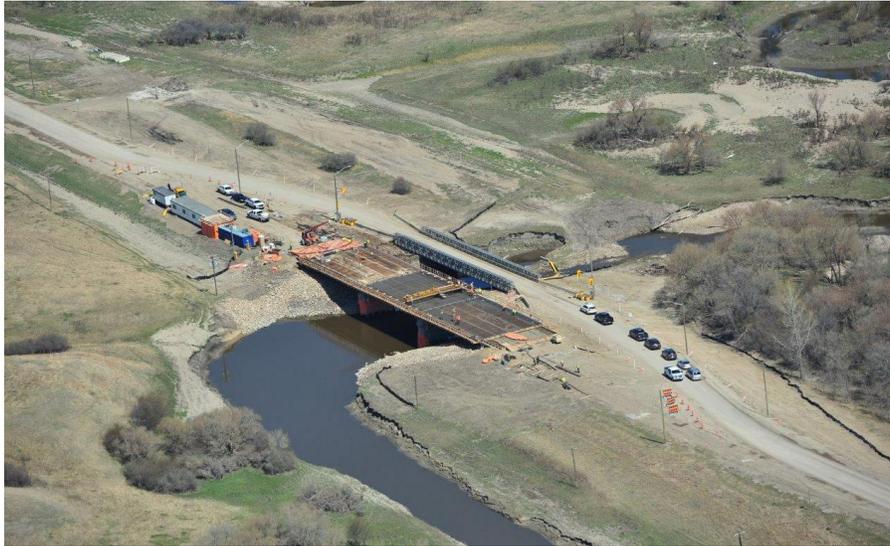
Figure 9: Aerial View of the PTH 83 over Gainsborough Creek Replacement Bridge During Construction, April 2015
