Rising to the Challenge: From Concept through Construction Repairs of the Existing Taylor Rd. (Callender Hamilton Through Truss Type) Bridge Grand Falls-Windsor, NL

Wade Pottie, P.Eng., ing.

Paper prepared for presentation at the Structures Session

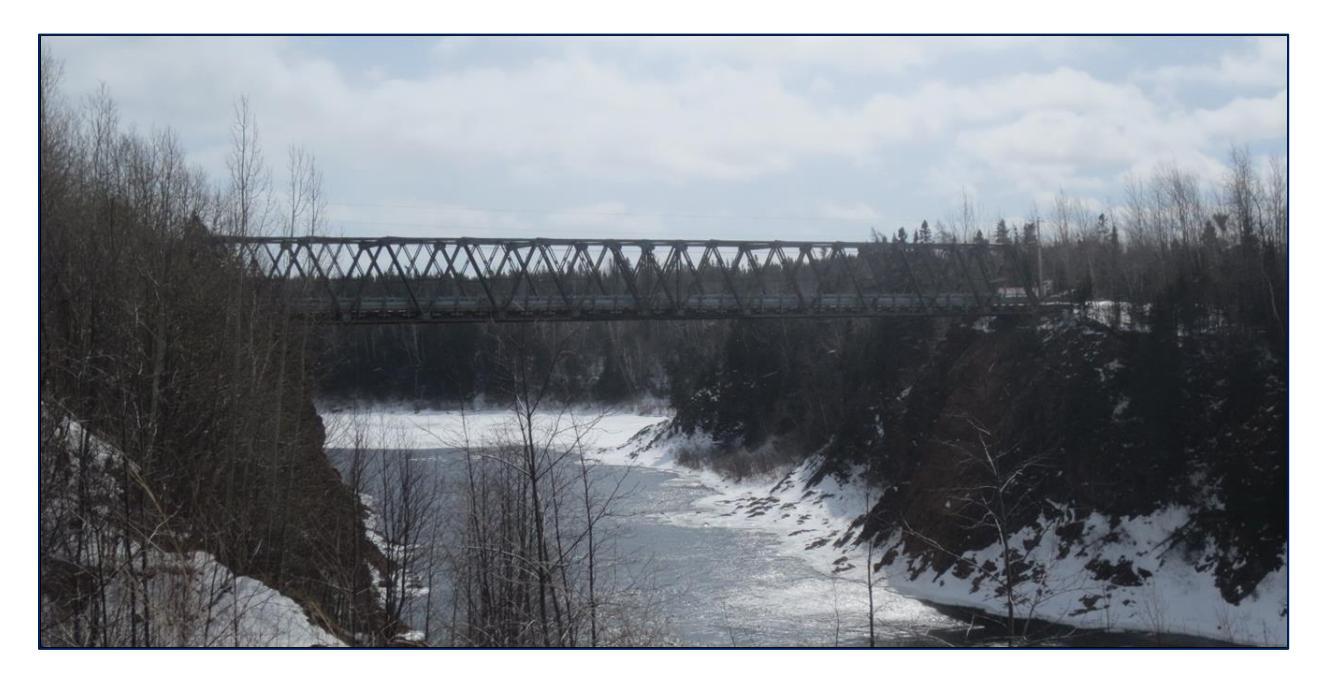
The location and position of the bridge, with a 76.2m span over the Exploits River whose substructure (i.e. abutments) are supported adjacent to 20m tall and near-vertical cliffs, presented its own challenges to the project. An elevation view of the bridge spanning above the Exploits River can be seen below in Figure 5. A standard method of repair for bridges that have sustained similar damage involves the construction of a temporary steel bent below and adjacent to the damaged portion of the truss in order to support the remainder of the bridge span, relieve the loads in the damaged members, and enable replacement in-kind. However, due to the significant drop below the bridge superstructure and the near-vertical face of the cliff directly in front of the south abutment, it was not reasonably feasible with the project budget and schedule to construct such a bent beneath the existing damaged section of the

Figure 5: Callender Hamilton Bridge spanning the Exploits River (south abutment at right end)

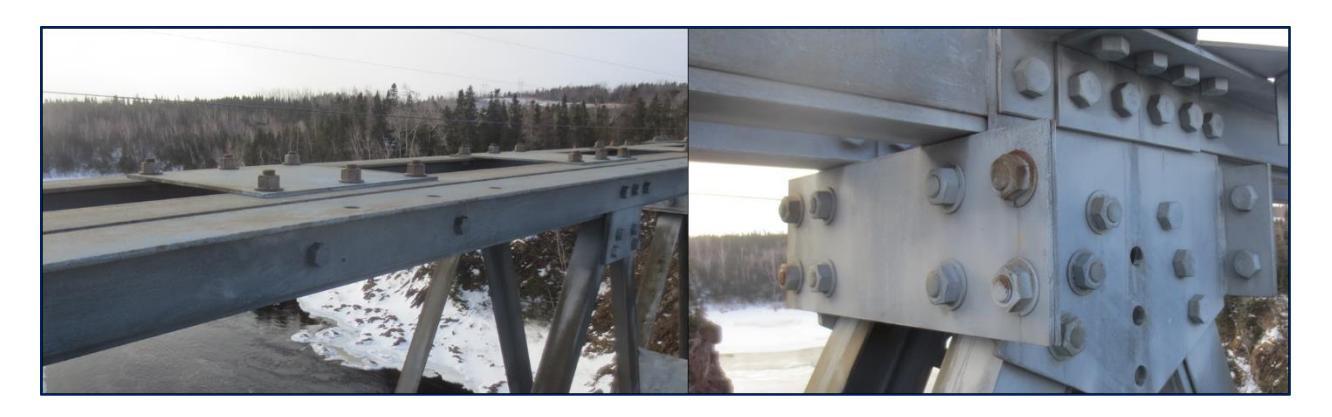
The first step to be taken in constructing the temporary jacking strut system involved the installation of temporary bracing plates to provide lateral stability to the top chord members prior to making any alterations to the structure. The individual components (i.e. angles) of the built-up truss top chords are tied together by intermittent bolts and batten plates as shown on the left of Figure 7 below. Global stability of the truss top chords is provided by braced points: vertically by gusset plates at the truss diagonal / redundant diagonal nodes and horizontally by connector plates at truss diagonal nodes as shown on the right in Figure 7 below.

Figure 7: Batten plates (*left*) and connector plates (*right*) providing stability to the top chord

In order to attach the temporary jacking struts to the top chord nodes, each strut was bolted to a connector plate (see Figure 7 above). The connector plates, as mentioned above, provide transverse stability to the truss by tying the vertical gussets together. In order to permit the attachment of the jacking strut to the connector plate, the bolts had to be temporarily removed from the connector plate so that the end plate of the strut could be bolted to the connector plate. To avoid temporary reduction in lateral stability of the top chords during the installation of the jacking strut end connection, bracing plates were installed on the top surface of the top chords directly above the connector plates. An installed temporary bracing plate is shown on the left in Figure 8 below.

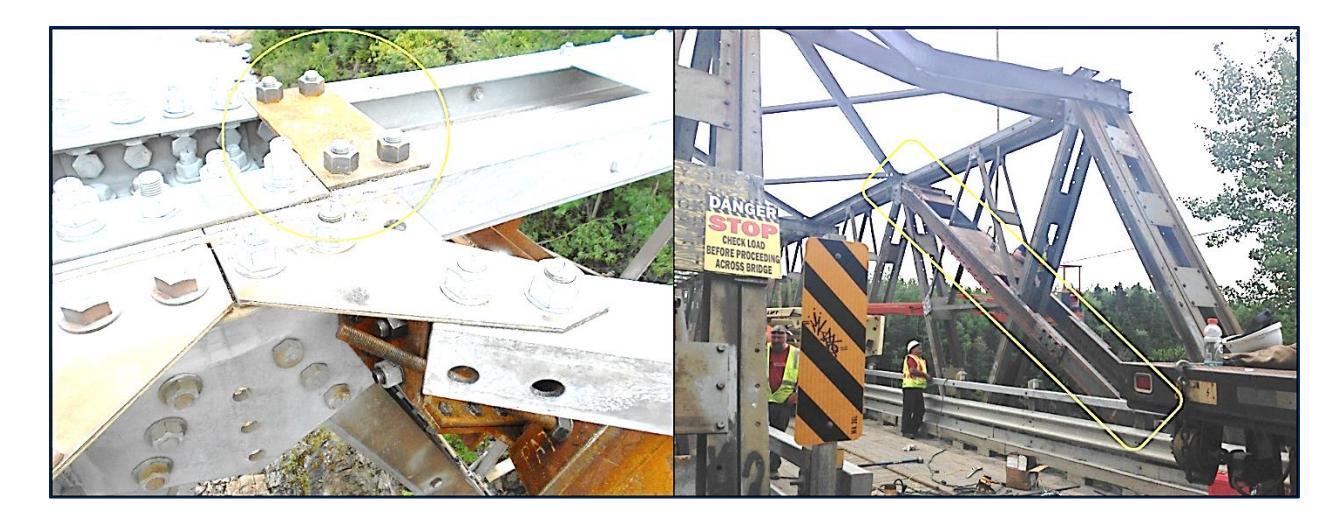
Figure 8: Temporary bracing plate (*left*); jacking strut assembled around existing truss members (*right*)

Once the temporary bracing plates were installed, the built-up temporary jacking struts were assembled around the existing truss diagonals. Each jacking strut was composed of two MC310 structural steel members interconnected at several locations along their lengths via bolted batten plates, strategically located to avoid conflict with the existing truss elements. The jacking system used to load the jacking struts was located near the lower node of the temporary struts for worker accessibility purposes. Each jacking system consisted of two different diameter circular HSS (hollow structural section) pipes centered on the strut centerline. Ring plates were welded around the outside surface of the smaller HSS, ensuring the gap between the two pipes was very small to minimize potential lateral displacement between the two segments. The innovative sleeve systems played a key role in the jacking system as they provided lateral stability to the system in all directions during the jacking procedure while still allowing the length of the strut to be adjusted. A jack was placed on either side of the HSS sleeve system (i.e. two jacks per strut) and would eventually be used to apply load to the jacking struts and relieve the load in the damaged members. Four threaded bars with nuts on either end were also included into the design, along with shim plates to "lock" the jacking strut lengths in place after the jacking procedure so that the jacks were not relied upon to support the bridge dead loads during replacement of the truss members. In addition to the main jacking struts, temporary braces and strengthening angles were installed to provide additional support to the system. A fully assembled jacking strut is shown in Figure 8. It should be noted that the jacks were not loaded at the stage of the procedure.

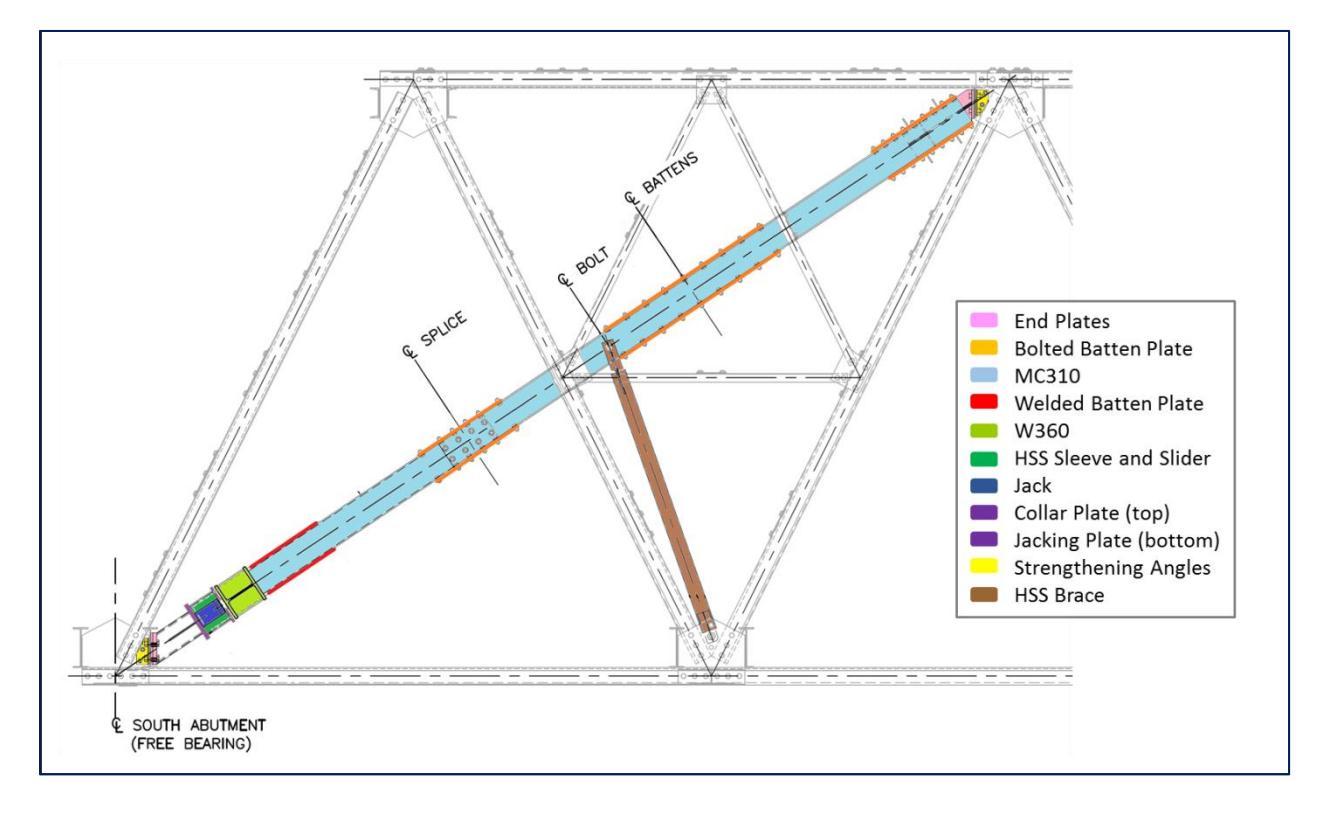
Figure 9: Temporary built-up jacking strut and jacking system (elevation view)

Before commencing the jacking procedure, the top strut and threaded bar cross bracing were installed between the two jacking struts to provide resistance to lateral wind loads. It should be noted that the threaded bar cross bracing was installed slack in this condition, so that they would not restrict (or take on loads) during the jacking process (which effectively elongates the temporary support system). The temporary support system is shown schematically in Figure 9 and Figure 10.

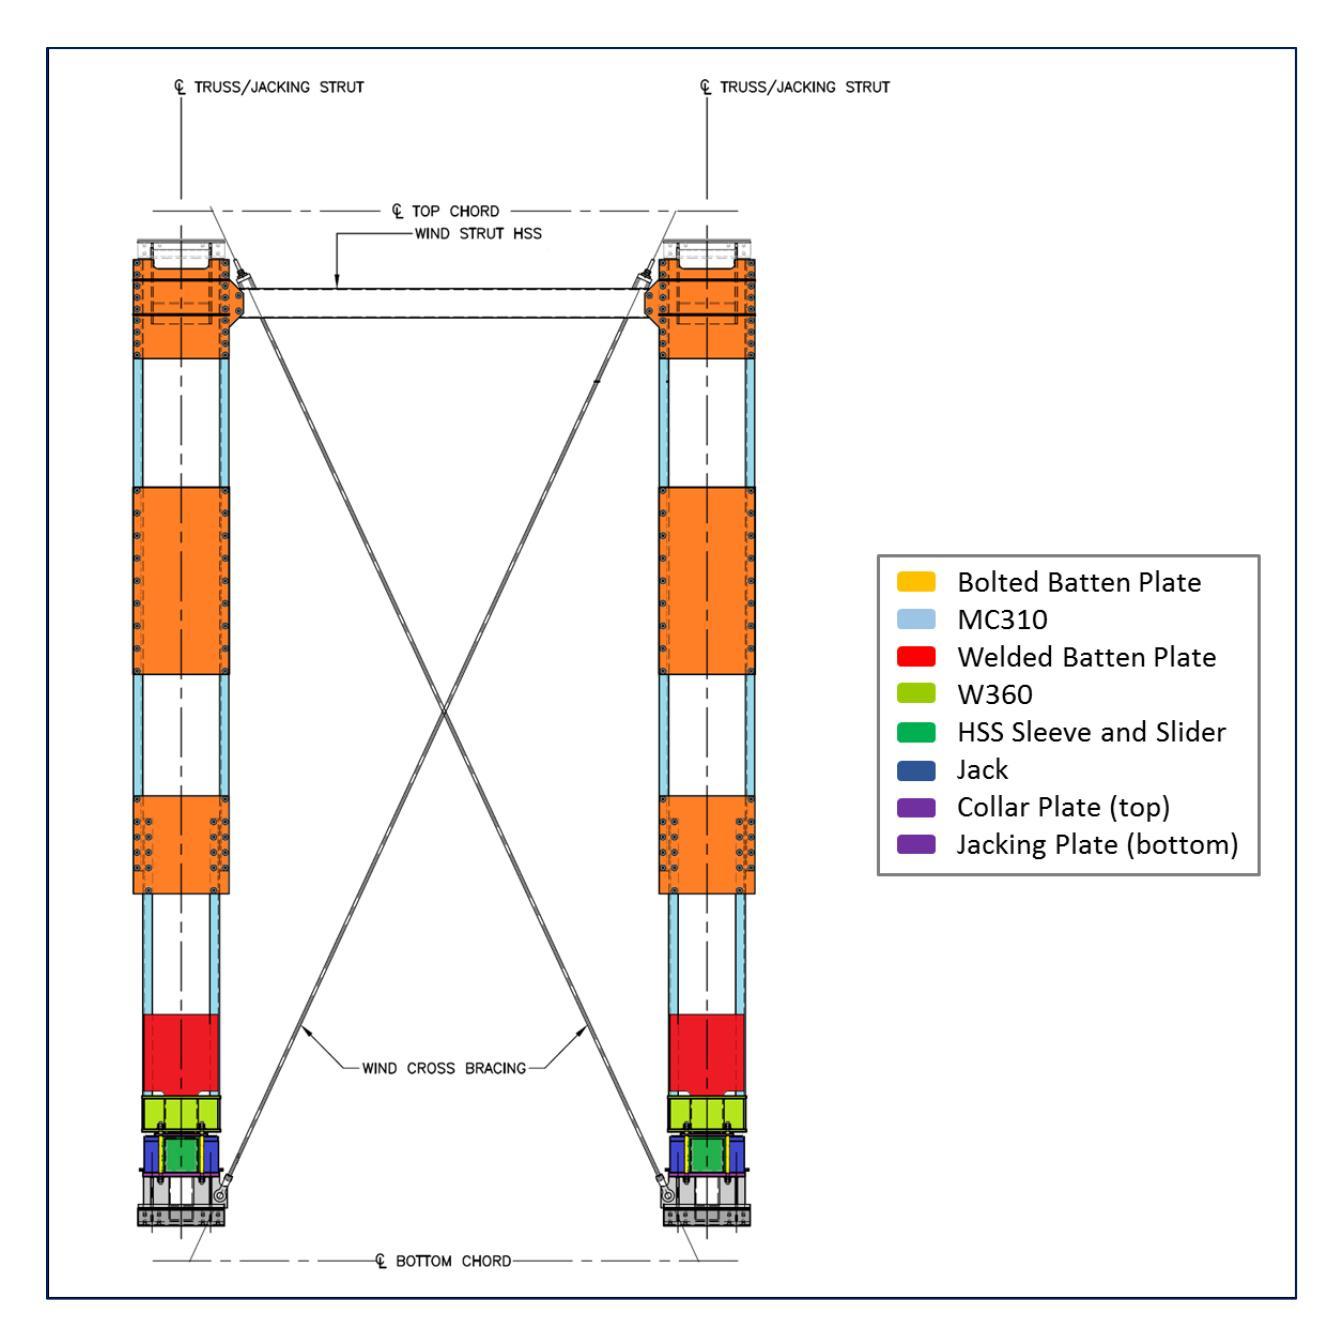
Figure 10: Temporary built-up jacking strut and jacking system (front view)

Once it had been confirmed that an adequate amount of load had been transferred to the jacking struts, the jacks were locked off, shim plates were installed between the two strut segments (W360 bottom flange and collar plate) to provide longitudinal continuity to the strut, and the threaded bars were snug tightened. The placement of the shim plates and tightening of the threaded bars served to secure the jacking struts in their extended positions. The pressure was then then slowly released from the jacks, gradually transferring the loads from the jacks to the shim pack / internally into the struts. The cross bracing threaded bars were then tightened into a snug, strain-compatible condition to provide a load path for transverse wind loads during member replacement. At this stage, all loads were relieved in the existing truss members, all temporary works assemblies were installed, and the Contractor was ready for member replacement. A fully-constructed and fully-loaded built-up jacking strut / jacking system, with all components labelled, is shown in Figure 11.
