Surficial Slope Instability  
and the Potential Contribution of Erosion Control Practice

Ian D. Corne, CPESC, M.Land.Arch., B.E.S.  
Technical Manager, GeoHydraulics  
Nilex Civil Environmental Group

Paper Prepared for Presentation  
at the  
Innovation in Geotechnical and Materials Engineering Session

of the 2018 Conference of the  
Transportation Association of Canada  
Saskatoon, SK

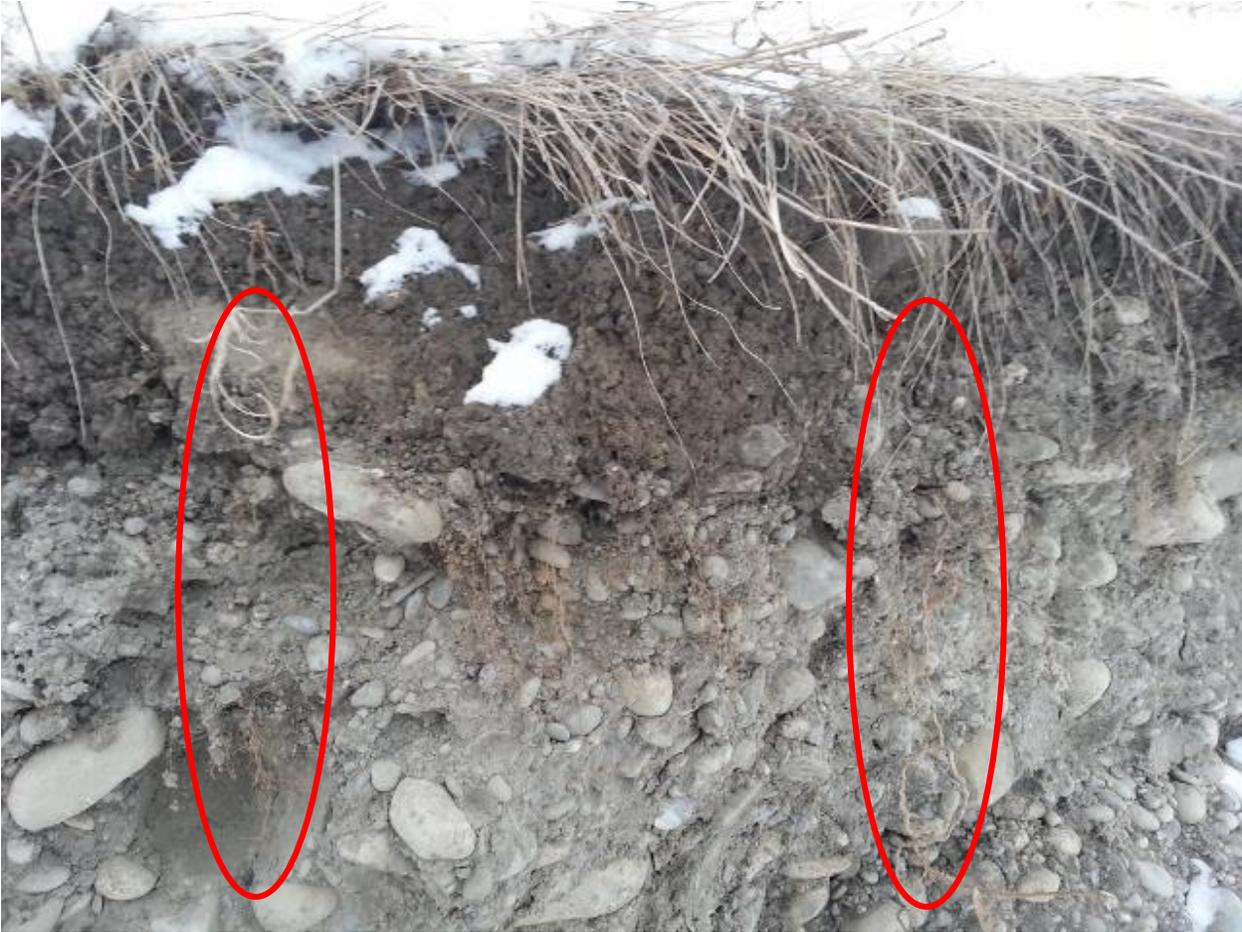
Figure 1. Root development at depth, mechanically attaching topsoil to subsoil

Early pioneering plant species addressed inorganic compacted soils with capacity to initiate nutrient cycling and ability to set root in compacted soils. Throughout the vegetation succession and soil building cycle, plant roots performed surficial stabilization by mechanically adhering surface soils to subsoils.

Highly elastic and strong vegetation roots evolved on site and over time to be able to mechanically hold rootbound soils in place, even in periods of high soil moisture concentrations when soils become heavy for moisture held in place by the very rootzone holding the soil to the surface.

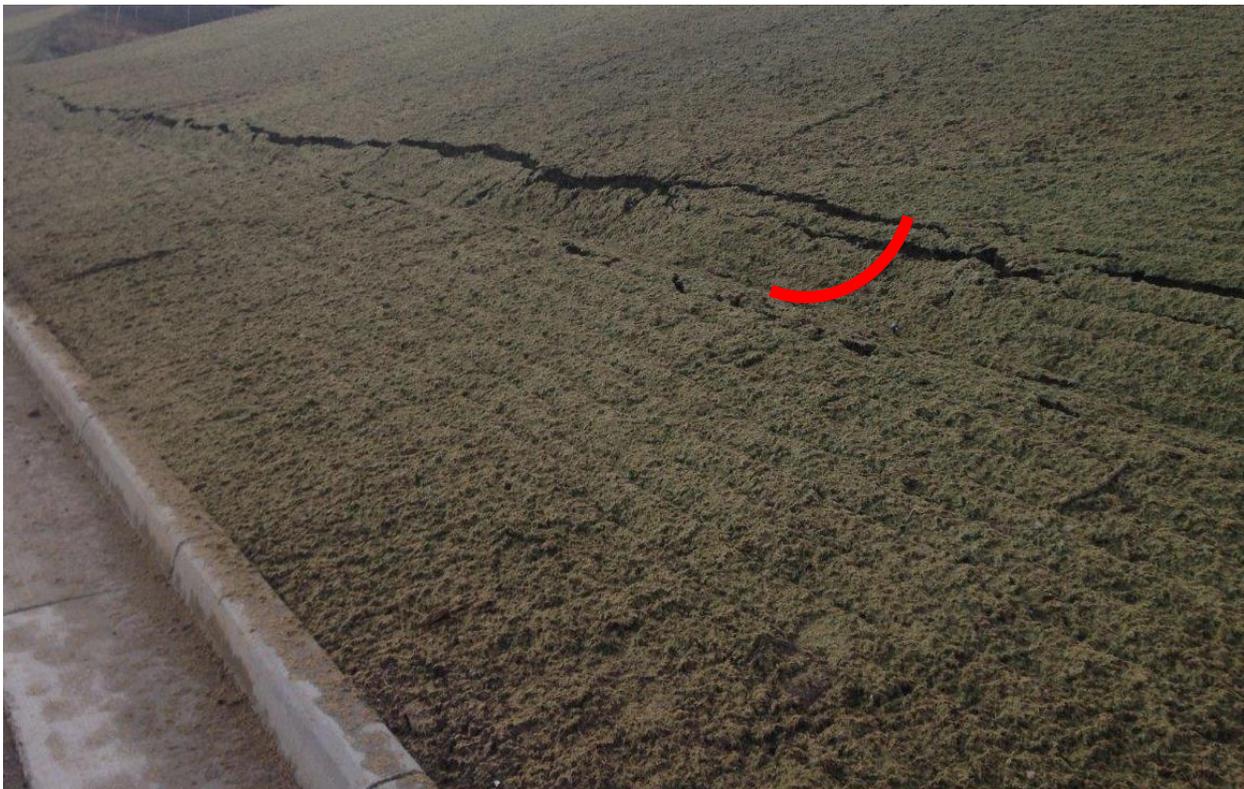
Figure 2. Cross-gradient water bar graded swale soil texturing

Shallow, short slopes, properly installed transverse-gradient water bars, as well as soil texturing are examples of good erosion control measures.

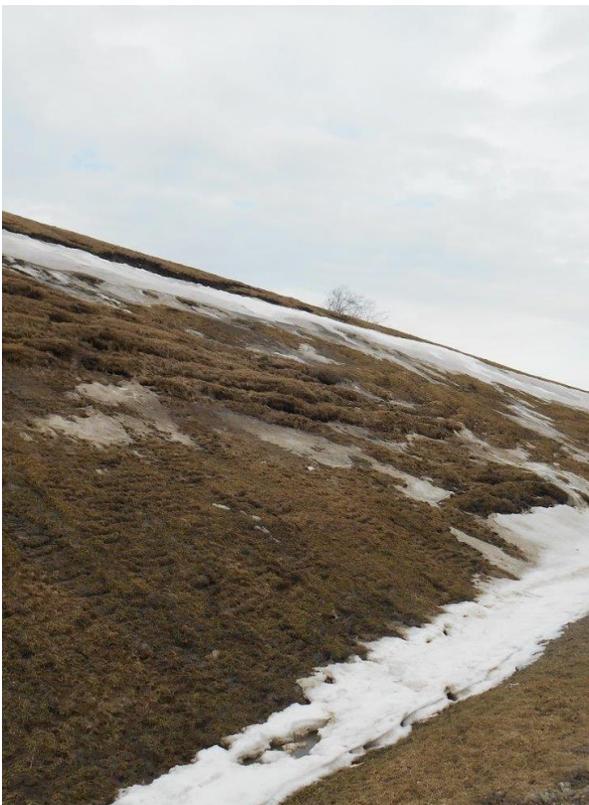
Figure 3. Sloughing well-vegetated slope within six months

Chronology of sloughing is as follows:

- There is a slip-plane where the topsoil meets the compacted civil grade soil.
- The specified climax species vegetation is not adept at breaking into the compacted grade and topsoil becomes rootbound and heavy.
- The topsoil is prone to slipping as it becomes heavier with roots.
- The rootbound soil holds significant weight in water along the fibrous rootzone.
- The wet, heavy rootbound soil sloughs.

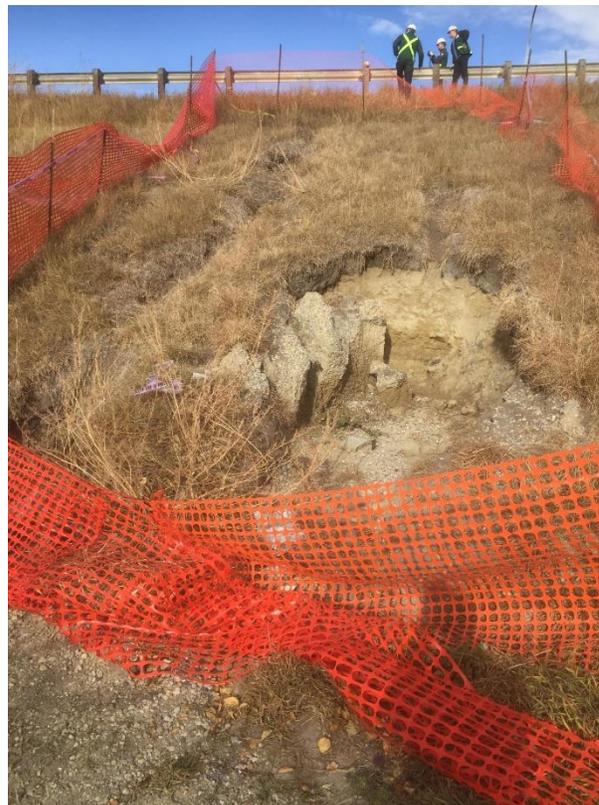
Figure 4. Sloughing well-vegetated slope after thirty years

Where in-situ soils built over thousands of years, have developed soil strength to site-specific conditions which may have resulted in 100mm of topsoil, removing, storing and replacing 100mm of that topsoil does not result in pre-construction soil stability characteristics.

Current practice sees placed topsoil designed to usually stand on a steeper gradient than in the original condition and the subsoil and the subsoil upon which it sits is typically more compacted than the pre-construction subgrade.

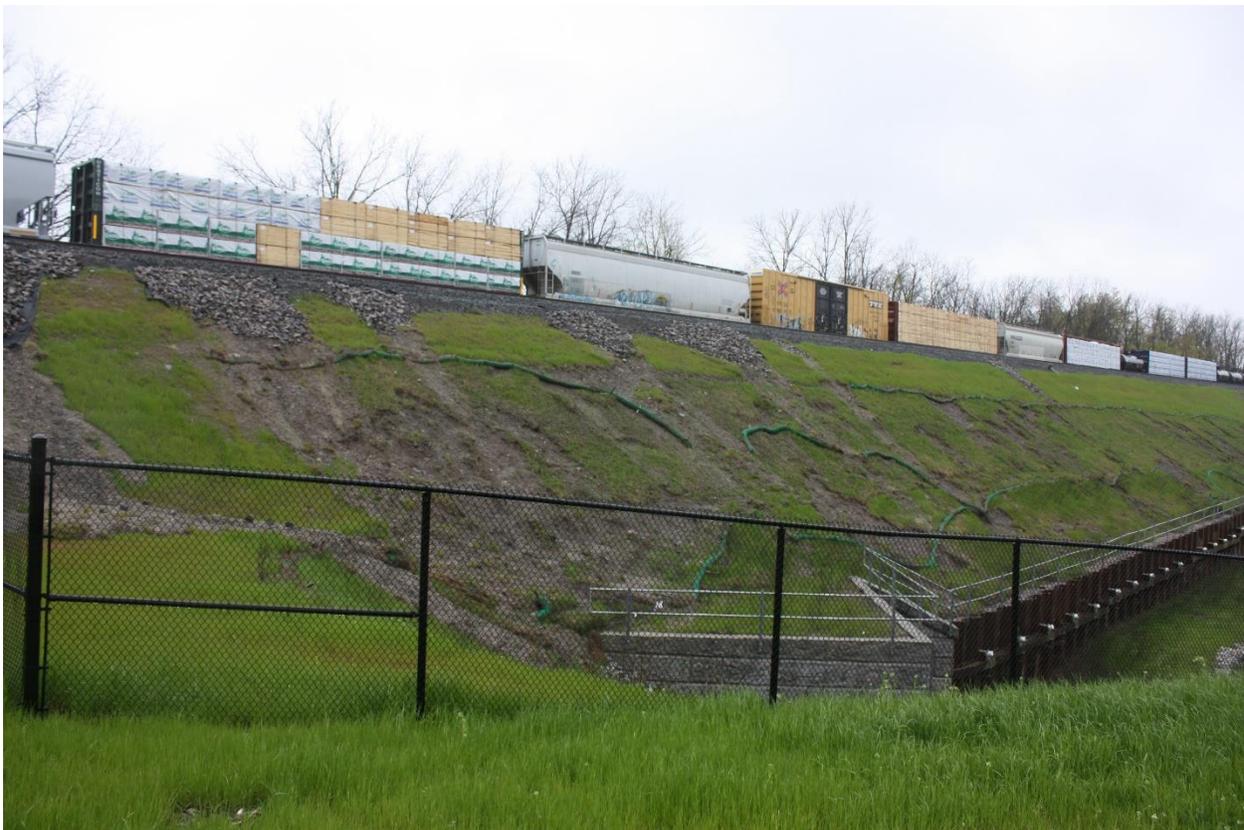
Figure 5. Slope interruption device contributing to surficial soil instability by moisture retention

In dry cycle years, water collected upstream of slope interruption products typically has a chance to percolate and leave the slope grade dry and at full shear capacity to carry the forces of the next rain event.

In wet cycle years, the civil grade in the vicinity of the device remains saturated and subsoil supporting the topsoil is at limited saturated shear capacity and results in saturated subgrade sloughing in addition to surficial topsoil sloughing.

Given commoditization of ESC products and installation, it is prudent to consider that this ESC measure will not be installed properly. Improperly installed ESC measures confound failure by causing water to quickly concentrate, resulting in expedited surface erosion.

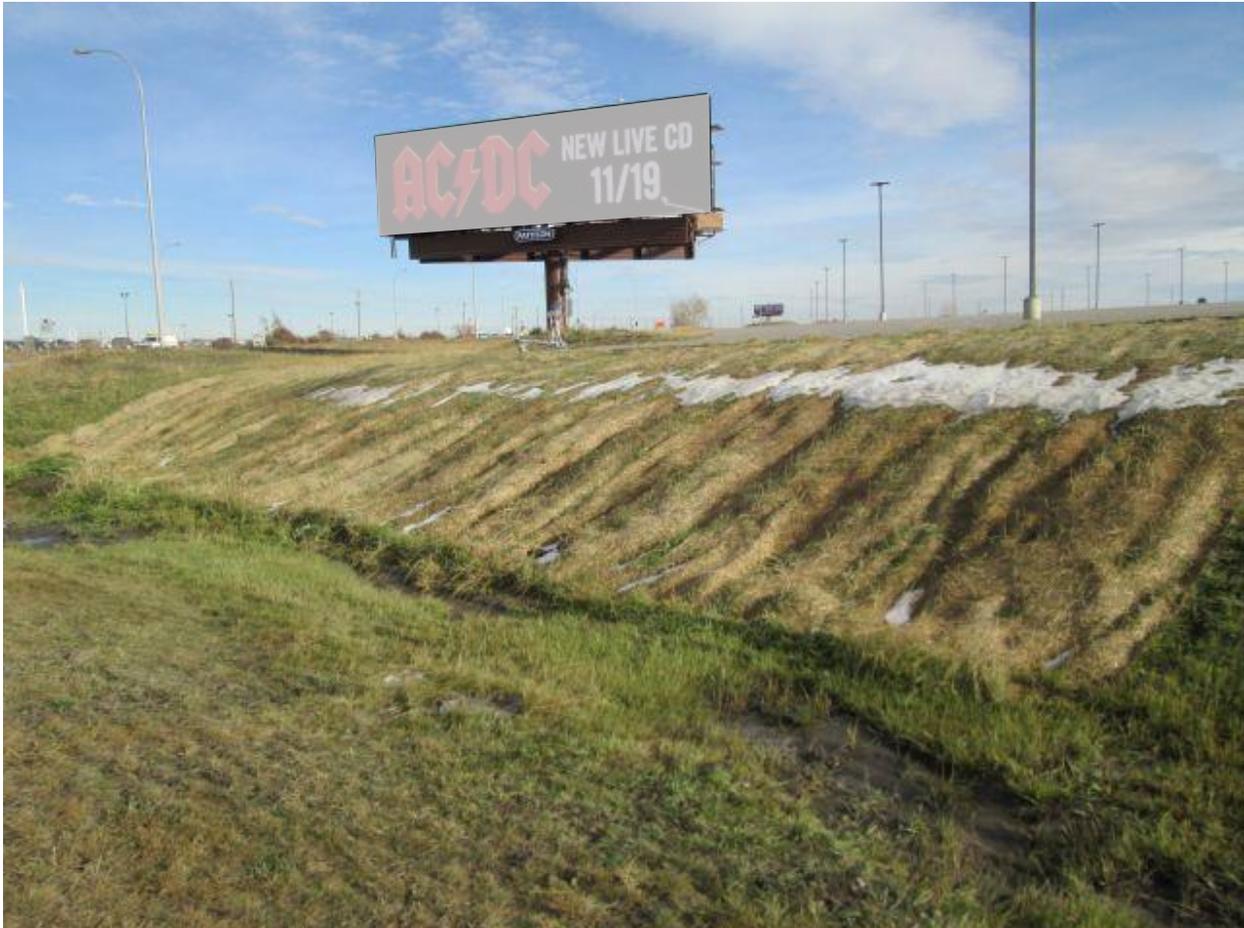
Figure 6. Erosion below Erosion Control Blankets not conformed to soil surface

Rolled Erosion Control Blankets (RECB) are a decades-old product category offering good erosion protection if installed properly. RECBs need to be installed with enough fasteners of sufficient style and length to hold the blanket against the soil surface causing intimate contact of the RECB to the ground. Intimate contact mitigates erosion below the erosion control blankets and associated seed migration.

Given commoditization of ESC products and installation, it is prudent to consider that this ESC measure will not be installed properly. Improper installation will result in erosion below the RECB.

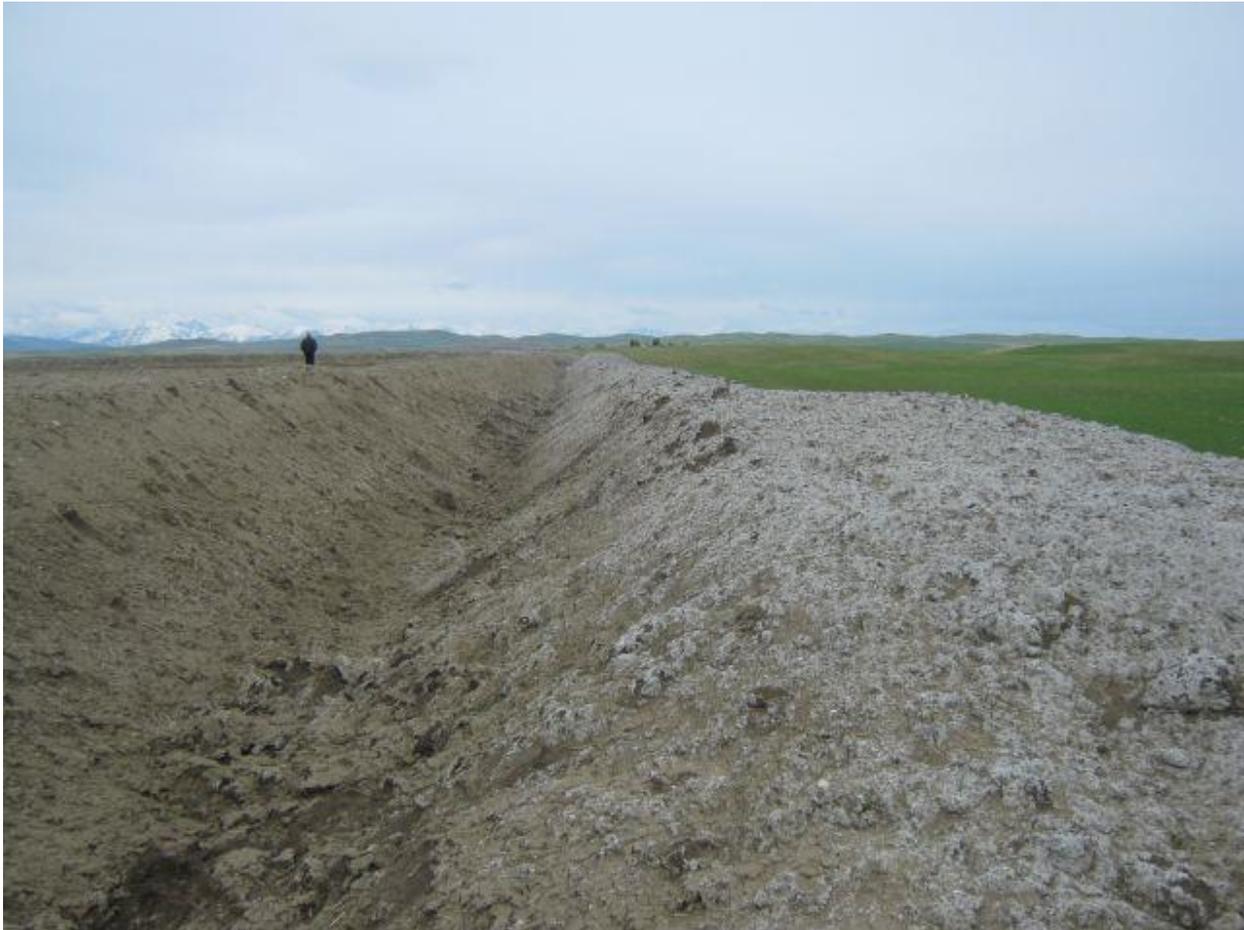
Figure 7. Highly conforming Hydraulically Applied Erosion Control mulch high wind performance

With the commoditization of RECBs products and installation, manufacturers of Hydraulically Applied Erosion Control Products (HECP) have been increasing the erosion control technical proficiency of these products, once limited to products for hydroseeding. High performance erosion control HECPs are quick and cost-effective to install and the higher performing erosion control matrices enjoy greater than one order of magnitude higher erosion control performance than RECBs.

Caution needs to be exercised in design and specification of this relatively new product category with attention placed on ability of the product attributes to best support vegetation establishment while controlling erosion. Attributes to consider include, but are not limited to, ability to hold moisture in the soil for germination, ability to install with intimate seed to soil contact and the ability of the matrix to interact within the soil for interim erosion protection until vegetation is established.

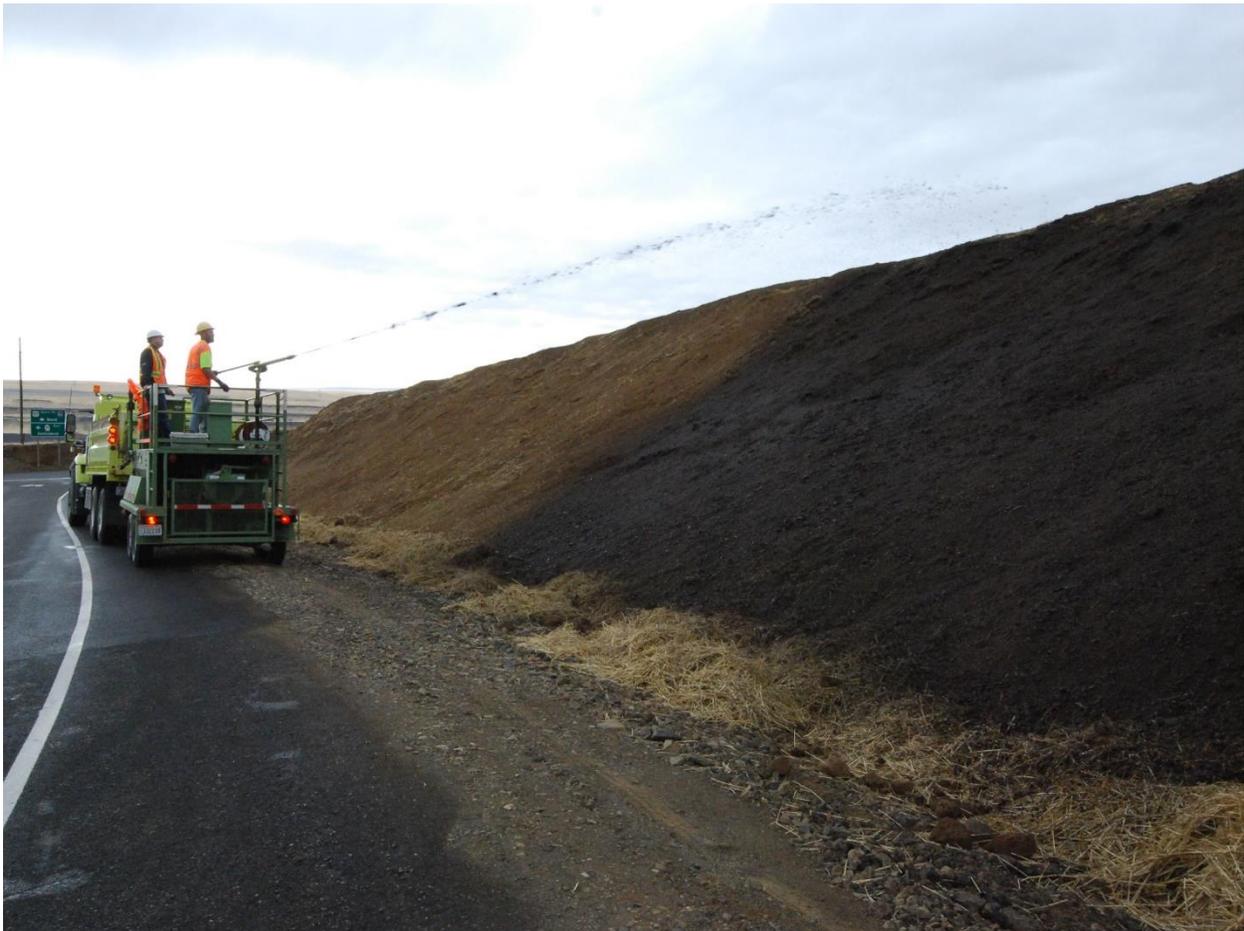
Figure 8. Hydraulically Applied Biotic Soil Amendment (HBSA)

The Erosion Control Technology Council industry group specifies a new product category Hydraulic Biotic Soil Amendments (HBSA) as being (ECTC 2016) “designed to be used as topsoil or compost alternatives when topsoil is not present, soil is lacking in organic matter, or there is little to no biological activity.”

For reasons of topsoil liability as discussed above, HBSAs are likely best employed with limited topsoil and in conjunction with careful consideration of the civil grade subsoil’s ability to support sustainable vegetation.

Caution needs to be exercised in design and specification of this new product category with attention placed on ability of the product attributes to best support sustainable vegetation establishment. Erosion control is required on top of HBSAs.
