# **The City of Edmonton Micro-surfacing Program A 30-Year Successful Pavement Preservation Program**

Hamid R. Soleymani, Ph.D., P.Eng  
Senior Pavement Engineer  
Infrastructure Maintenance  
City of Edmonton  
[hamid.soleymani@edmonton.ca](mailto:hamid.soleymani@edmonton.ca)

Paper prepared for the Testing and Modeling of Roadway/Embankment Materials and Geotechnical Engineering session of the 2022 TAC Conference & Exhibition - Edmonton

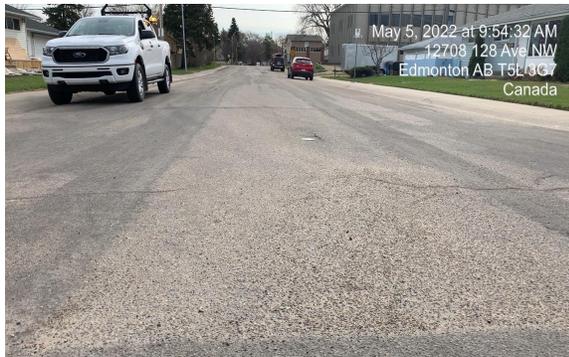
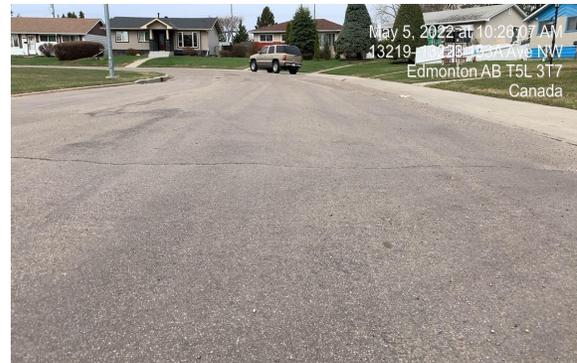
Field observation showed that at high traffic locations with turning movements, MSF has failed due to delamination and ravelling. At lower traffic areas, MSF still was in place. Certainly the effectiveness of the MSF was lower at the locations with many reflected cracks. One interesting observation was around a roundabout boulevard with only local traffic which MSF was still

effective after 8 years. Photos 1 and 2 show the difference between high and low traffic locations. It was concluded that MSF has done its job and still is effective at low traffic locations. Also, the difference between the parking and driving lanes were clear. It is not expected to resurface this neighborhood with another MSF in the future as it needs a mill and fill or rehab in most locations.

Photo 1: Ravelled areas after 8 years (left) and Photo 2: A better MSF performance in a roundabout boulevard was still effective after 8 years

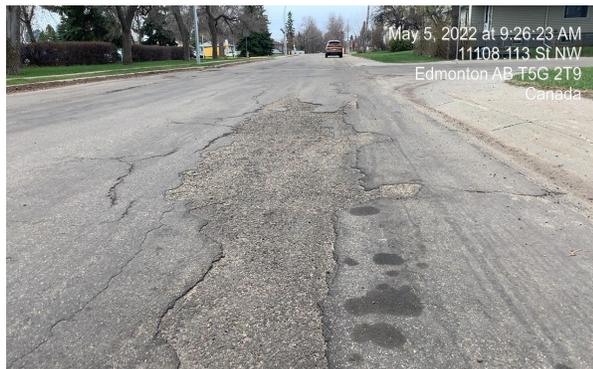
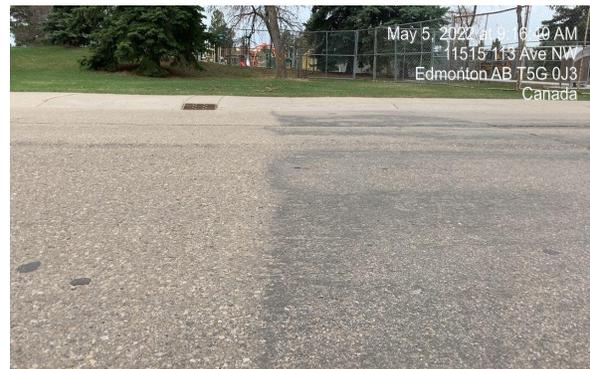
**Case Study II - Prince Rupert Neighborhood (Type I, application rate 8.84 kg/m<sup>2</sup>, placed in 2015)**

This MSF application was placed with low rate and fine gradation and was 7 years at the time of inspection. Images from pre-construction condition of roads indicated that MSF was placed at the end of this surface life with aged surface and many repaired and unrepaired cracks that have been reflected. In different locations, 20% to 60% of MSF was still visible. Delaminated/ravelled areas were at high traffic locations and mainly in the wheelpaths. Although a mill and fill was more effective, MSF has performed reasonably to postpone the rehabilitation. Photos 3 and 4 show a ravelled area and the difference between a non-treated and MSF treated surface.

Photos 3 and 4: Delaminated MSF area (left) and difference between untreated and MSF treated surface after 7 years (right)

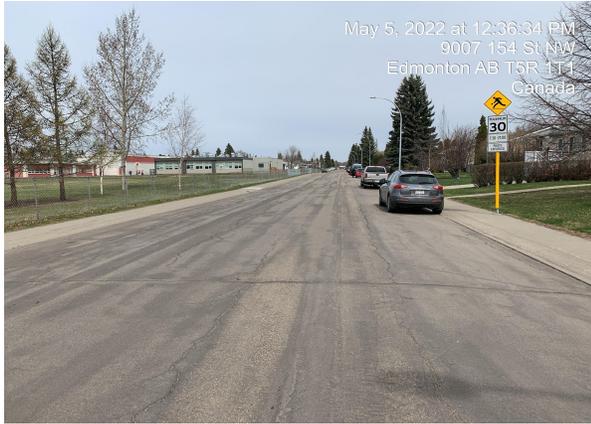
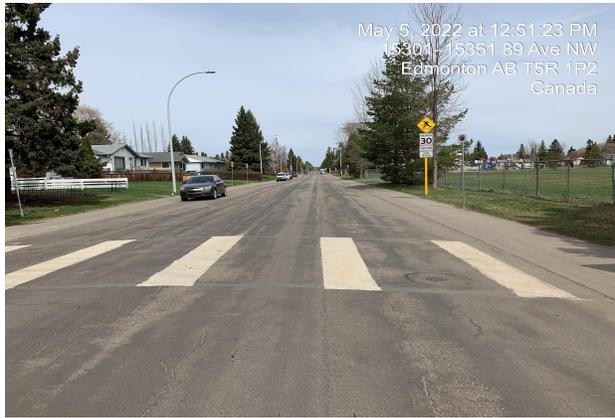
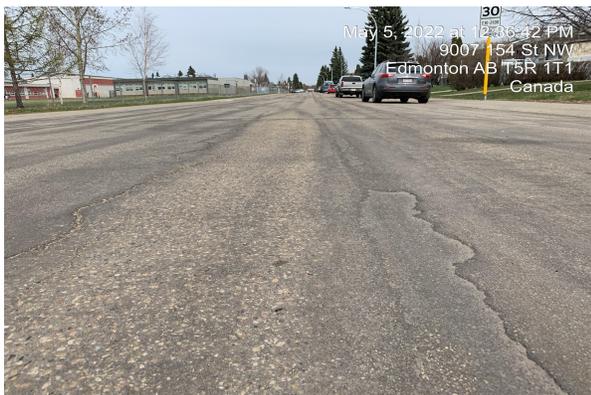
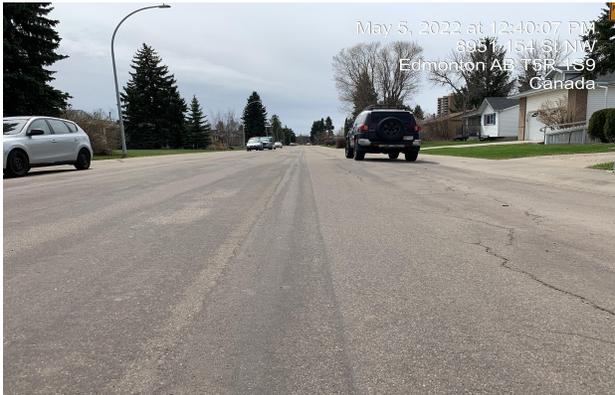
**Case Study III- Jasper Place Neighborhood (Type I, application rate 6.54 kg/m<sup>2</sup>, placed in 2016)**

Images from pre MSF application indicate that MSF was placed on a surface with many cracks, but was structurally sound. MSF was ravelled in the wheelpath areas, but was in place in other areas. This MSF was with the slurry seal fine gradation (Type 1) and with a low rate of the application; therefore, a life of 5 to 6 year could be considered as a reasonable performance. Due to extensive cracks, another MSF is not recommended for this road in the future. Photos 5 to 8 show the condition of MSF at this location.

Photos 5 to 8 show the condition of MSF after 6 years. Some ravelled areas between the wheelpaths were observed.

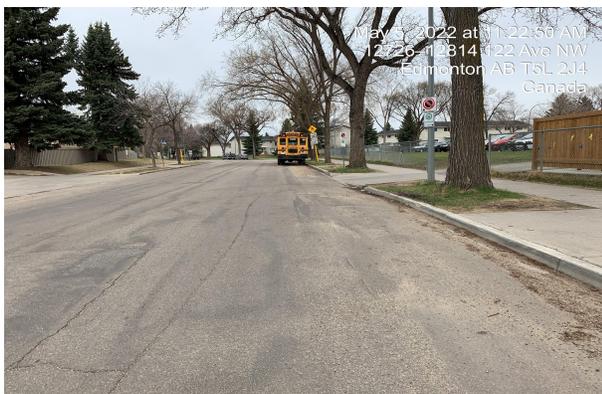
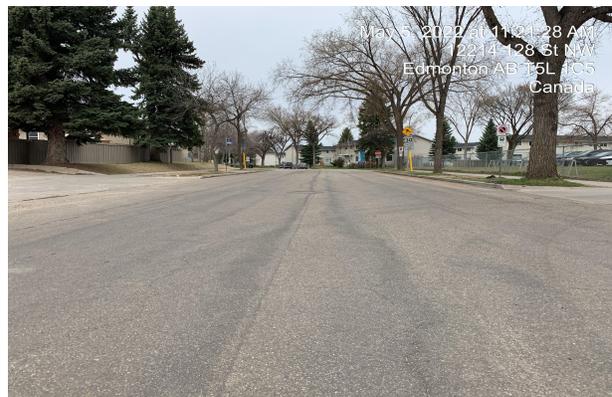
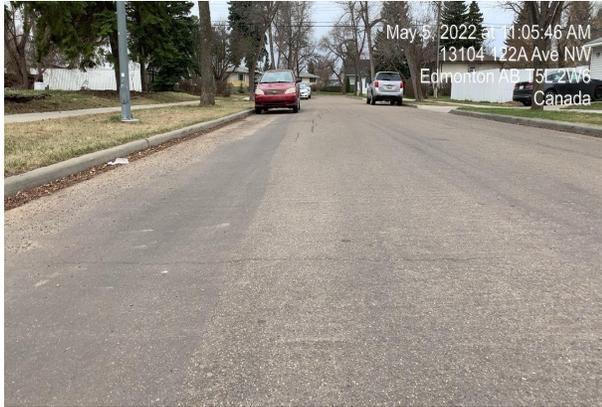
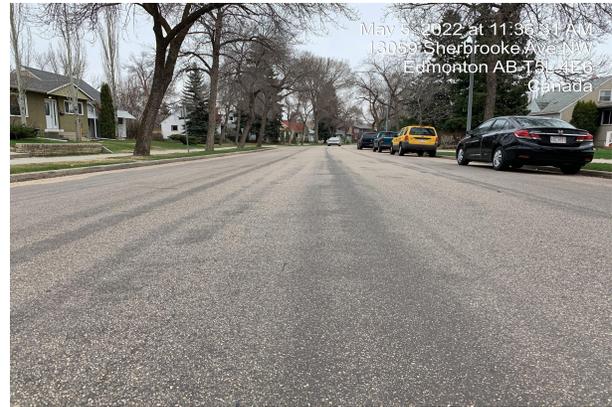
**Case Study IV - Sherbrooke Neighborhood (Type II, application rate 14.82 kg/m<sup>2</sup>, placed in 2020)**

Images from pre-construction indicate that MSF was placed at the early ages (8-10 years) after paving which was in a good condition without many cracks. At the time of inspection no failure or delamination was observed. Not many reflected cracks existed, only limited transverse cracks were reflected. Photos 9 to 12 show the effectiveness of MSF at the time of inspection after 2 years. Another MSF can be applied at this location in 5-7 years.

Photos 9 to 12: Effectiveness of MSF at different locations after 2 years

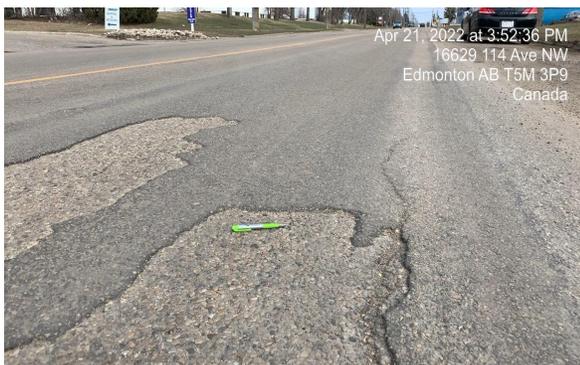
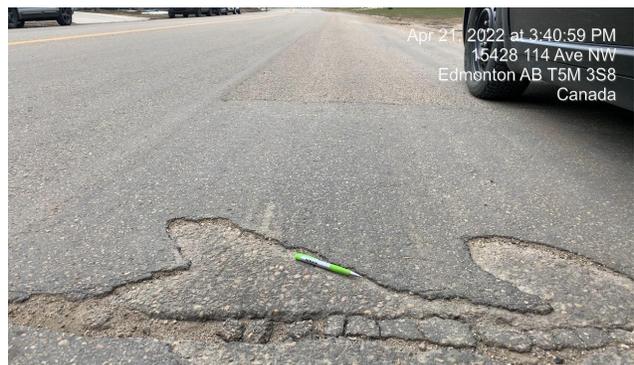
Based on field observations, this location was an extreme application for a MSF and it is not expected to last more than 5 years. Some damaged areas close to the curbs reflected in both directions. Most cracks reflected after the first winter. At two localized locations some surface delamination existed. One failed location was close to the rail crossing that had structural problems and another location could be related to dirty surface before MSF application in front of an approach. Except for these two locations, MSF was effective in other locations. If the main objective of this MSF was to provide short-term ride improvements and to postpone the next rehab, it can be claimed that MSF has done its job and has improved the ride significantly. Photos 13 and 14 show two delaminated areas close to the railway crossing. Photos 15 and 16 show locations with better MSF performance.

Photos 13 and 14: Two localized failed MSF locations

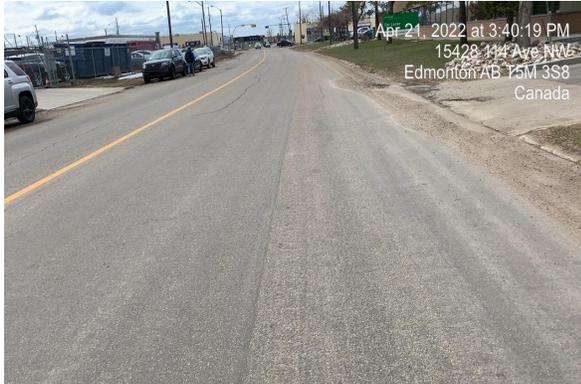
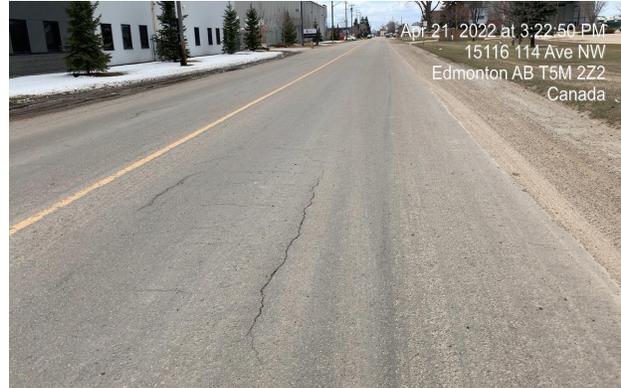
Photos 15 and 16: Area with reasonable MSF performance. Difference of surface colors between two lanes was noticed

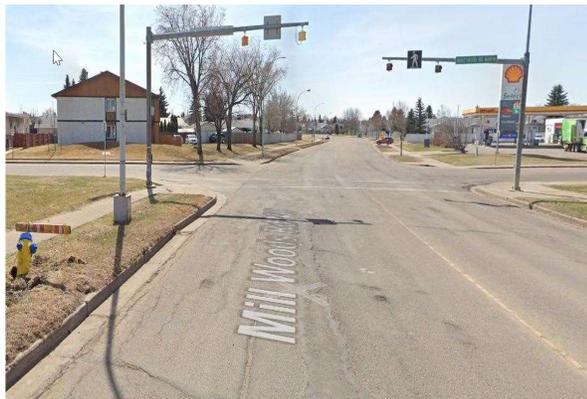
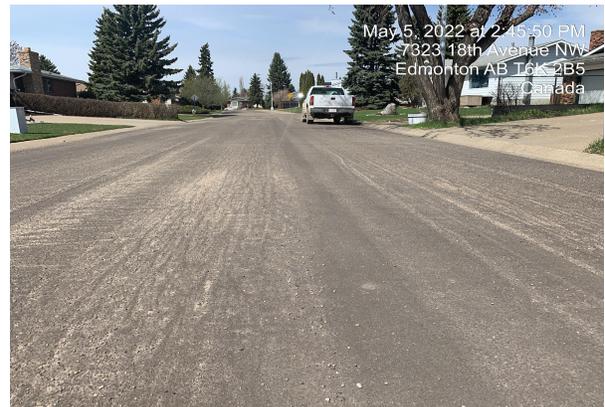
**Case study VI - Millwood Road at Knottwood North (Type II, application rate 14 kg/m<sup>2</sup>, placed in 2021)**

This MSF project was less than one year old at the time of inspection. MSF was in place without any ravelling or delamination. Limited longitudinal cracks were reflected. One observation was the presence of drag marks in most locations. Photos 17 and 18 show before and after MSF application conditions of this road.

Photo 17 : Pre-treatment condition (left). Photo 18: MSF condition after the first year. A drag mark was visible in most locations (right)
